ROOF EVALUATION REPORT

***FRANKLIN TOWNSHIP COMM. SCHOOL CORPORATION
THOMPSON CROSSING ELEMENTARY SCHOOL
7525 EAST THOMPSON ROAD
INDIANAPOLIS, INDIANA***

MARCH 17, 2021

**R.M.I. # 021-193
MARCH 17, 2021**

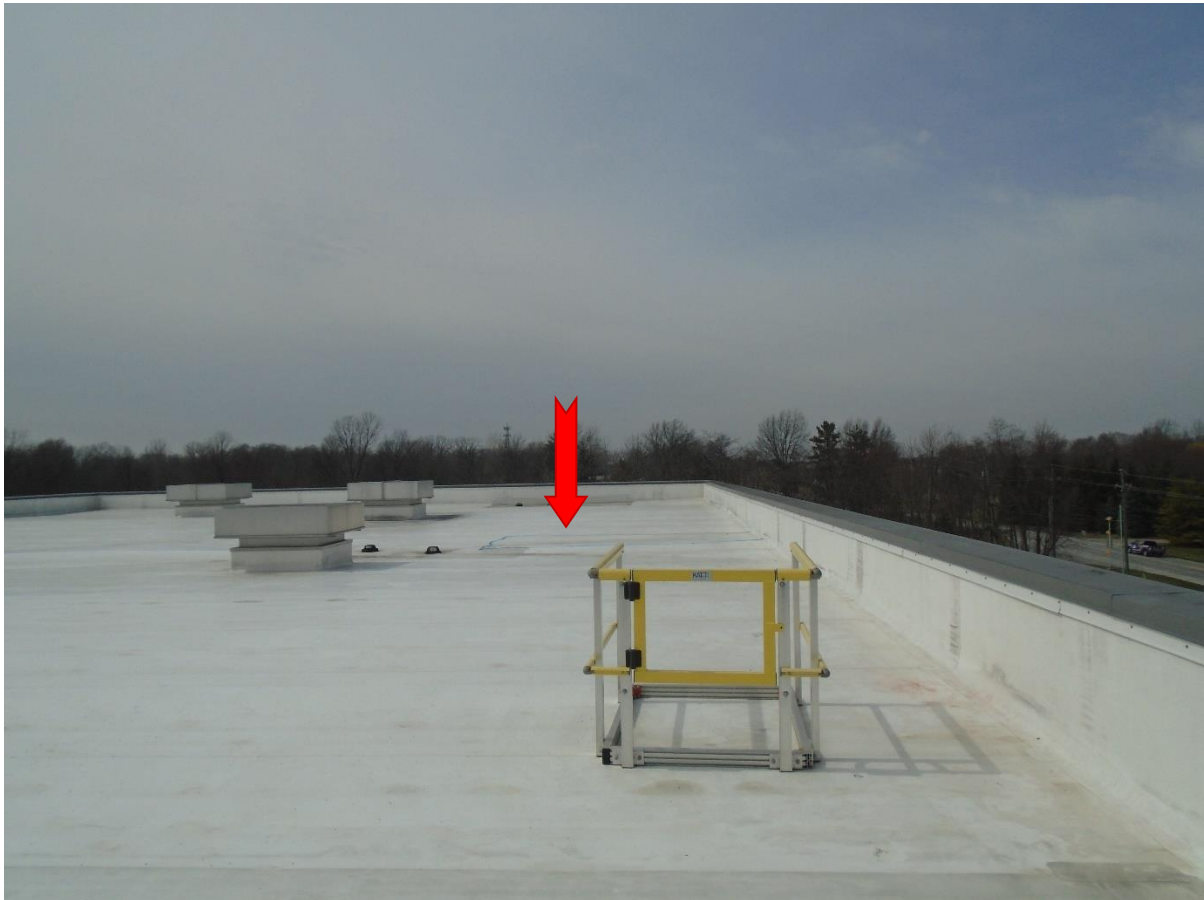
PHOTO TWO

CONDITION: **A view of wet substrate (*in the distance*) identified in the Infrared Roof Moisture Survey; one surface anomaly was identified in this area.**

RECOMMENDED ACTION: **All affected material should be removed and replaced with matching materials.**

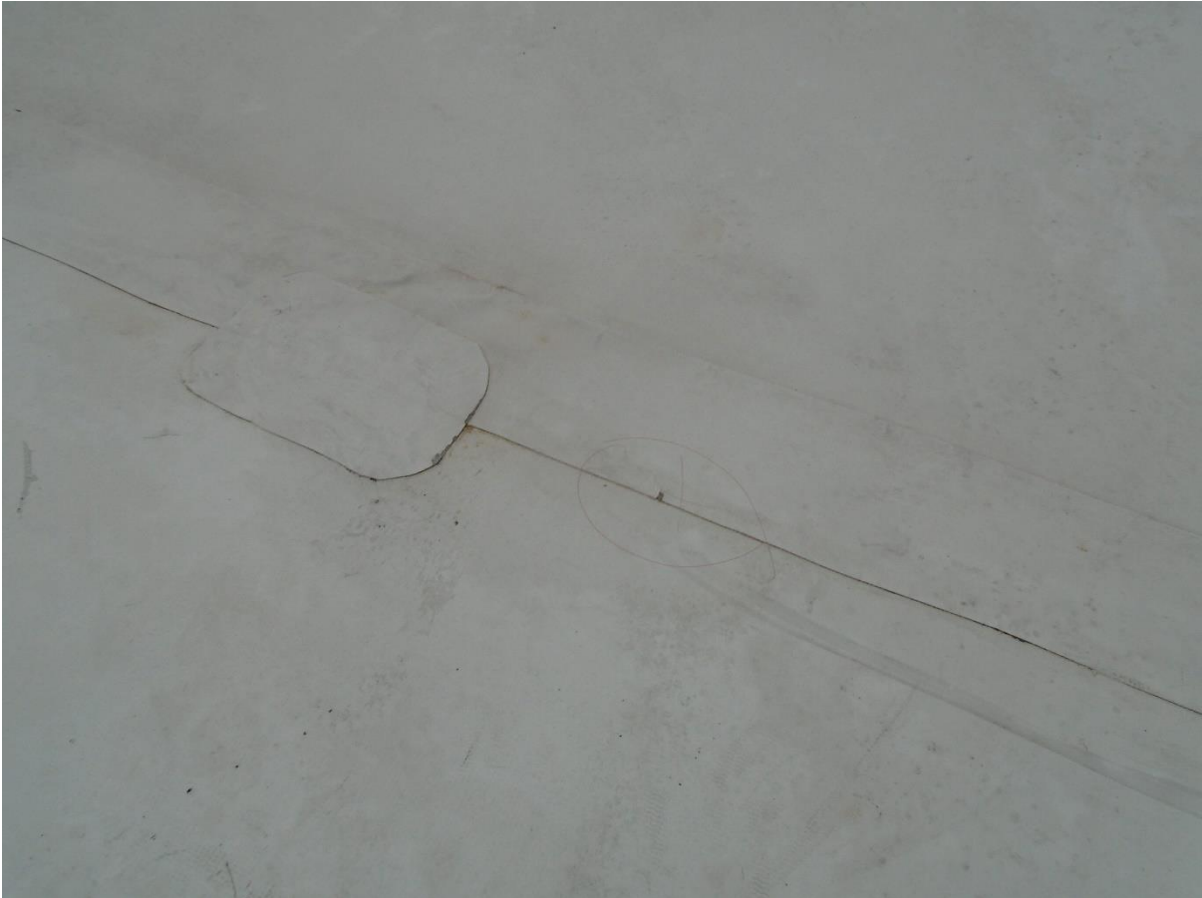
PHOTO THREE

CONDITION: There is a void in the field seam at this location.

RECOMMENDED ACTION: The void should be repaired with Thermoplastic membrane.

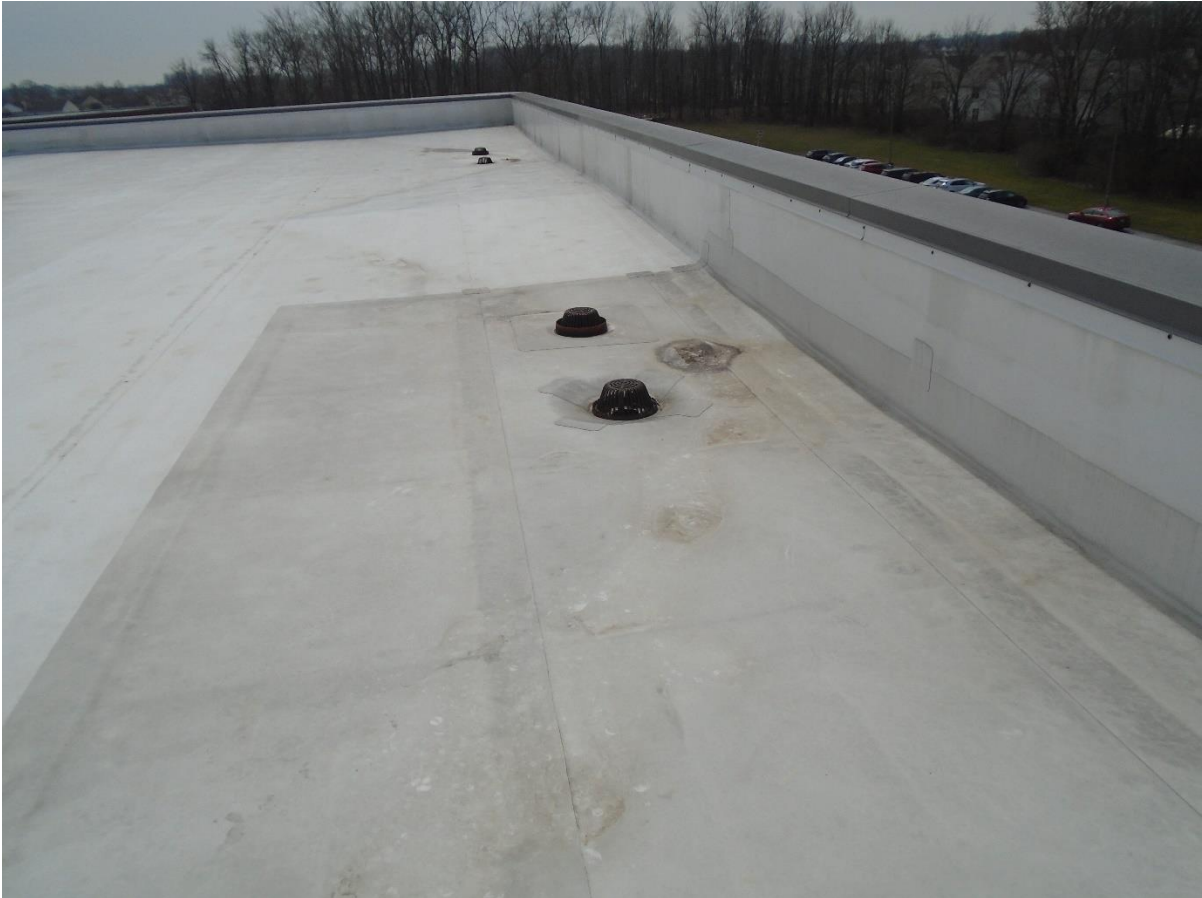
PHOTO FOUR

CONDITION: Previous repairs were noted in random locations.

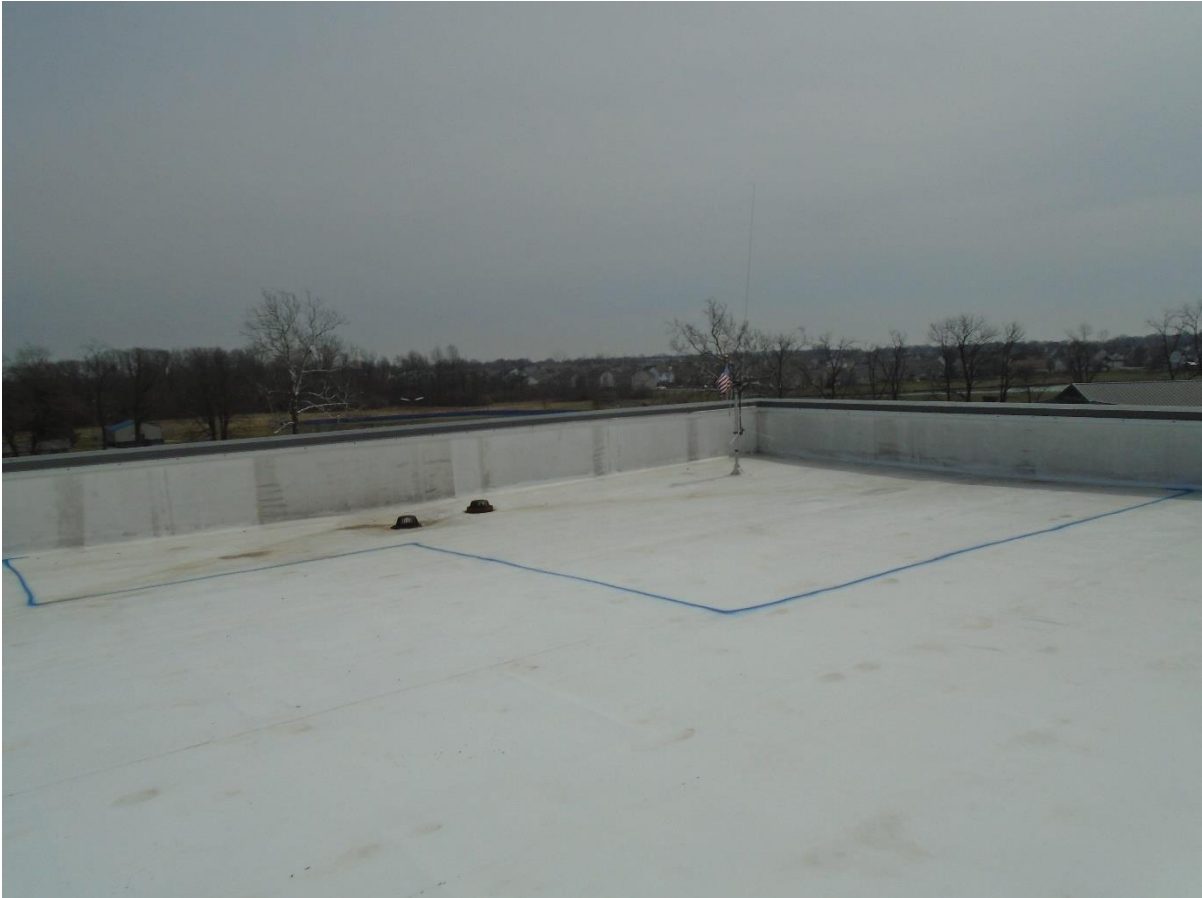
PHOTO FIVE

CONDITION: **A view of wet substrate identified in the Infrared Roof Moisture Survey; several surface anomalies were identified in this area.**

RECOMMENDED ACTION: **All affected material should be removed and replaced with matching materials.**

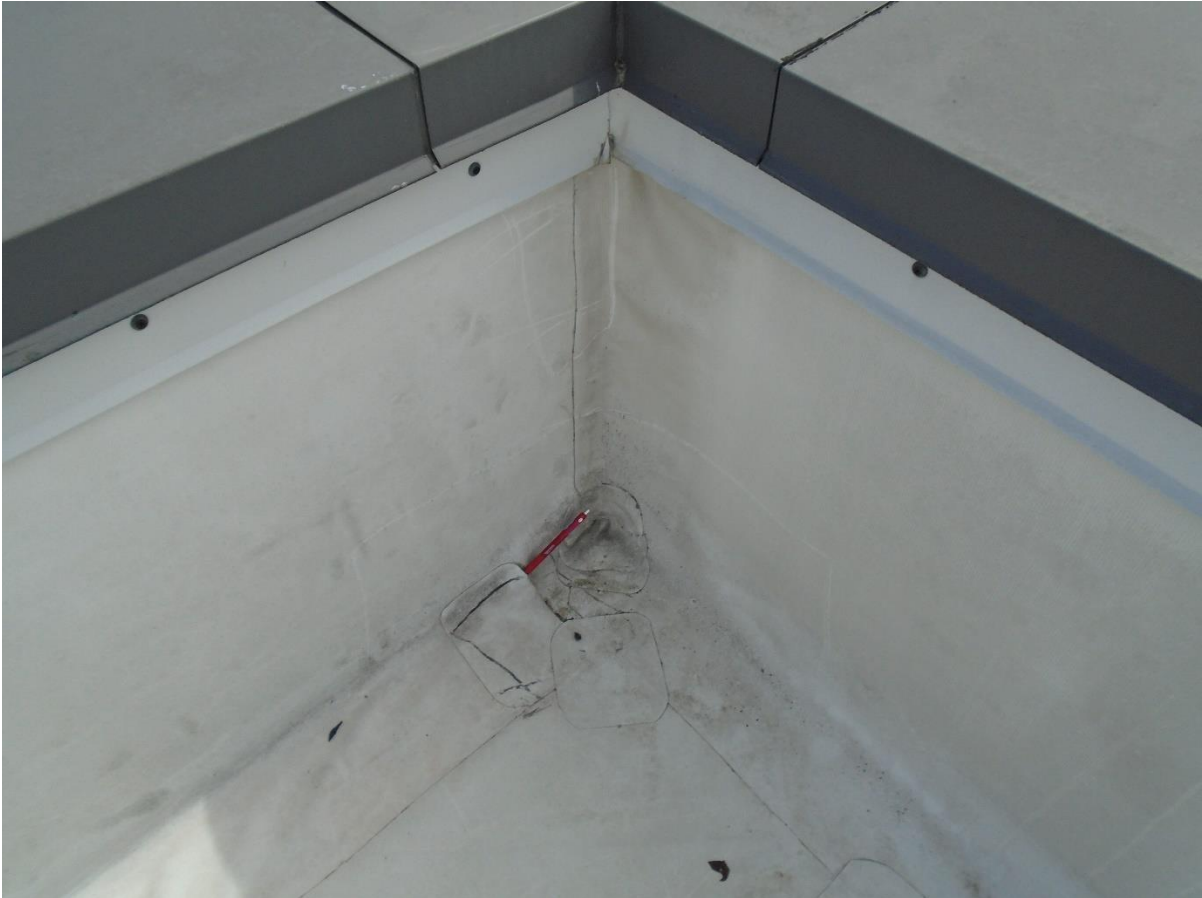
PHOTO SIX

CONDITION: There is a void in the corner flashing at this location.

RECOMMENDED ACTION: The void should be repaired with matching Thermoplastic membrane.

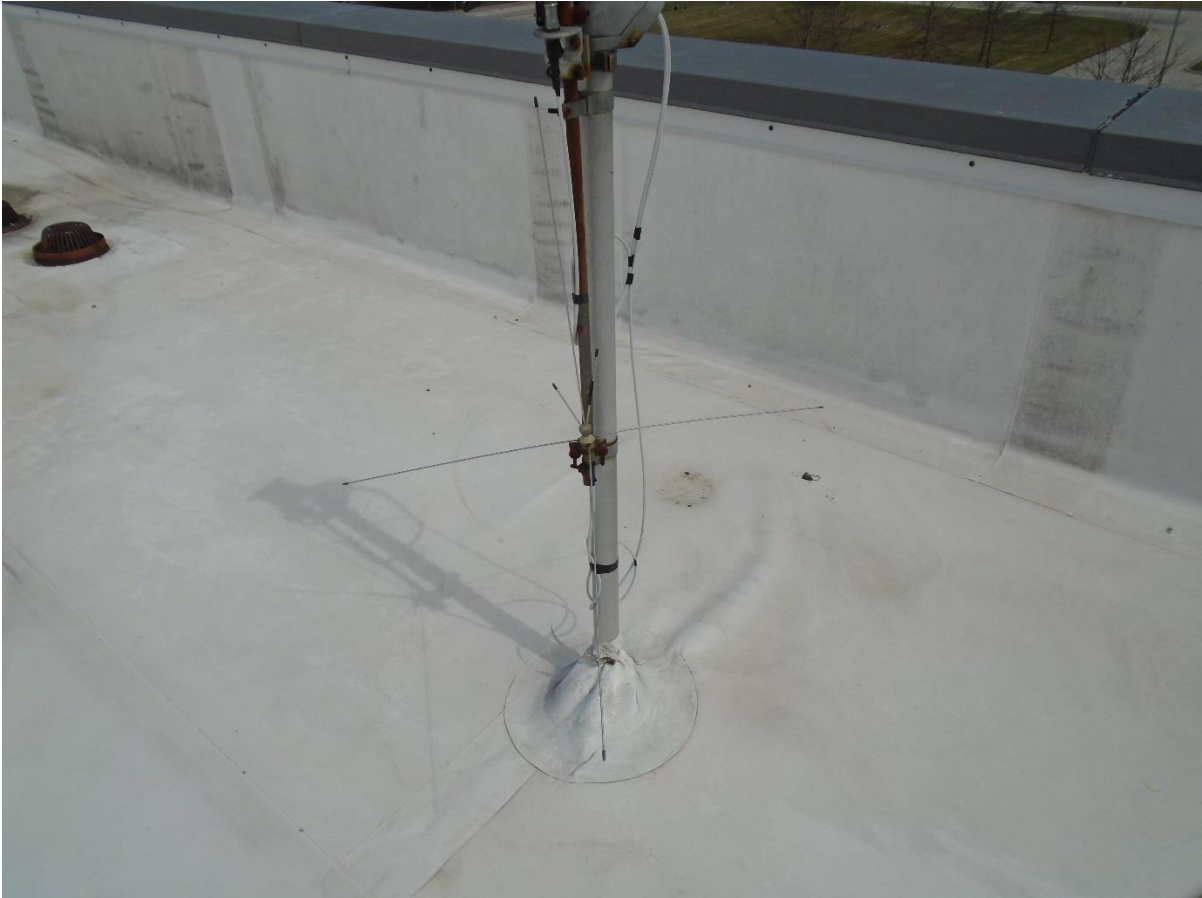
PHOTO SEVEN

CONDITION: The pipe boot is disfigured at this location.

RECOMMENDED ACTION: The pipe boot should be removed and replaced with a prefabricated Thermoplastic pipe boot.

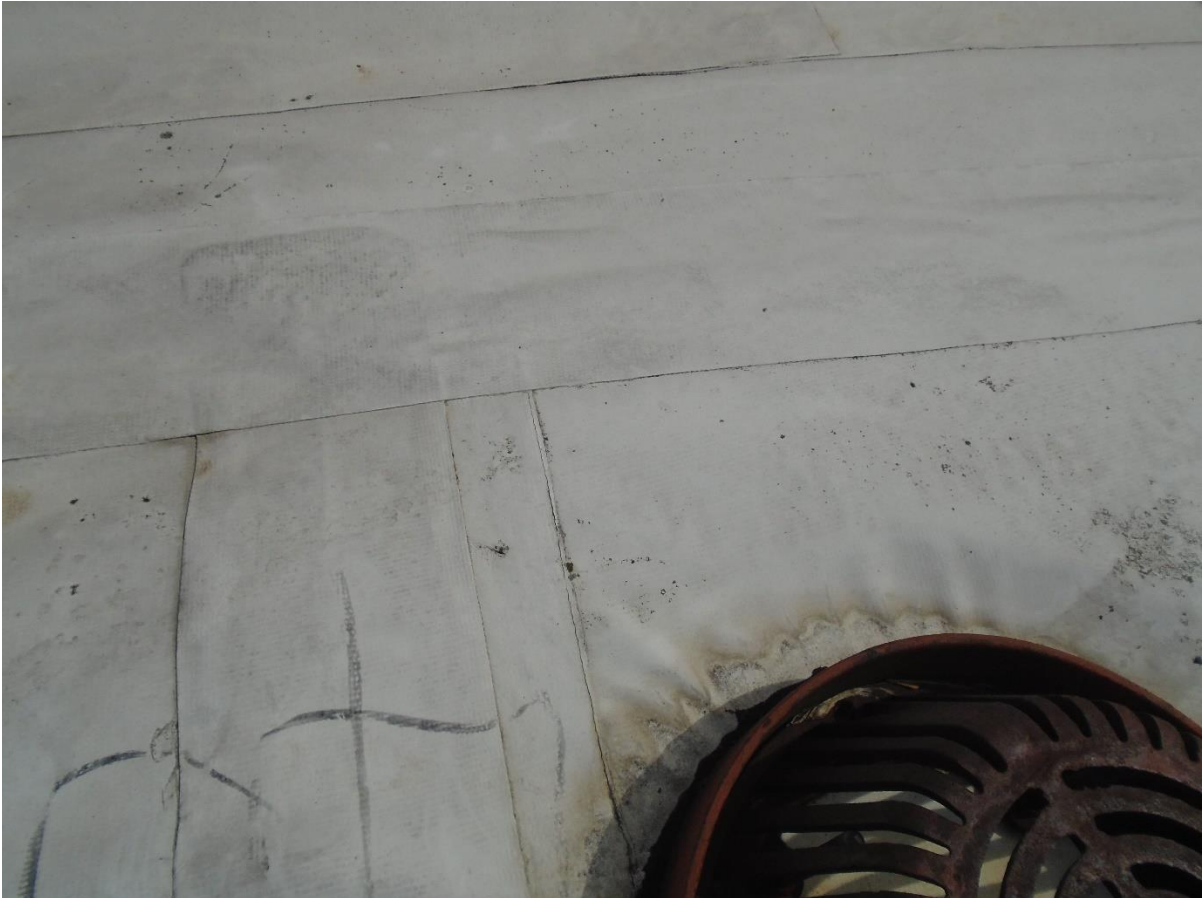
PHOTO EIGHT

CONDITION: The field membrane is cracking at this location.

RECOMMENDED ACTION: The affected membrane should be covered with a Thermoplastic "target patch".

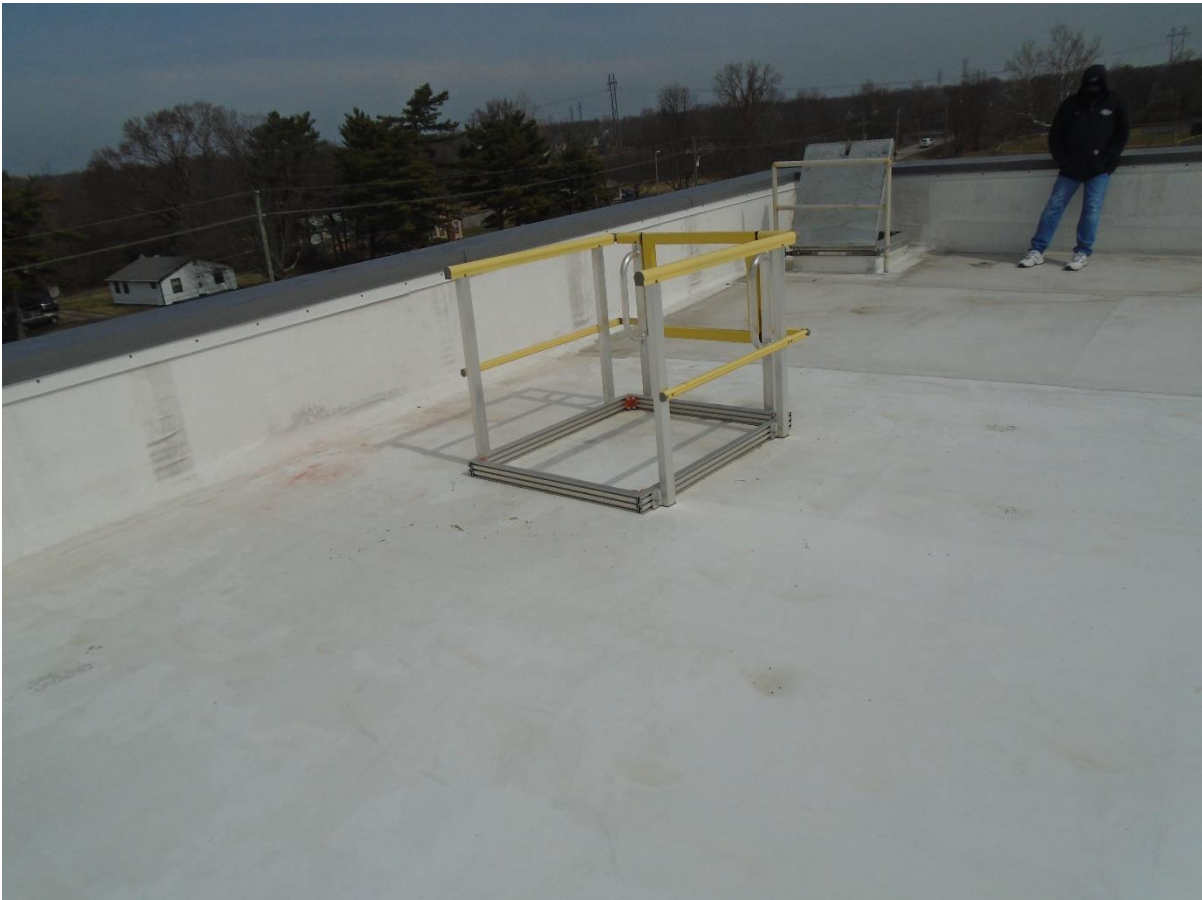
PHOTO NINE

CONDITION: Another view of view of an uninstalled roof hatch safety surround. Nutec Roofing will be on site the week of April 12, 2021 to reinstall the gate as it was part of the roof repair scope of work they completed in 2020.

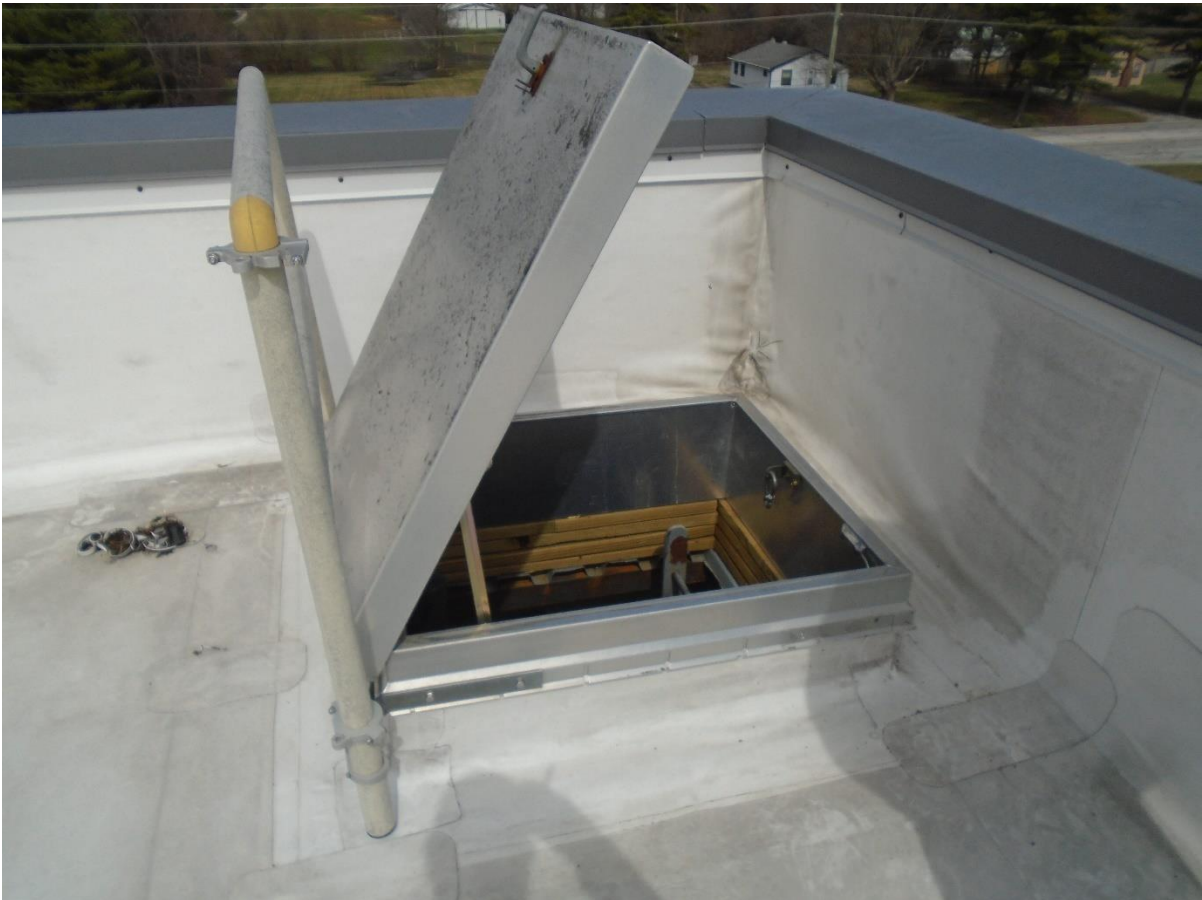
PHOTO TEN

CONDITION: Roof traffic around the roof hatch presents a fall hazard. A safety rail system should be installed along this perimeter.

RECOMMENDED ACTION: Correction of this condition should be considered in the design phase of the roof replacement.

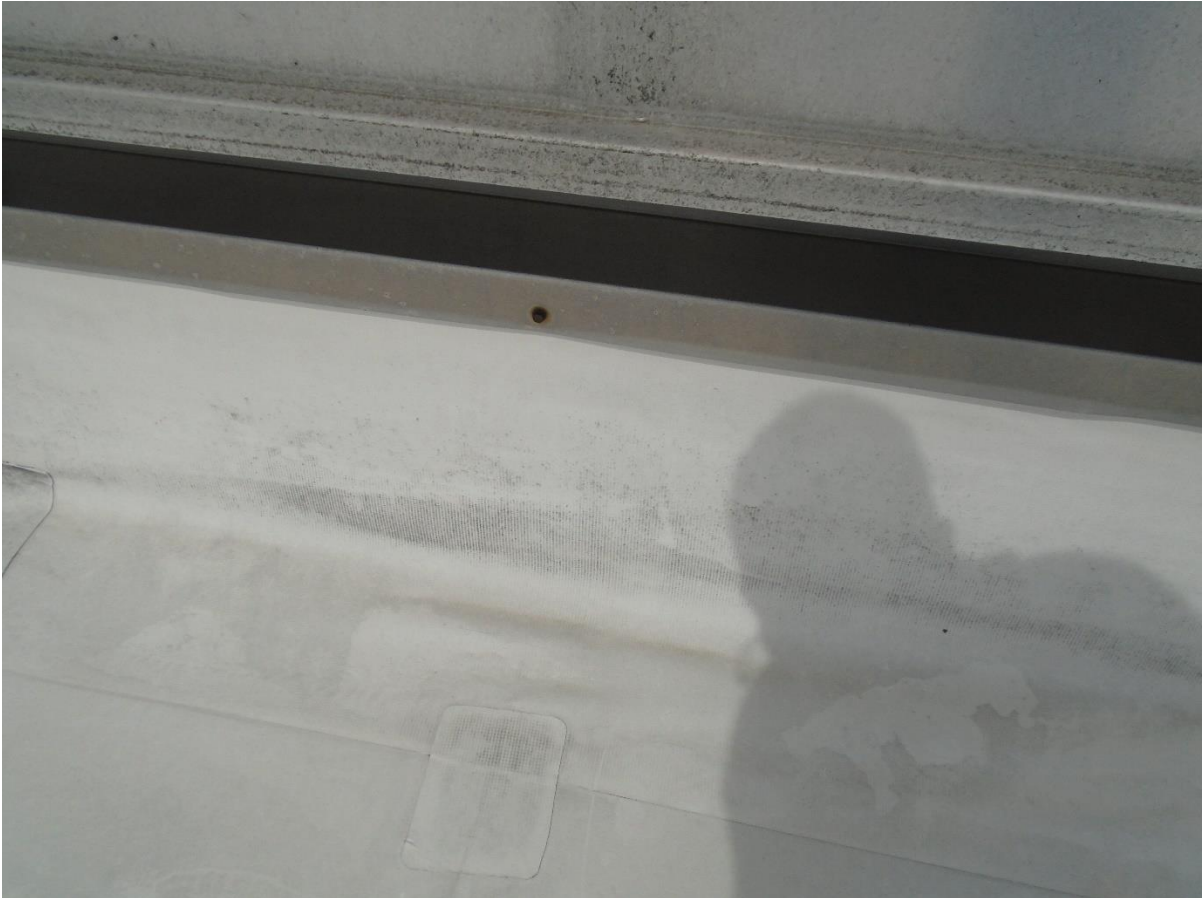
PHOTO ELEVEN

CONDITION: The membrane flashings are deteriorating at random locations.

RECOMMENDED ACTION: This condition should be monitored until roof replacement in 2022.

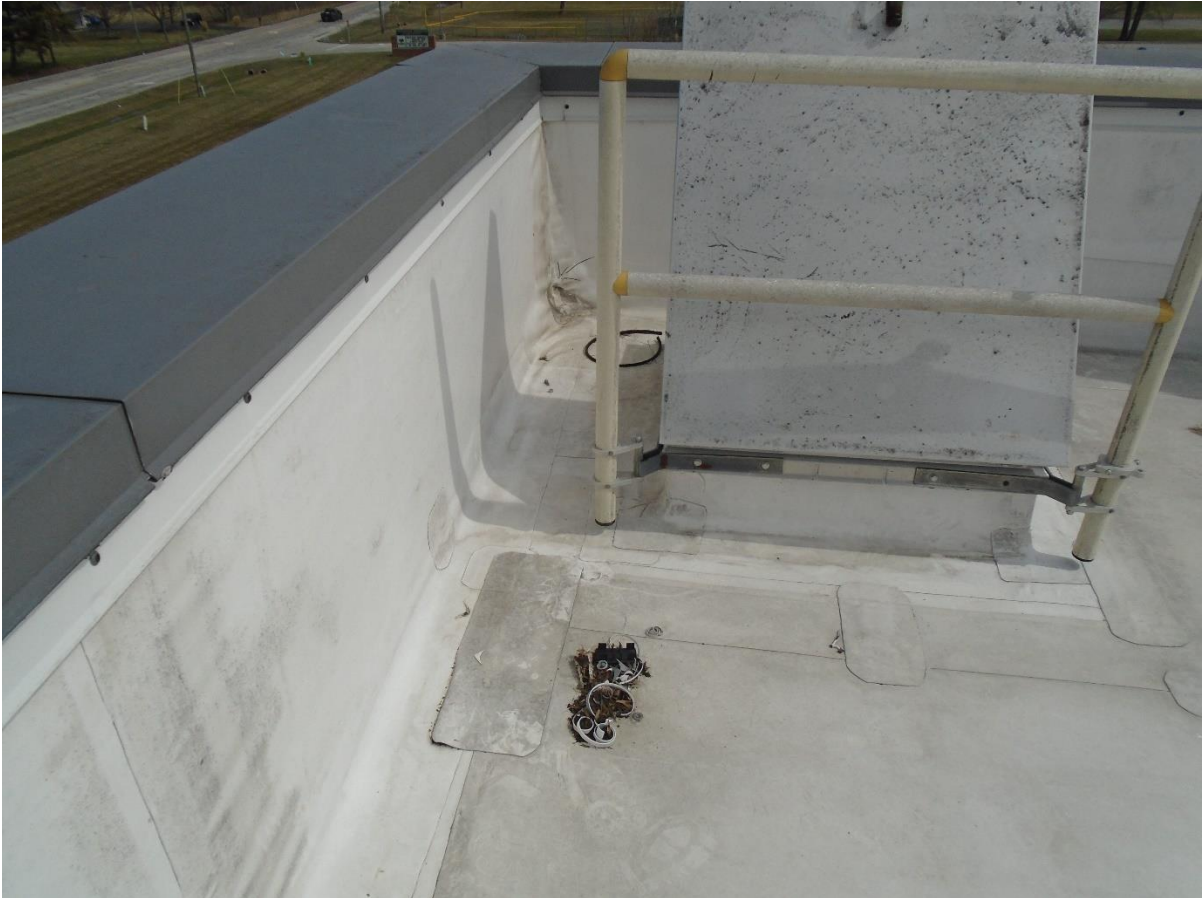
PHOTO TWELVE

CONDITION: There is a void in the previous repair attempt at this location.

RECOMMENDED ACTION: The void should be repaired with matching Thermoplastic membrane.

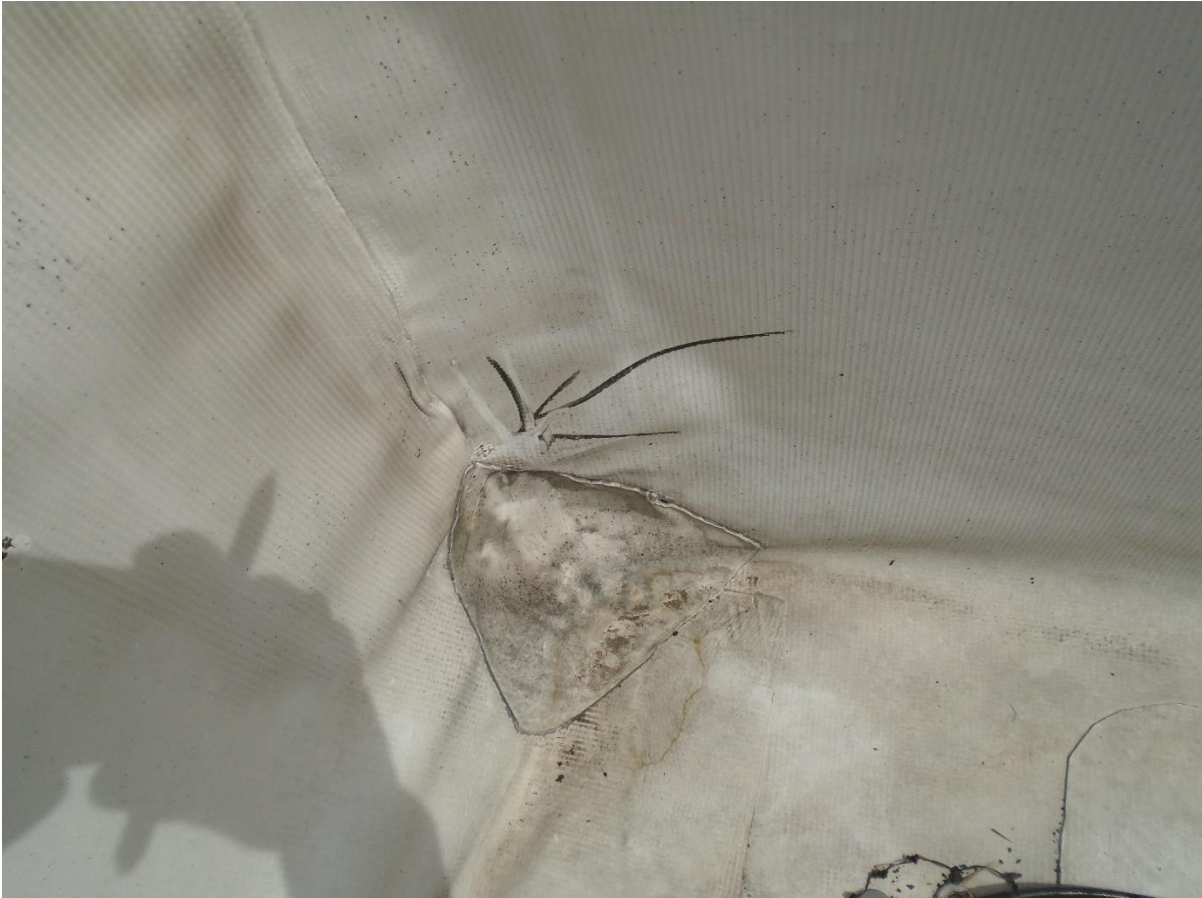
PHOTO THIRTEEN

CONDITION: There is a void in the corner flashing at this location.

RECOMMENDED ACTION: The void should be repaired with matching Thermoplastic membrane.

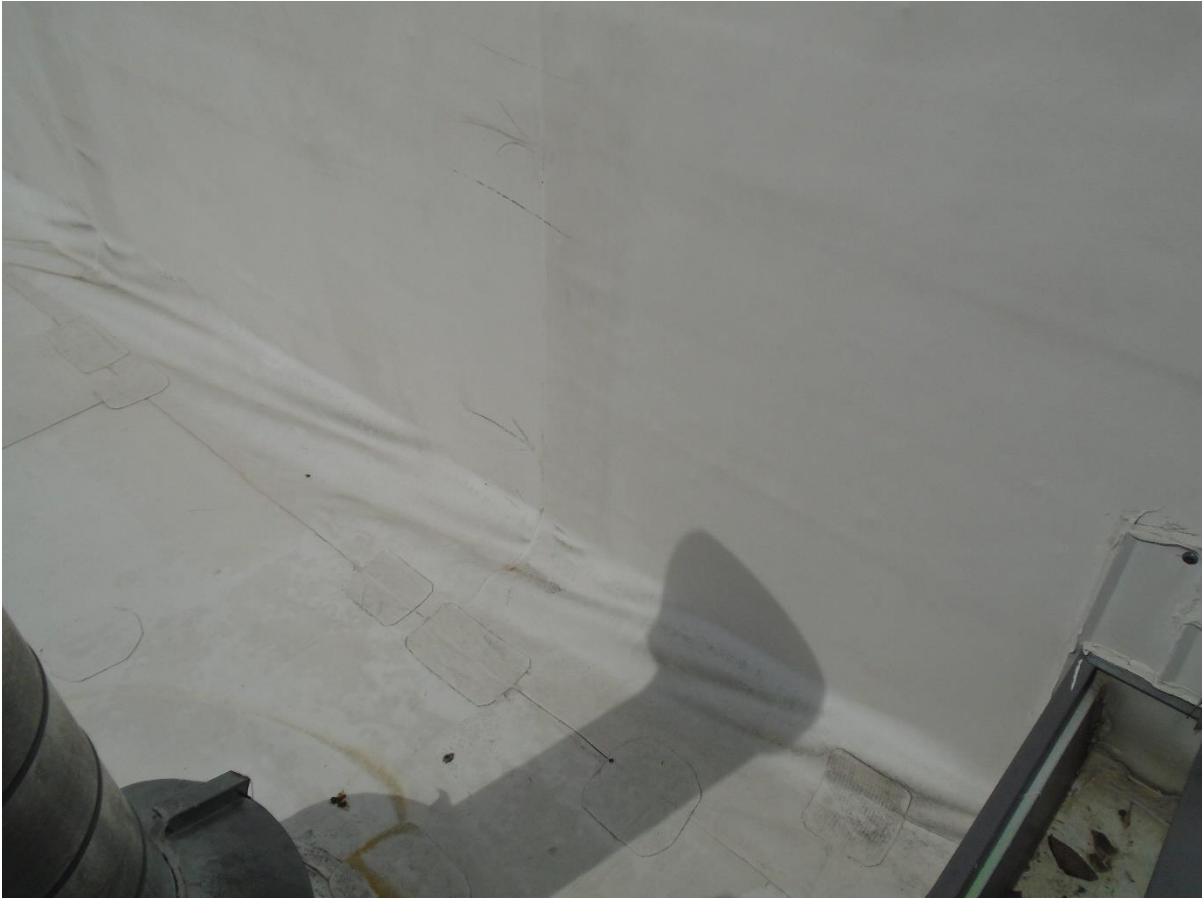
PHOTO EIGHTEEN

CONDITION: The membrane base flashing is racking in random locations.

RECOMMENDED ACTION: This condition should be monitored until roof replacement in 2022.

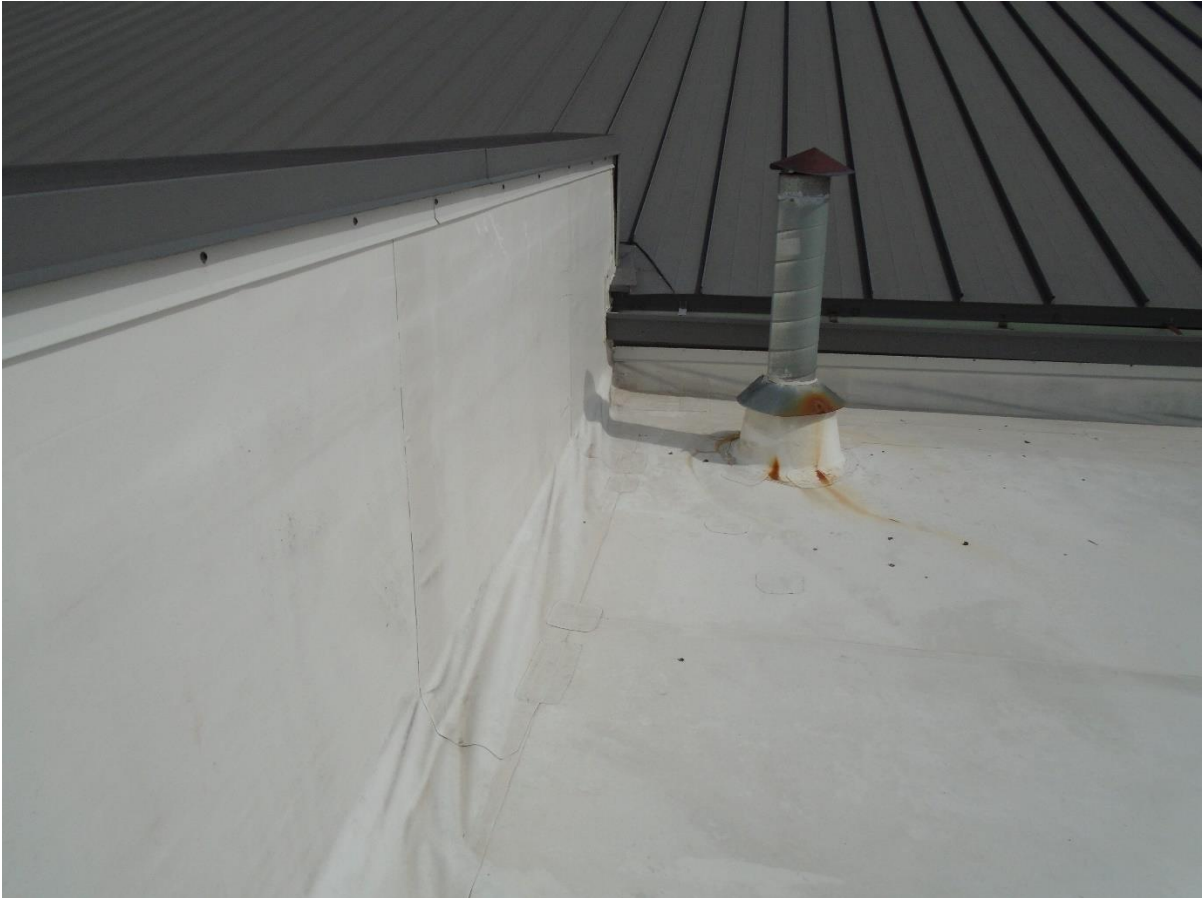
PHOTO NINETEEN

CONDITION: The sheet metal cap is rusted at this location.

RECOMMENDED ACTION: All rusted material should be painted with a rust inhibitor paint.

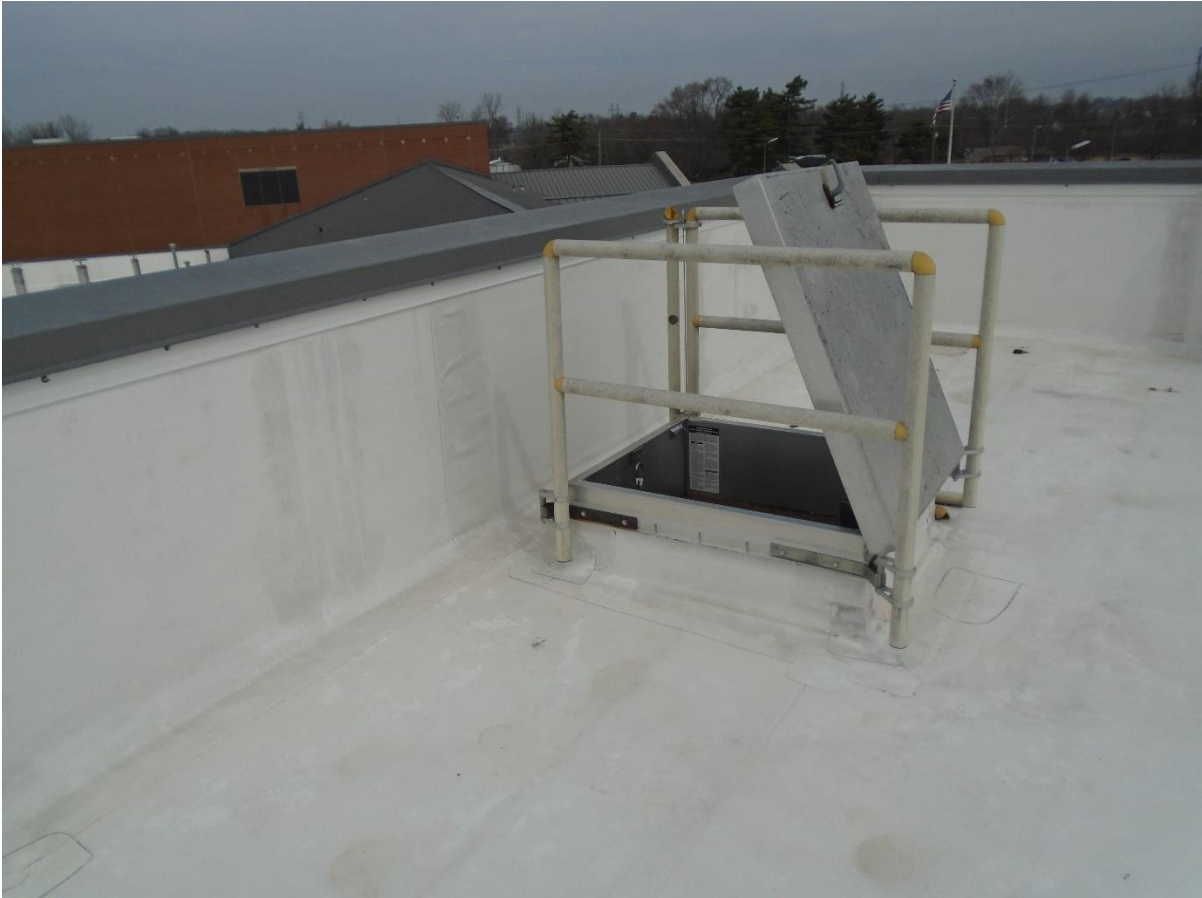
PHOTO TWENTY-ONE

CONDITION: Use of the roof hatch presents a fall hazard. A safety operable rail system should be installed around this roof hatch.

RECOMMENDED ACTION: Correction of this condition should be considered in the design phase of the roof replacement.

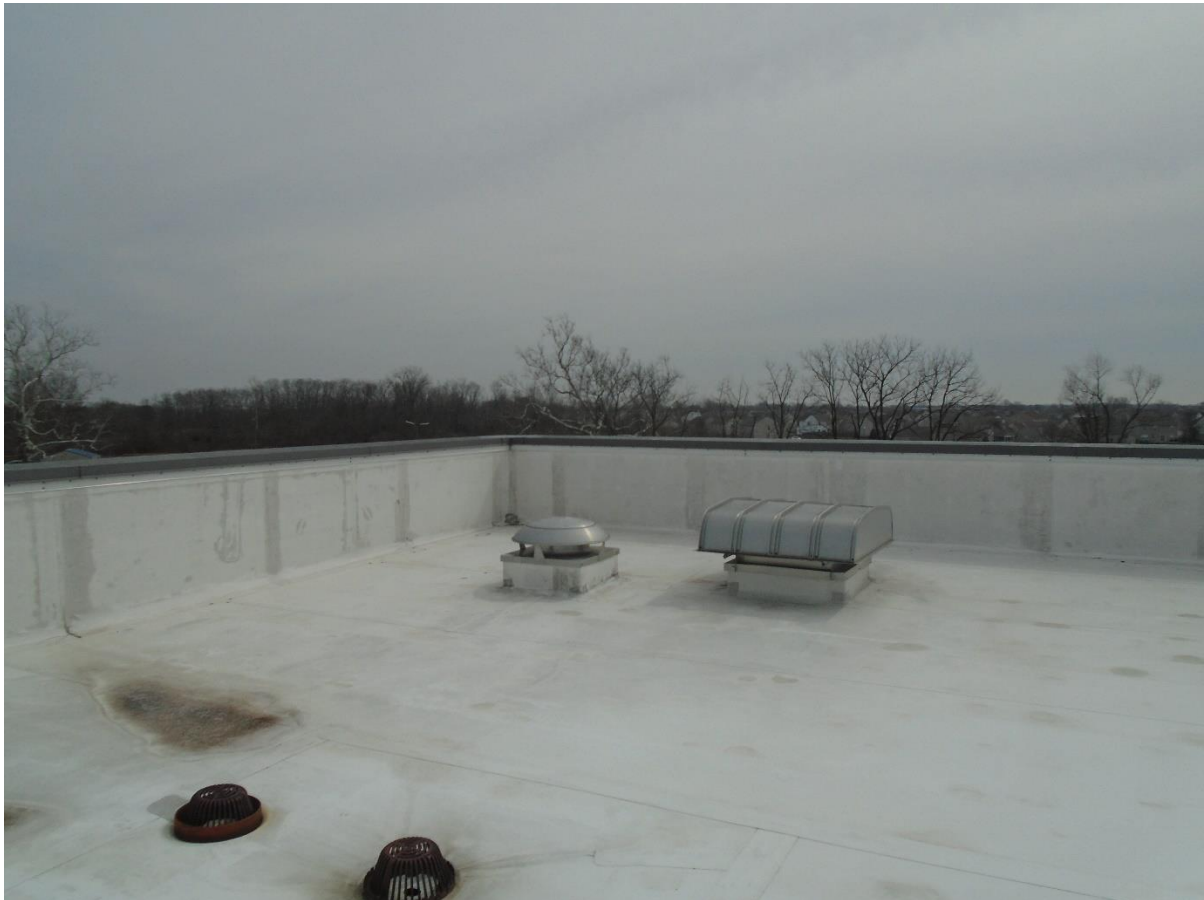
PHOTO TWENTY-TWO

CONDITION: **A view of wet substrate identified in the Infrared Roof Moisture Survey; no surface anomalies were identified in this area.**

RECOMMENDED ACTION: **All affected material should be removed and replaced with matching materials.**

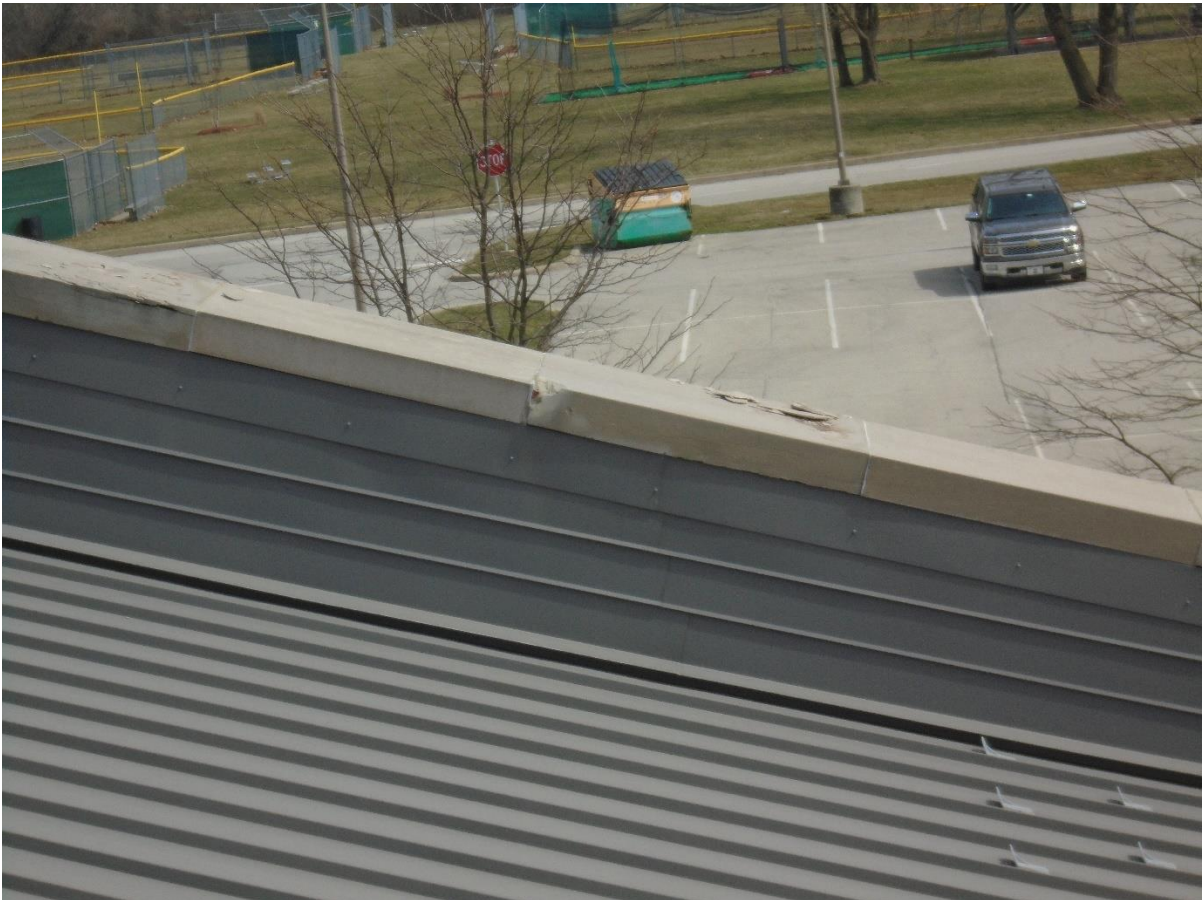
PHOTO TWENTY-NINE

CONDITION: The masonry coping stones are deteriorating at this location.

RECOMMENDED ACTION: A masonry professional should evaluate.

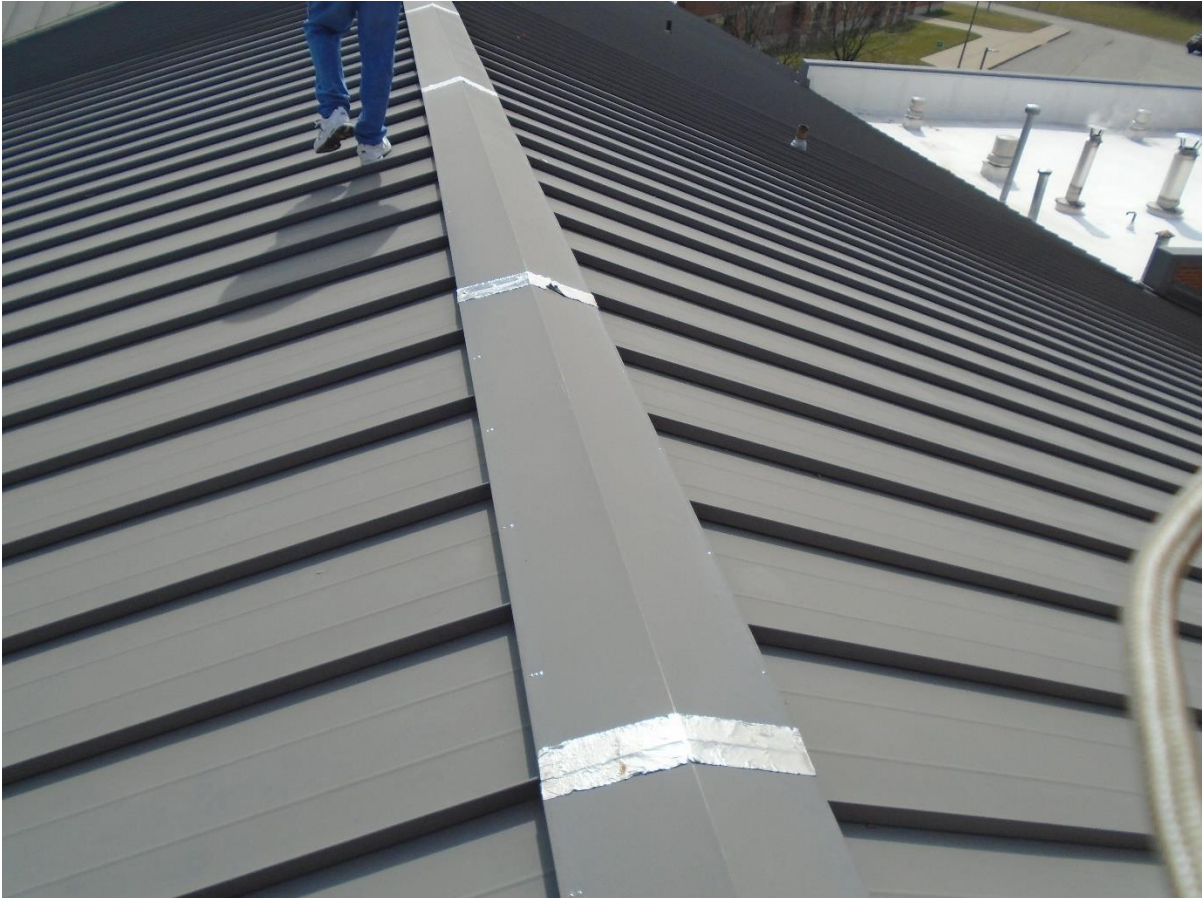
PHOTO THIRTY

CONDITION: A view of previous repairs on Section J.

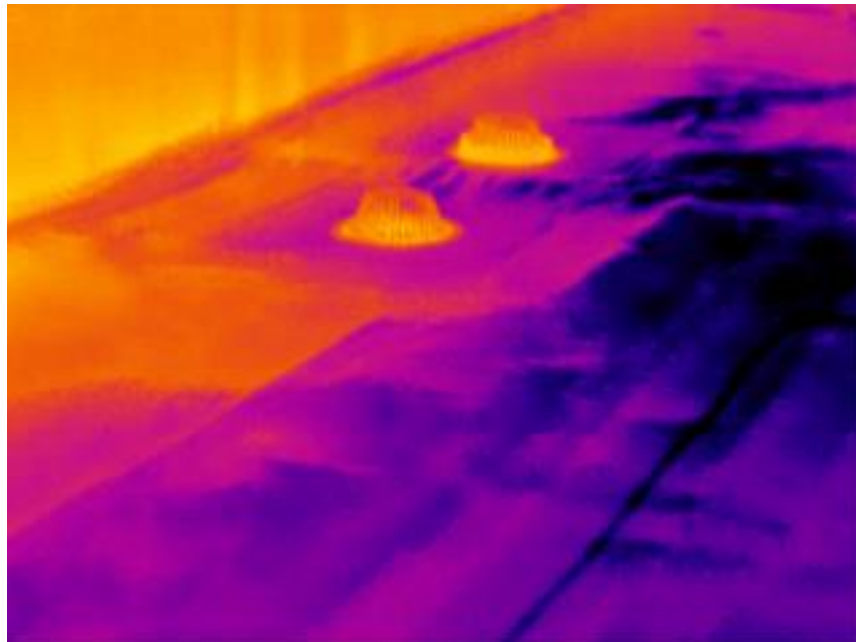
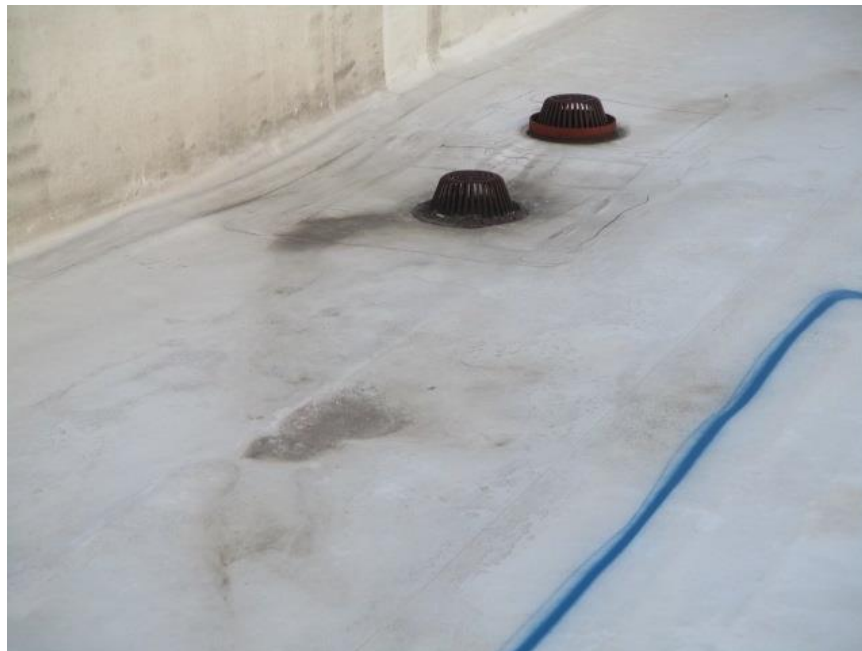
THERMOGRAM ONE

LOCATION: Roof Section A, Wet Area #1

REMARKS: The brighter areas appearing on the surface of the roof depict moisture laden insulation. This wet area, located in the north drain valley, was one of two wet areas detected on this upper-level roof section.

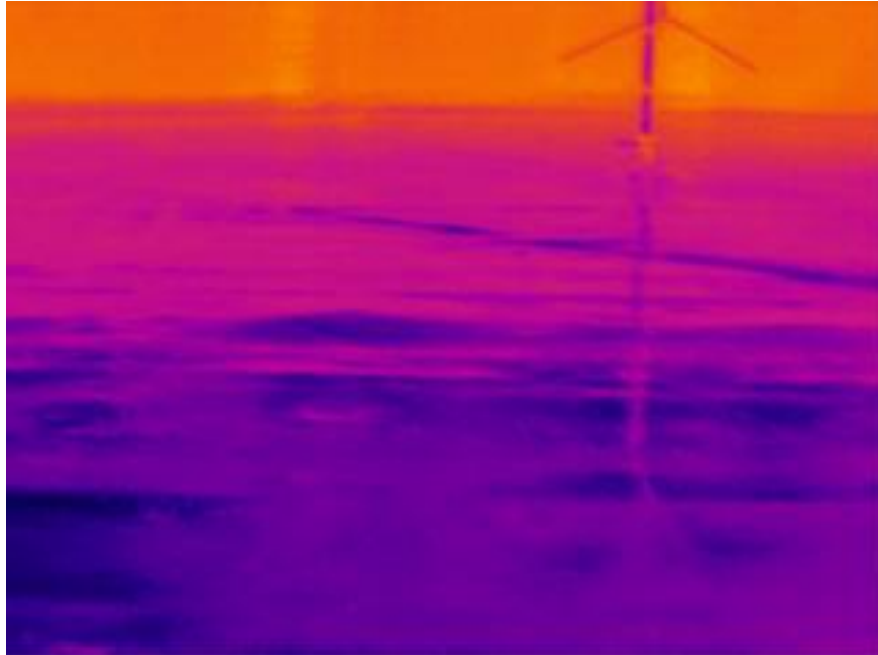
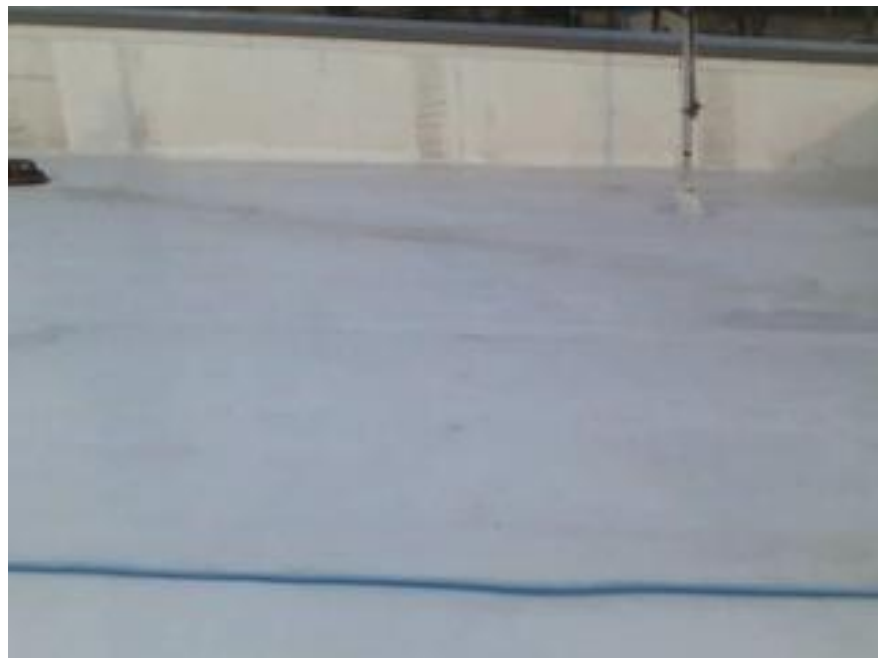
THERMOGRAM TWO

LOCATION: Roof Section D, Wet Area #2

REMARKS: Sub-surface moisture is migrating down the slope of the roof in this area.
