## ***ROOF EVALUATION REPORT***

***FRANKLIN TOWNSHIP COMMUNITY SCHOOL CORPORATION  
SOUTH CREEK ELEMENTARY SCHOOL  
9010 EAST SOUTHPORT ROAD  
INDIANAPOLIS, INDIANA***

***REVISED APRIL 12, 2021***

**R.M.I. # 021-192  
*REVISED* APRIL 12, 2021**

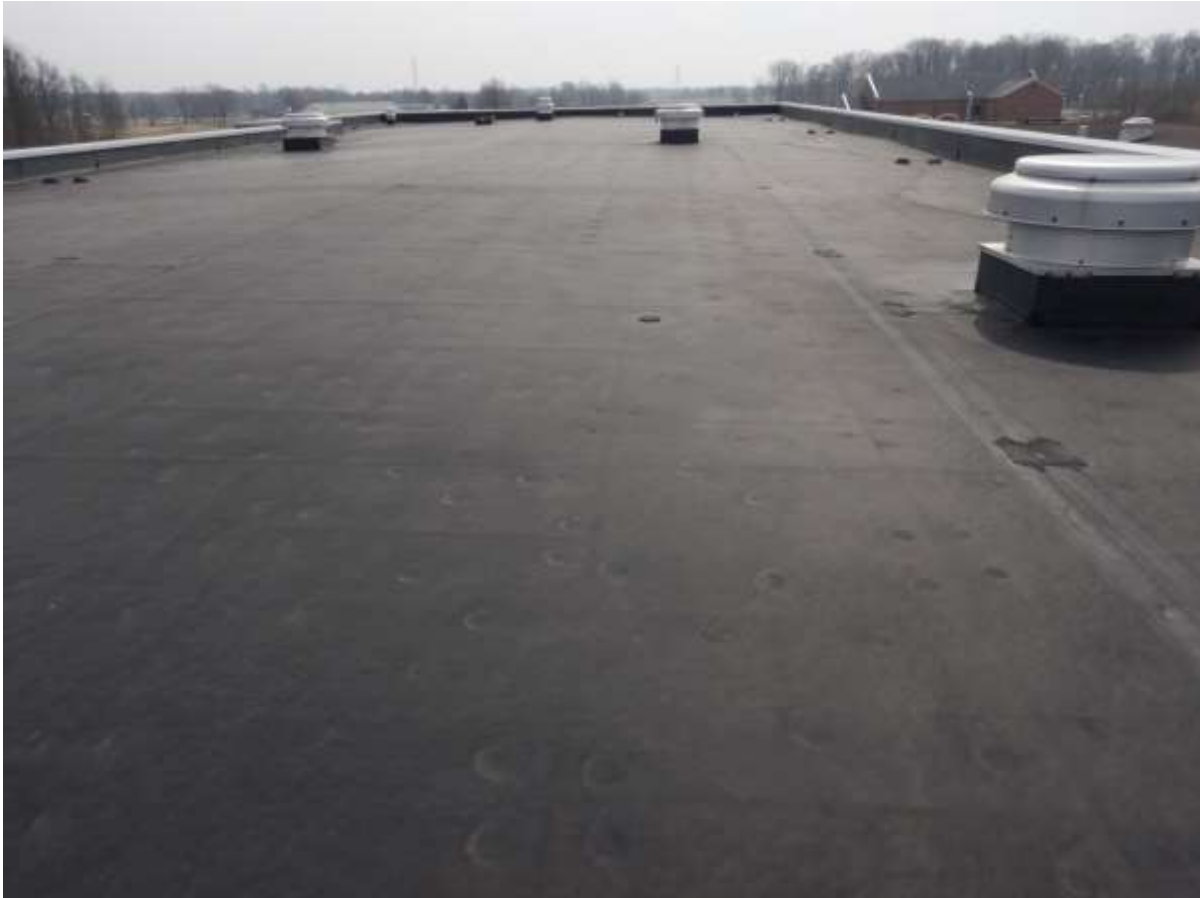
**PHOTO ONE**

**CONDITION:** An overview of the Fully Adhered EPDM Roof System on Section A.

**RECOMMENDED ACTION:** For your information.

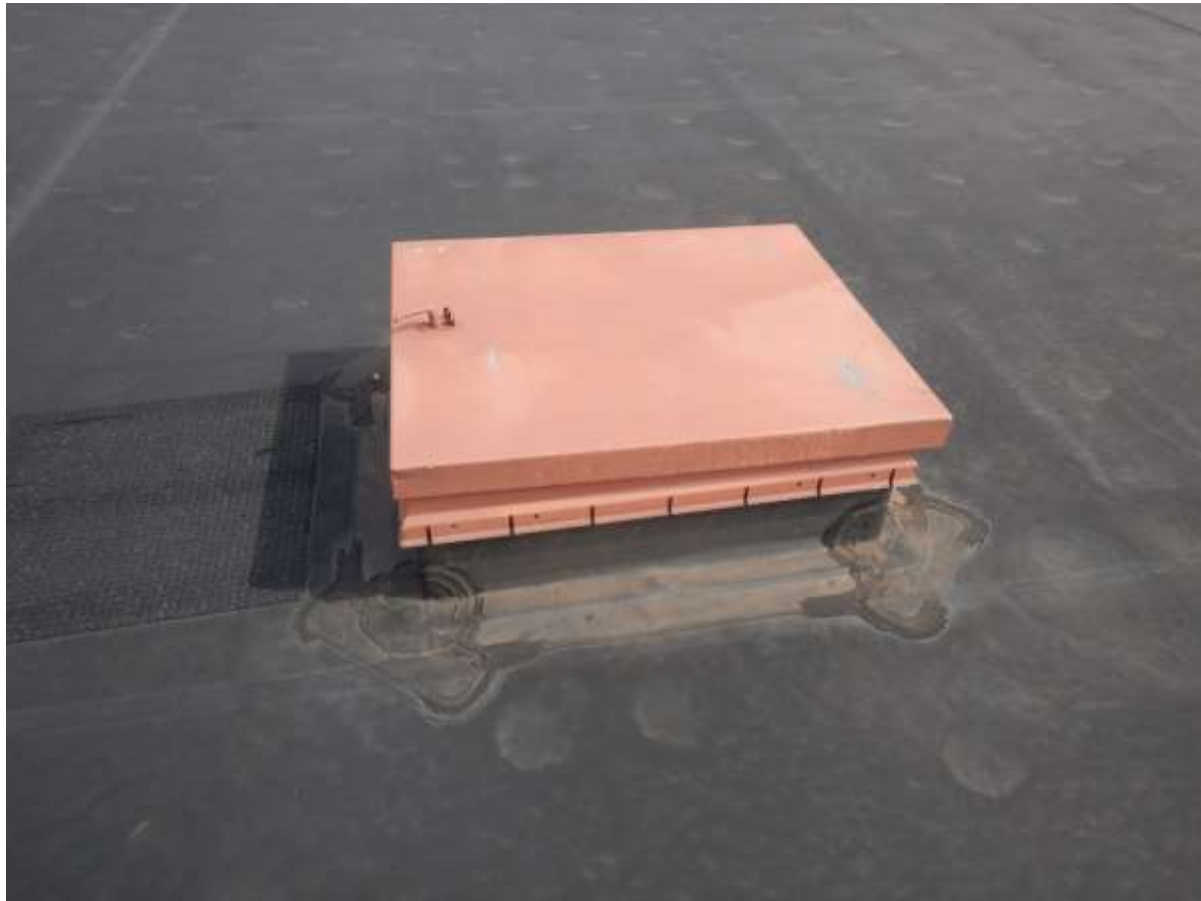
**PHOTO TWO**

**CONDITION:** Use of the roof hatch presents a fall hazard. A safety rail system should be installed around this roof hatch.

**RECOMMENDED ACTION:** For your information.

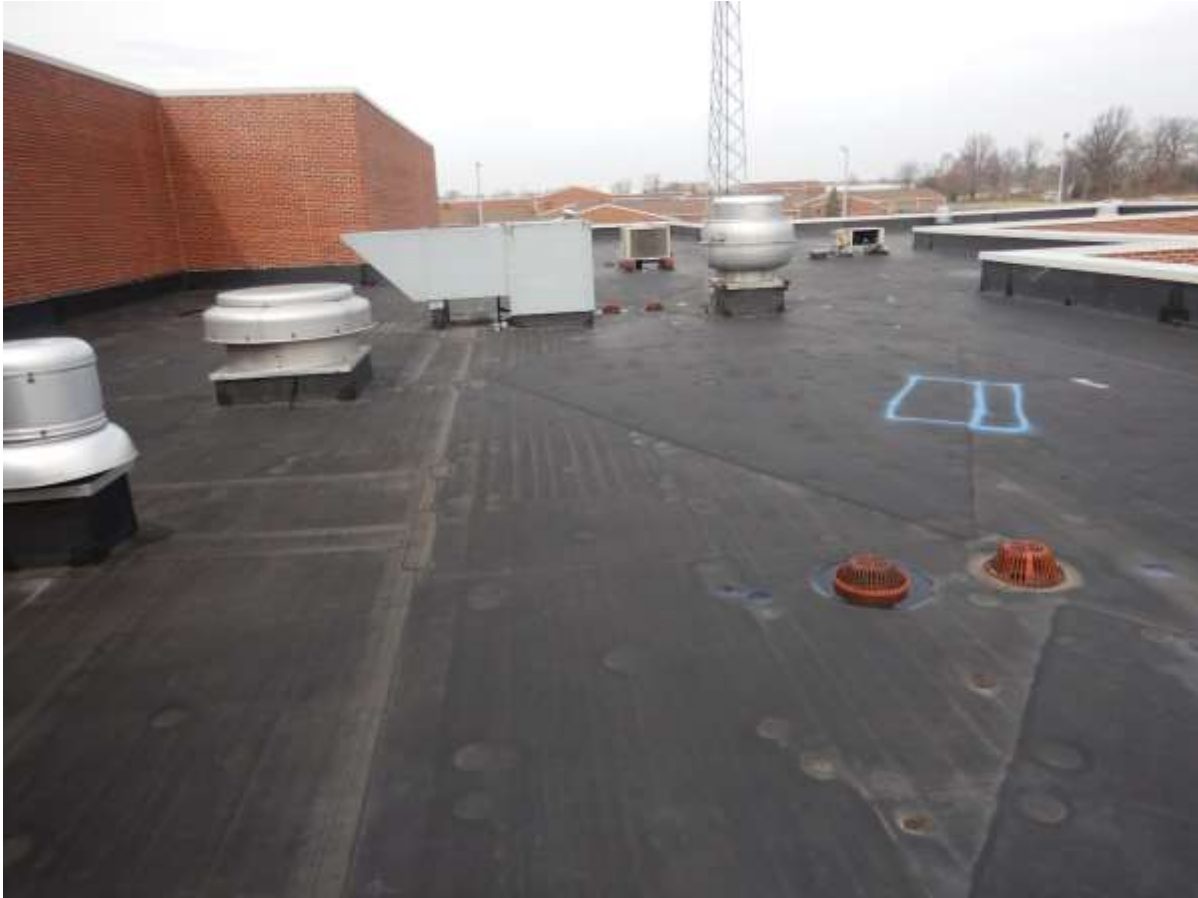
**PHOTO THREE**

**CONDITION:** An overview of the Fully Adhered EPDM Roof System on Section B.

**RECOMMENDED ACTION:** For your information.

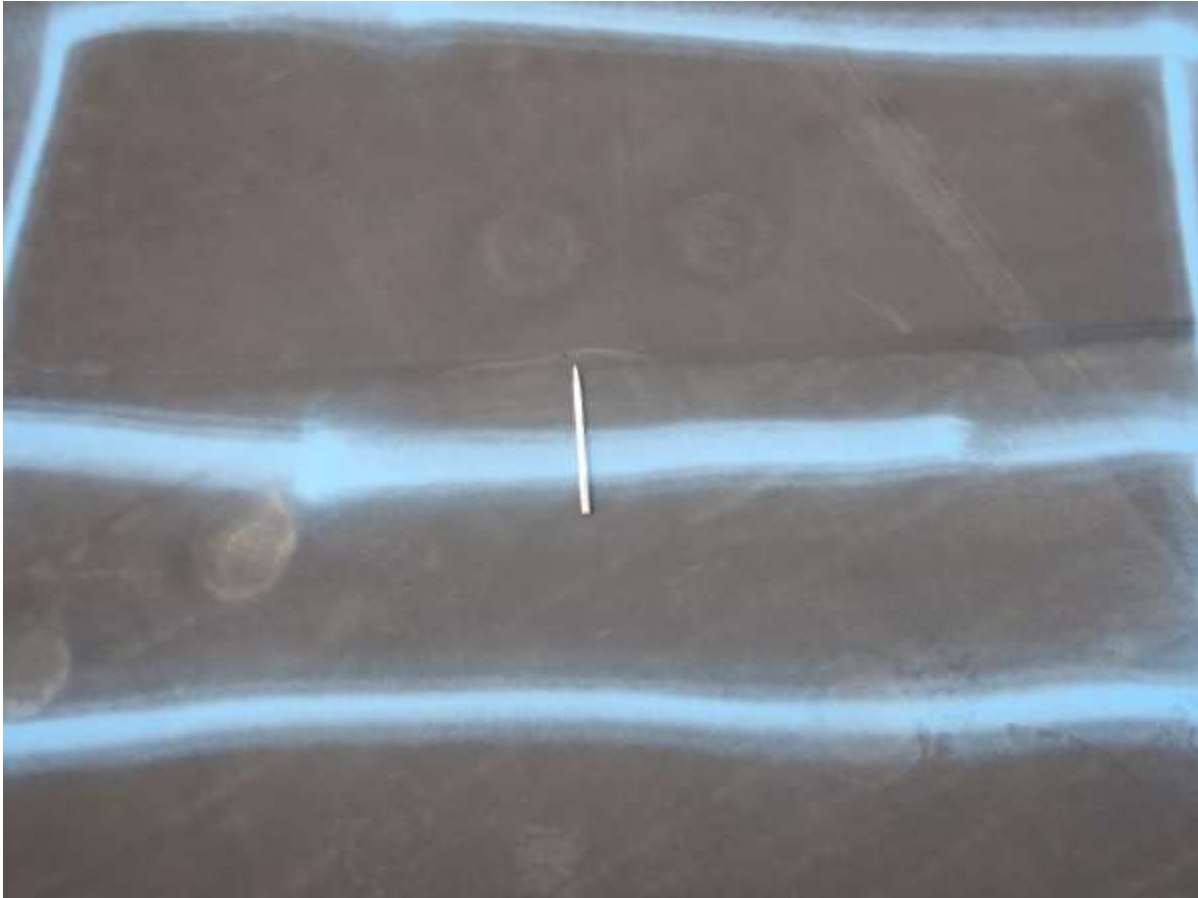
**PHOTO FOUR**

**CONDITION:** The field membrane is damaged within this area of wet substrate identified in the Infrared Roof Moisture Survey.

**RECOMMENDED ACTION:** All affected material should be removed and replaced with matching Firestone materials.

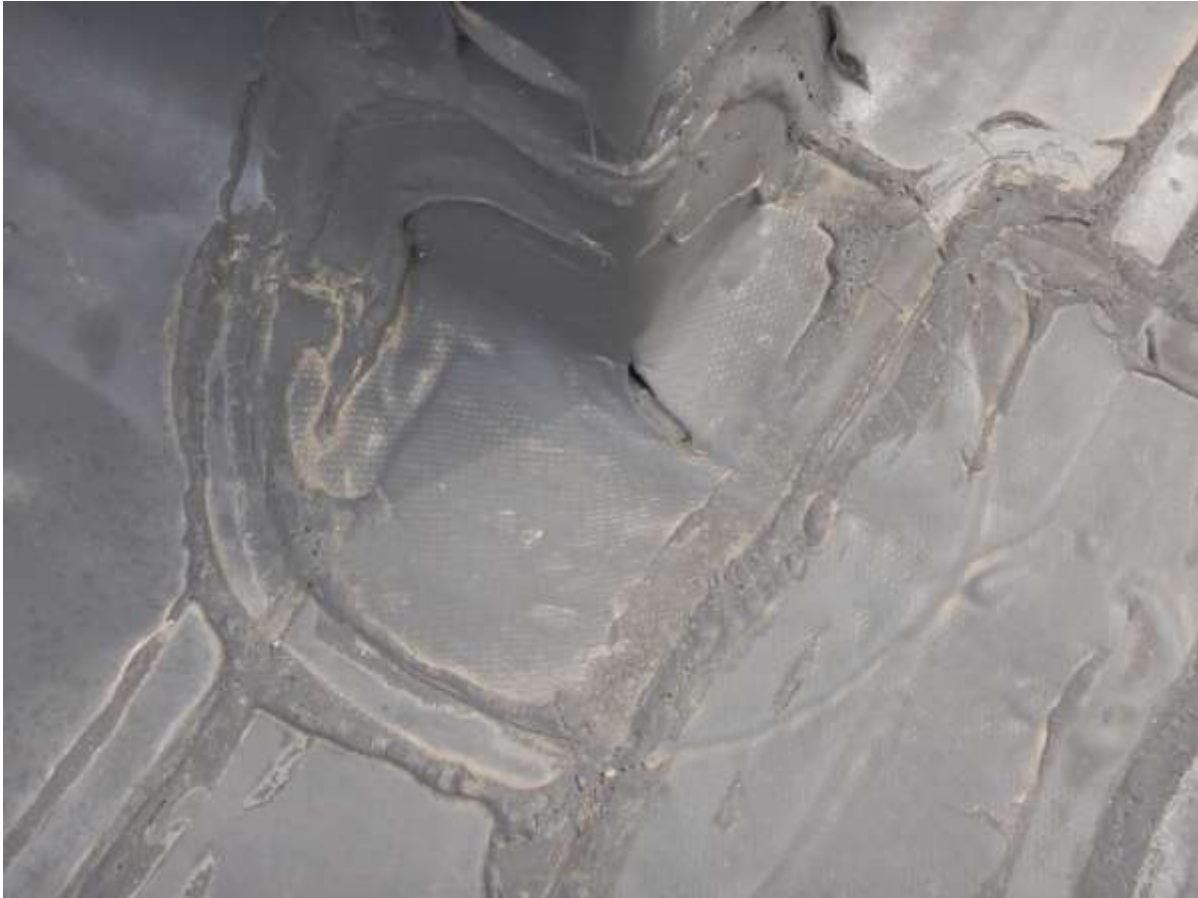
**PHOTO FIVE**

**CONDITION:**    There is a void in the corner flashing at this location.

**RECOMMENDED ACTION:**    The void should be repaired with Firestone membrane to match existing.

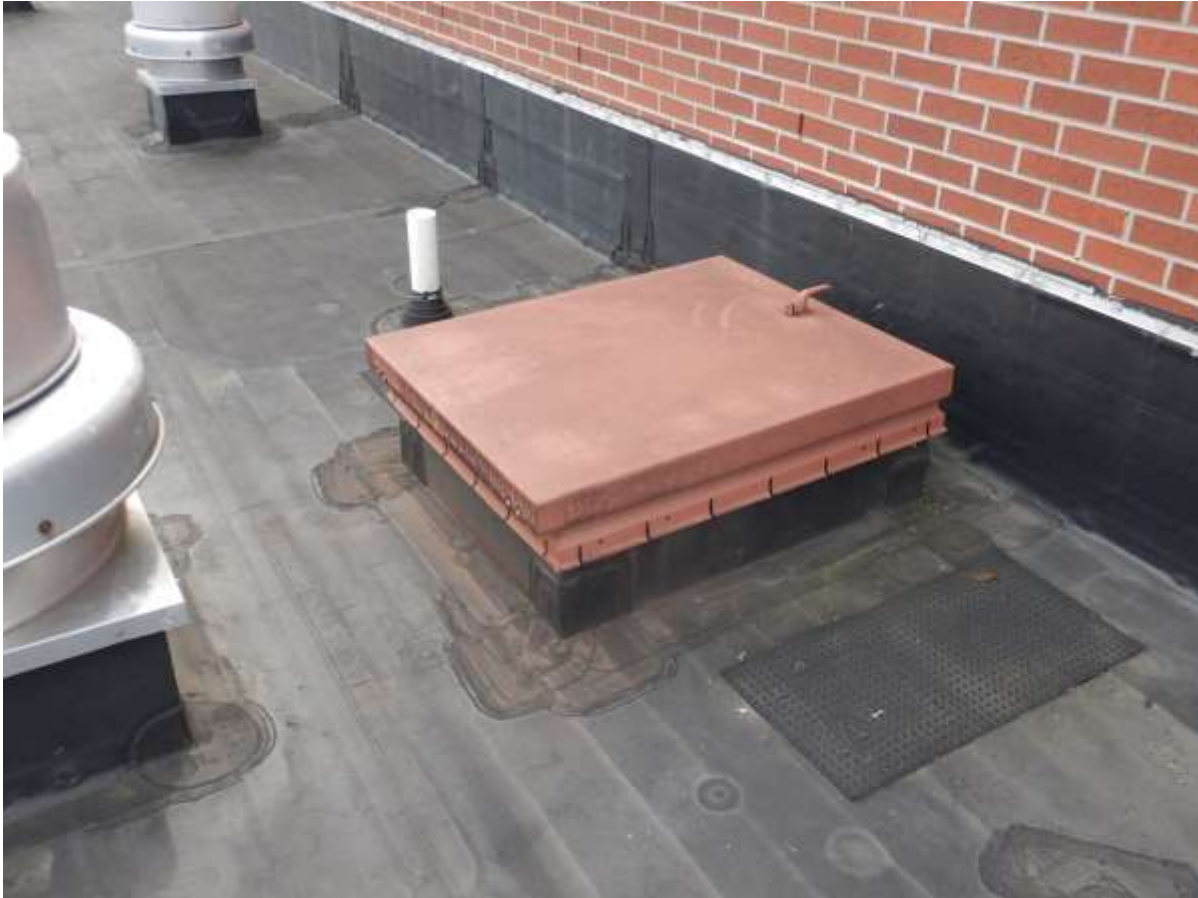
**PHOTO SIX**

**CONDITION:**    Use of the roof hatch presents a fall hazard. A safety rail system should be installed around this roof hatch.

**RECOMMENDED ACTION:**    For your information.

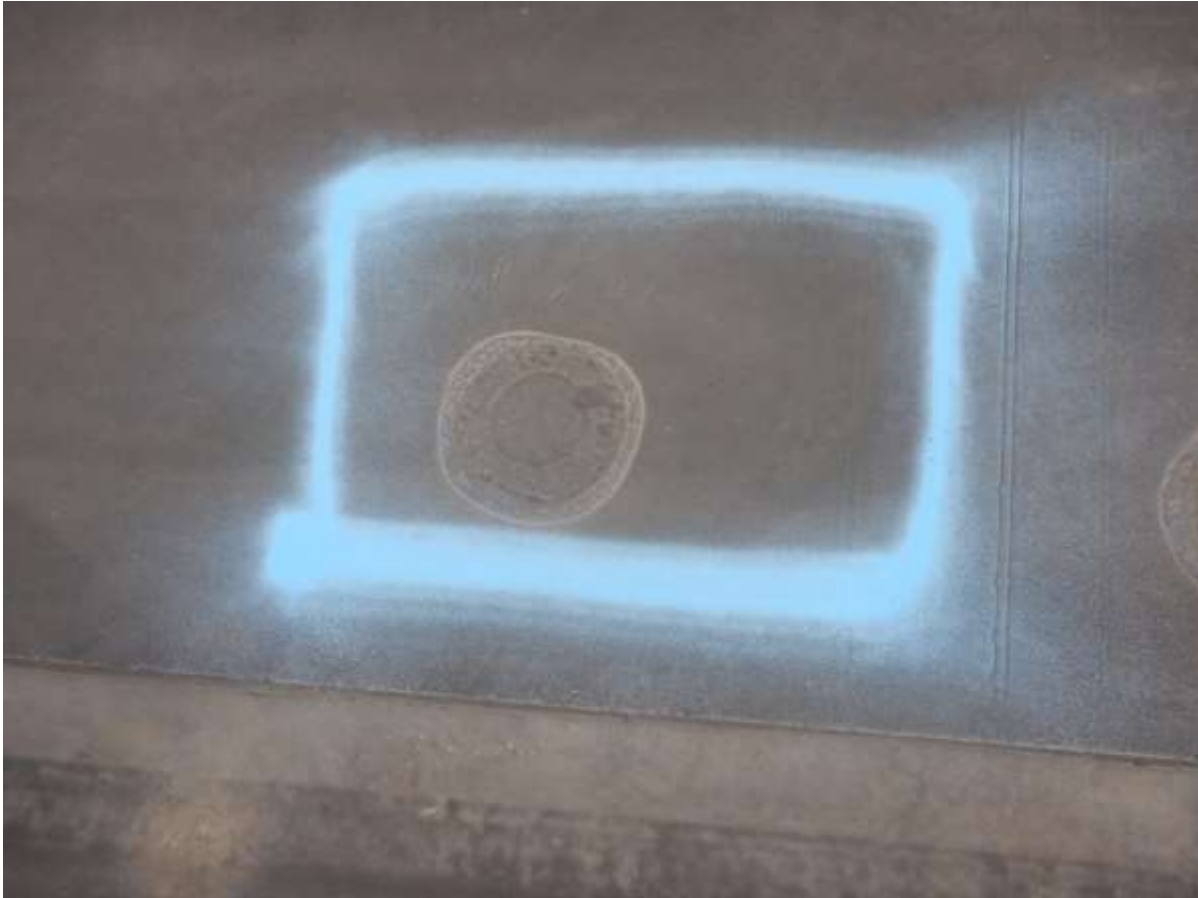
**PHOTO SEVEN**

**CONDITION:** The field membrane is damaged within this area of wet substrate identified in the Infrared Roof Moisture Survey.

**RECOMMENDED ACTION:** All affected material should be removed and replaced with matching Firestone materials.

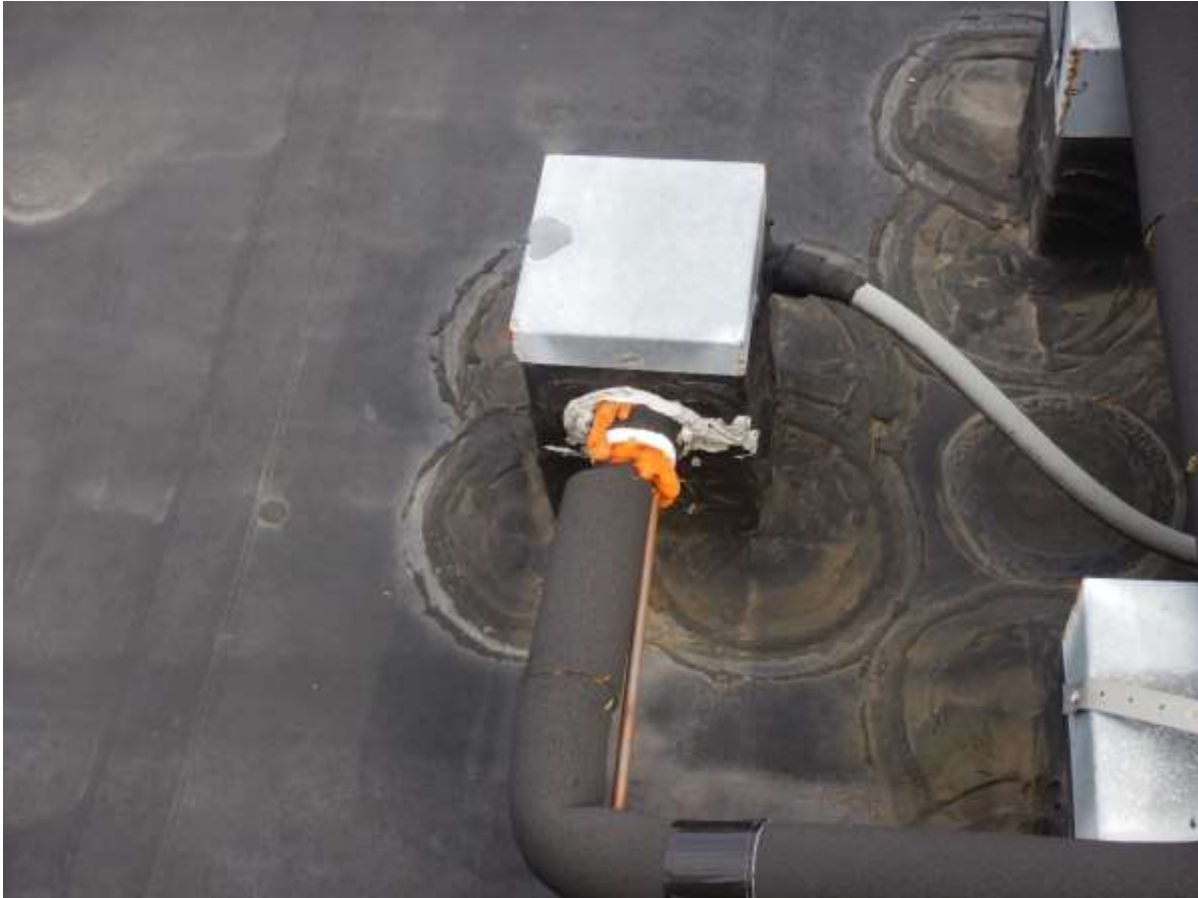
**PHOTO EIGHT**

**CONDITION:** There is a void in the pipe penetration at this location.

**RECOMMENDED ACTION:** A new sheet metal cap should be installed and extend eight -inches (8") over the pipe penetration.

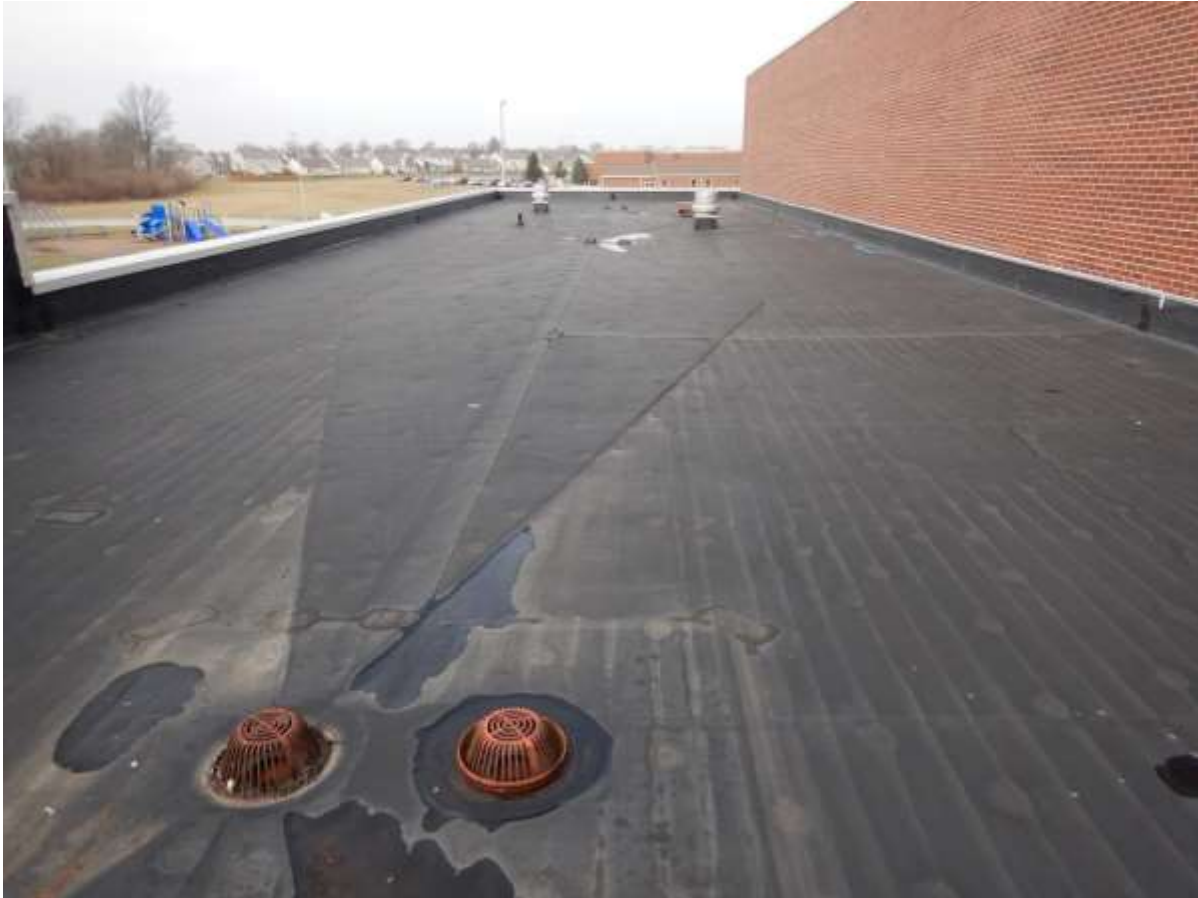
**PHOTO NINE**

**CONDITION:** An overview of the Fully Adhered EPDM Roof System on Section C.

**RECOMMENDED ACTION:** For your information.

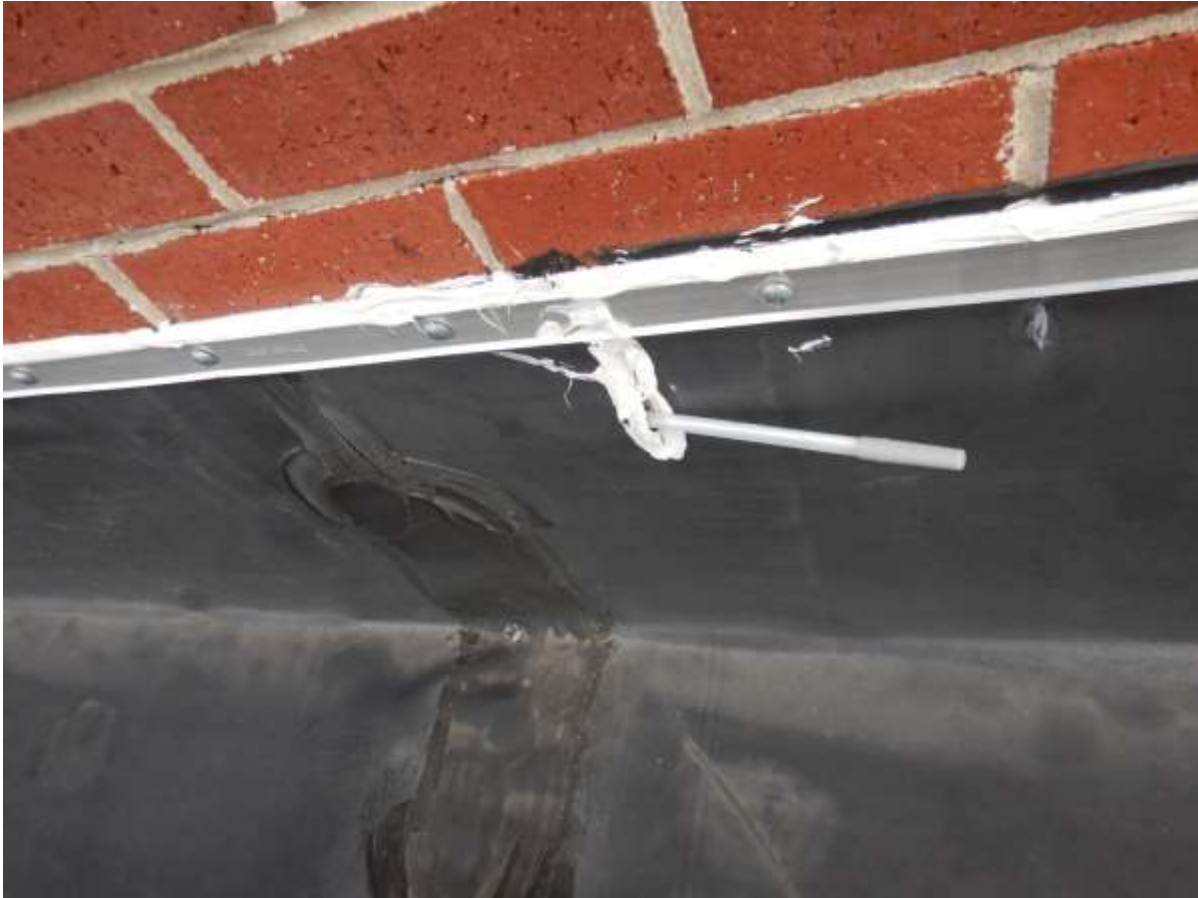
**PHOTO TEN**

**CONDITION:** The base flashing is split at this location.

**RECOMMENDED ACTION:** The void should be repaired with Firestone membrane to match existing.

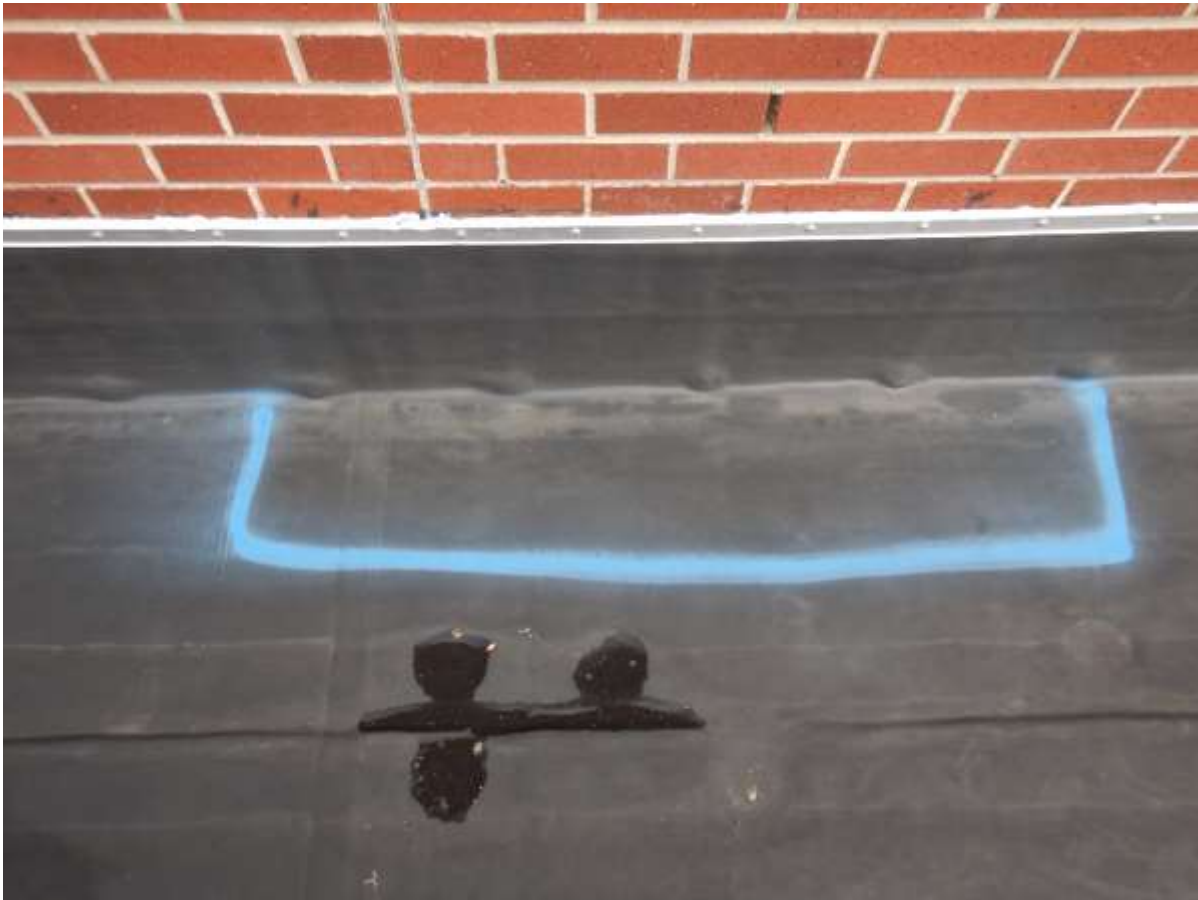
**PHOTO ELEVEN**

**CONDITION:** A view of wet substrate identified in the Infrared Roof Moisture Survey; no surface anomalies were identified in this area.

**RECOMMENDED ACTION:** All affected material should be removed and replaced with matching Firestone materials.

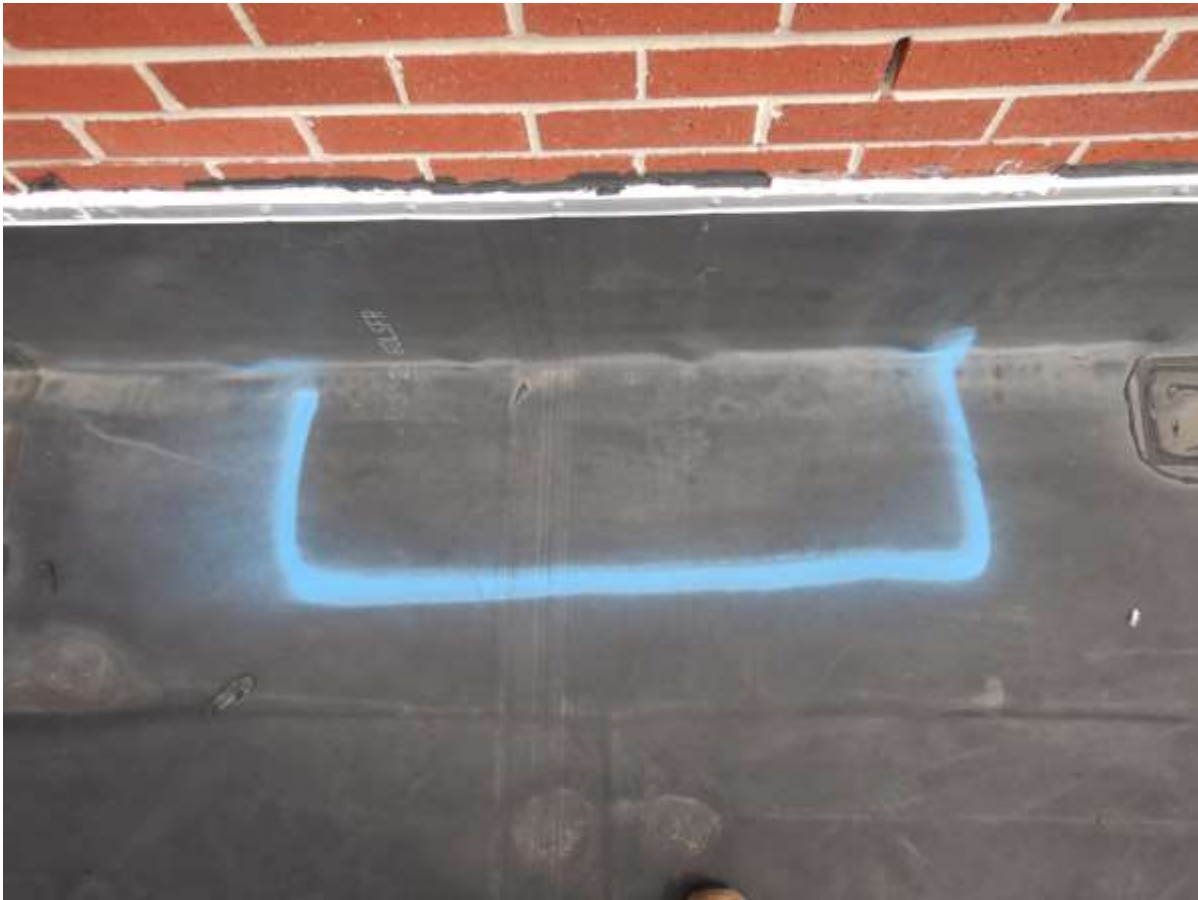
**PHOTO TWELVE**

**CONDITION:** A view of wet substrate identified in the Infrared Moisture Roof Survey; no surface anomalies were identified in this area.

**RECOMMENDED ACTION:** All affected material should be removed and replaced with matching Firestone materials.

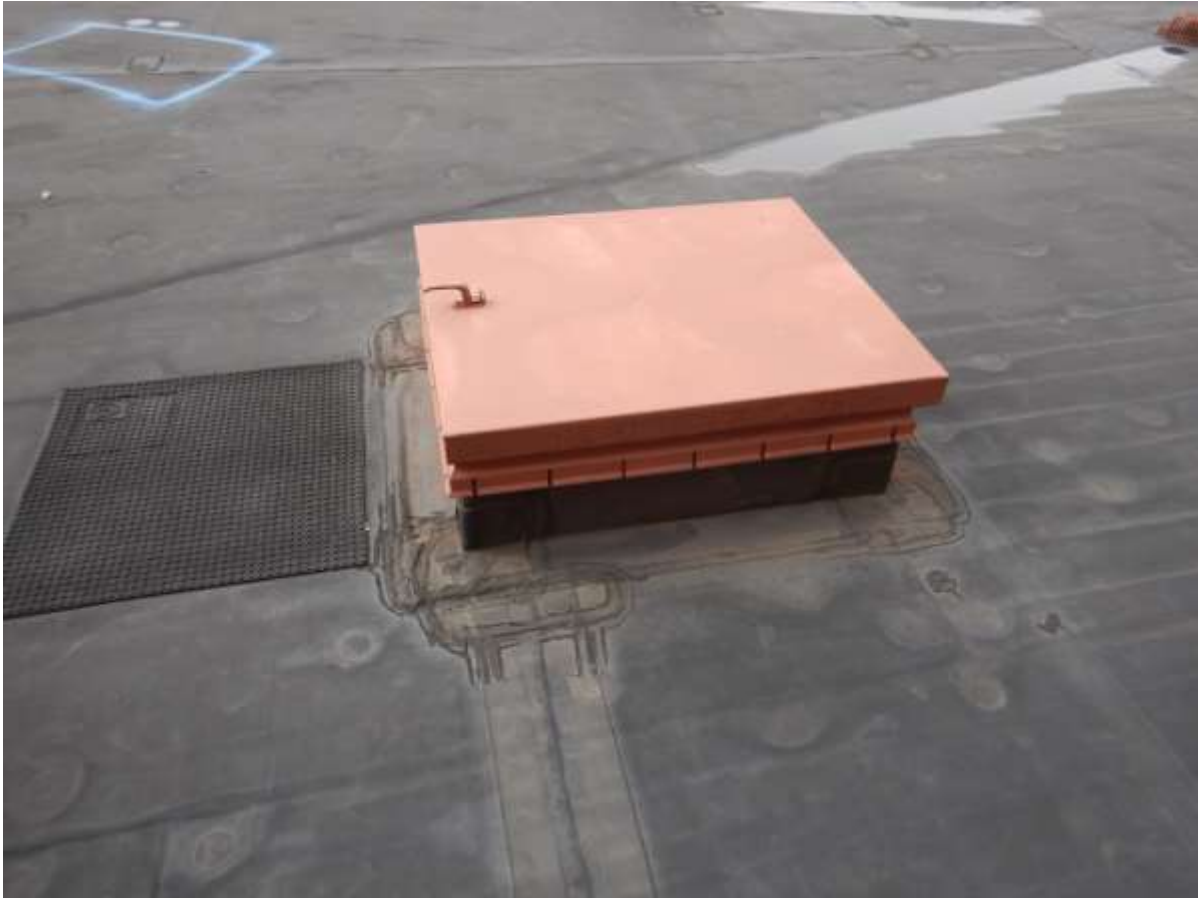
**PHOTO THIRTEEN**

**CONDITION:** Use of the roof hatch presents a fall hazard. A safety rail system should be installed around this roof hatch.

**RECOMMENDED ACTION:** For your information.

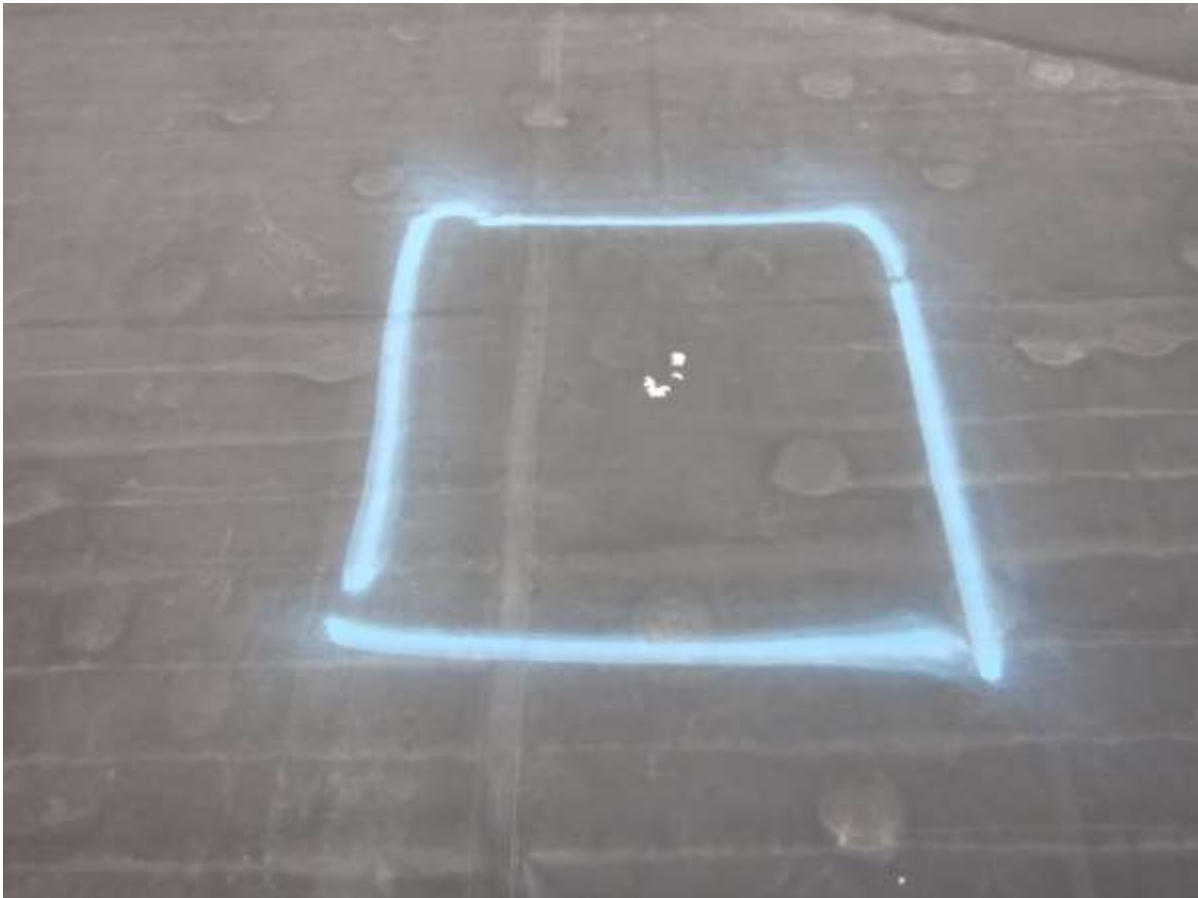
**PHOTO FOURTEEN**

**CONDITION:** The field membrane is damaged within this area of wet substrate identified in the Infrared Roof Moisture Survey.

**RECOMMENDED ACTION:** All affected material should be removed and replaced with matching Firestone materials.

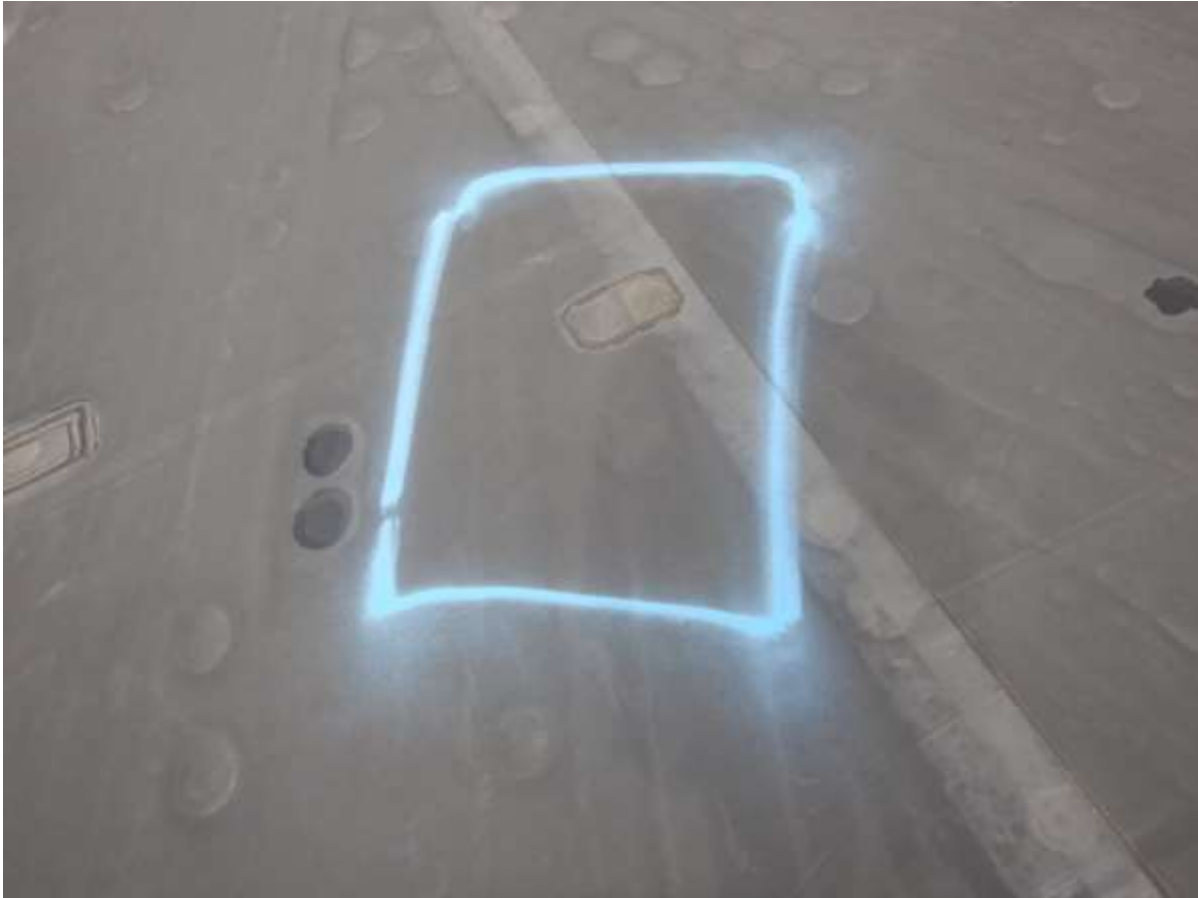
**PHOTO FIFTEEN**

**CONDITION:** The field membrane is damaged within this area of wet substrate identified in the Infrared Roof Moisture Survey.

**RECOMMENDED ACTION:** All affected material should be removed and replaced with matching Firestone materials.

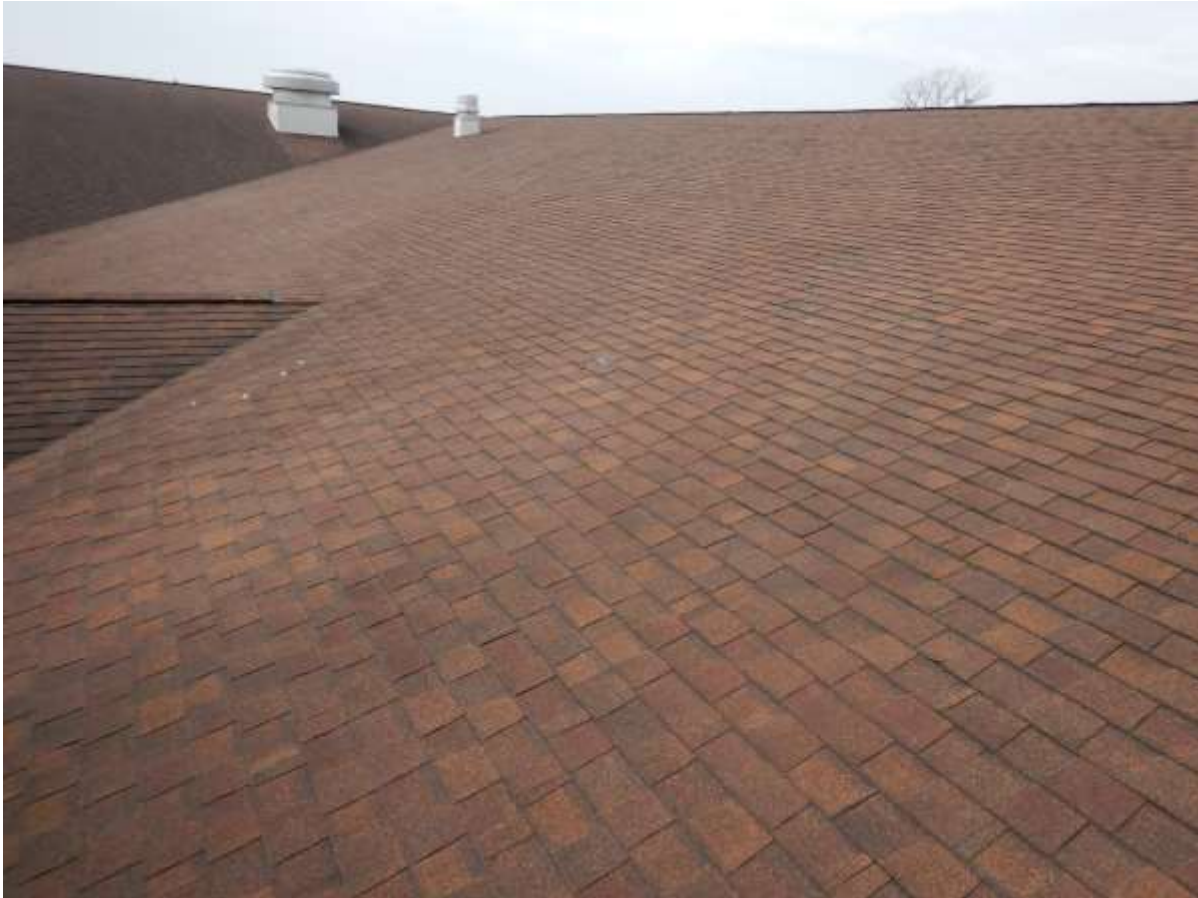
**PHOTO SIXTEEN**

**CONDITION:** An overview of the existing Dimension Shingle Roof System on Section D1.

**RECOMMENDED ACTION:** For your information.

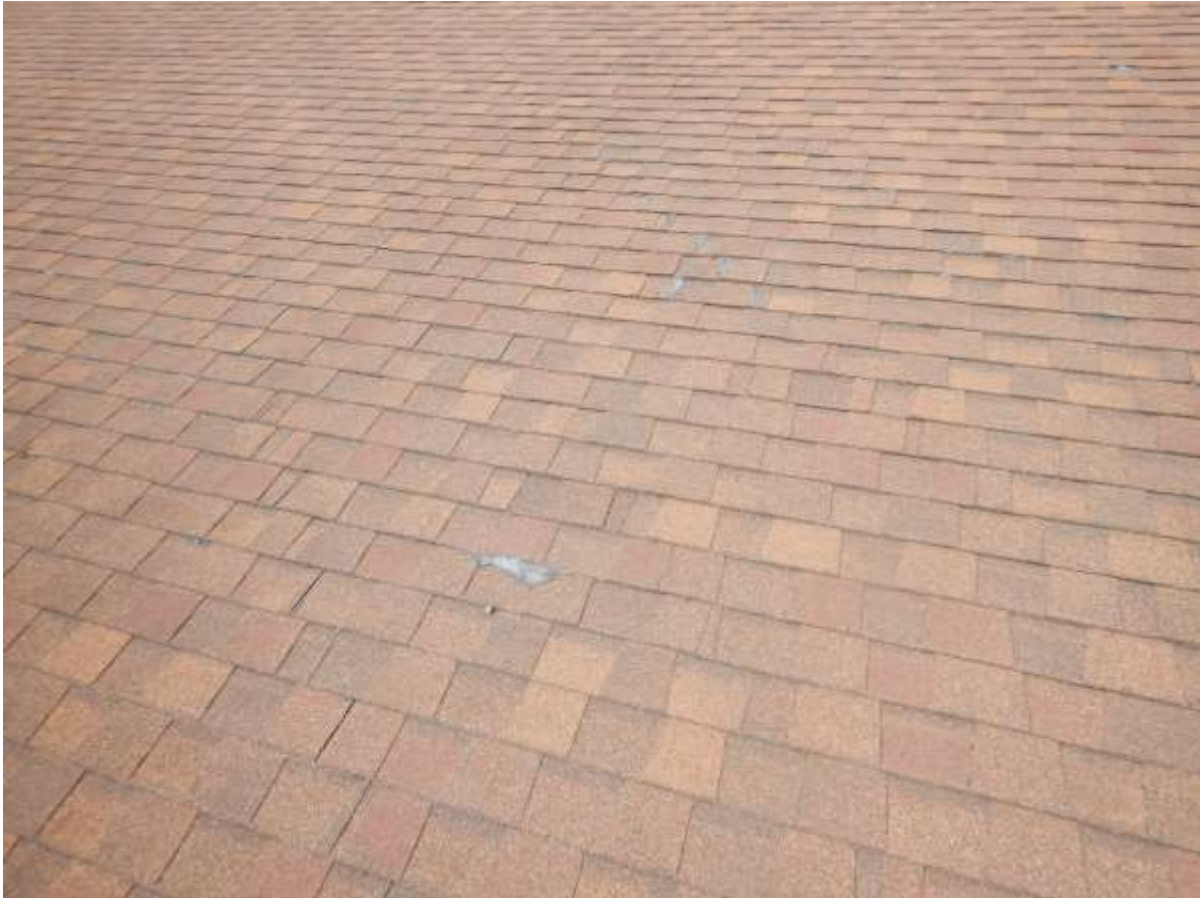
**PHOTO SEVENTEEN**

**CONDITION:** Previous repairs were noted in random locations.

**RECOMMENDED ACTION:** This condition will be corrected during roof replacement.

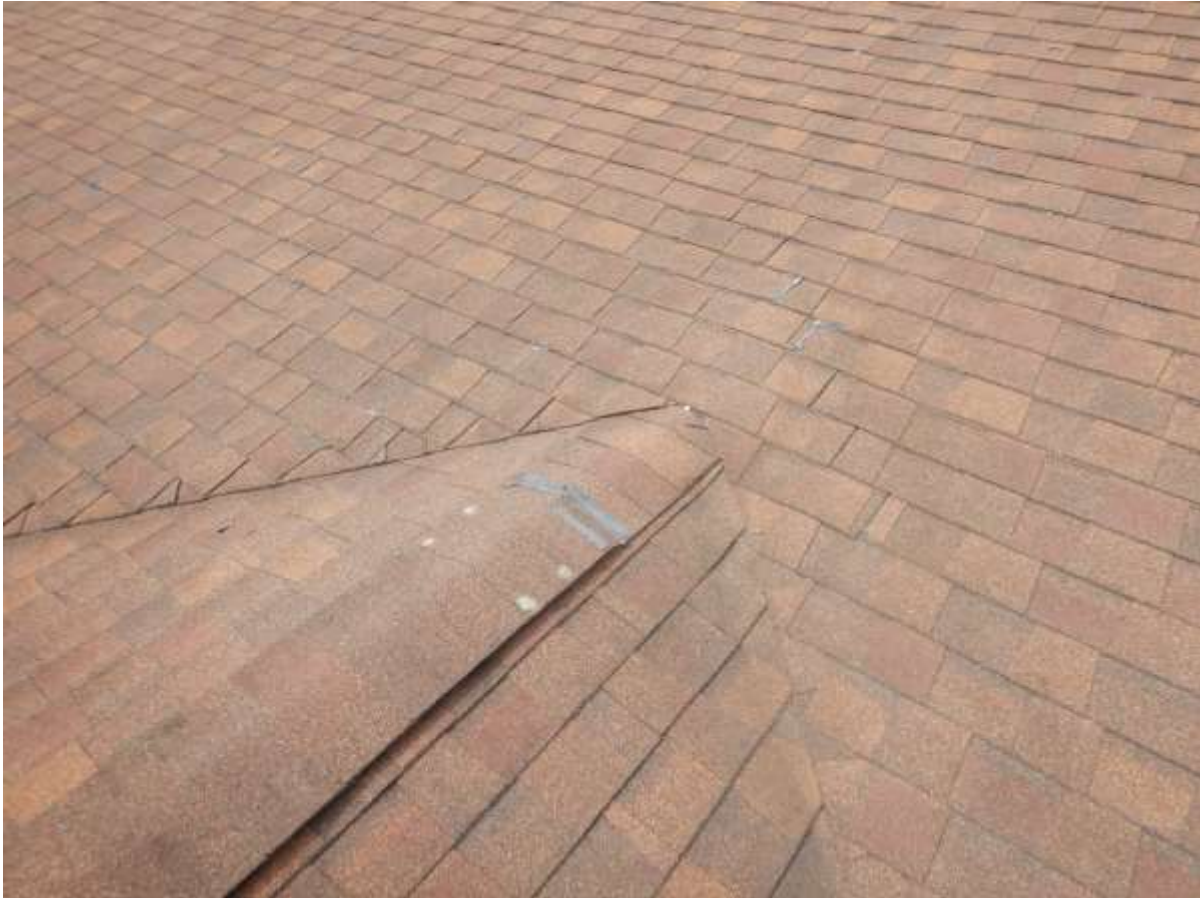
**PHOTO EIGHTEEN**

**CONDITION:** Previous repairs were noted in random locations.

**RECOMMENDED ACTION:** This condition will be corrected during roof replacement.

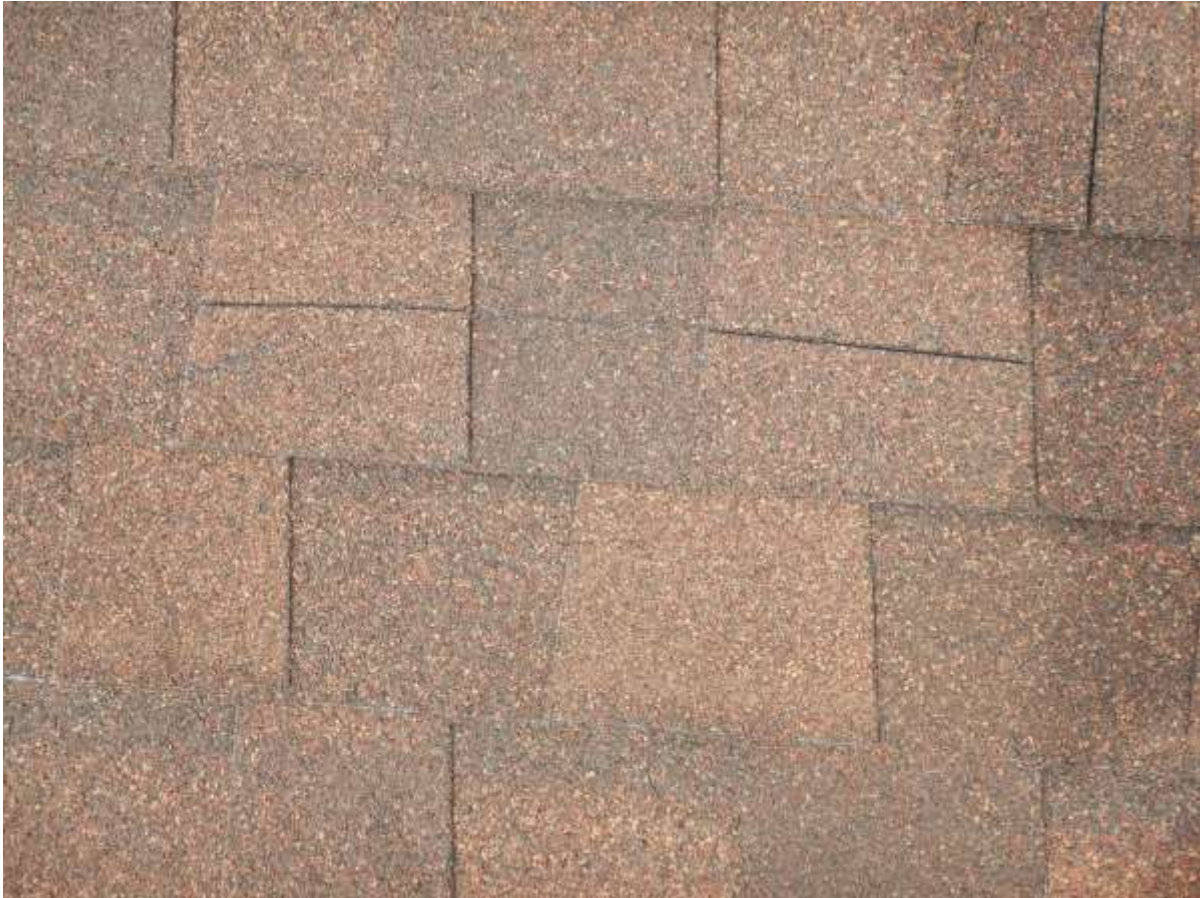
**PHOTO NINETEEN**

**CONDITION:** The shingle surface is scored at this location.

**RECOMMENDED ACTION:** This condition will be corrected during roof replacement.

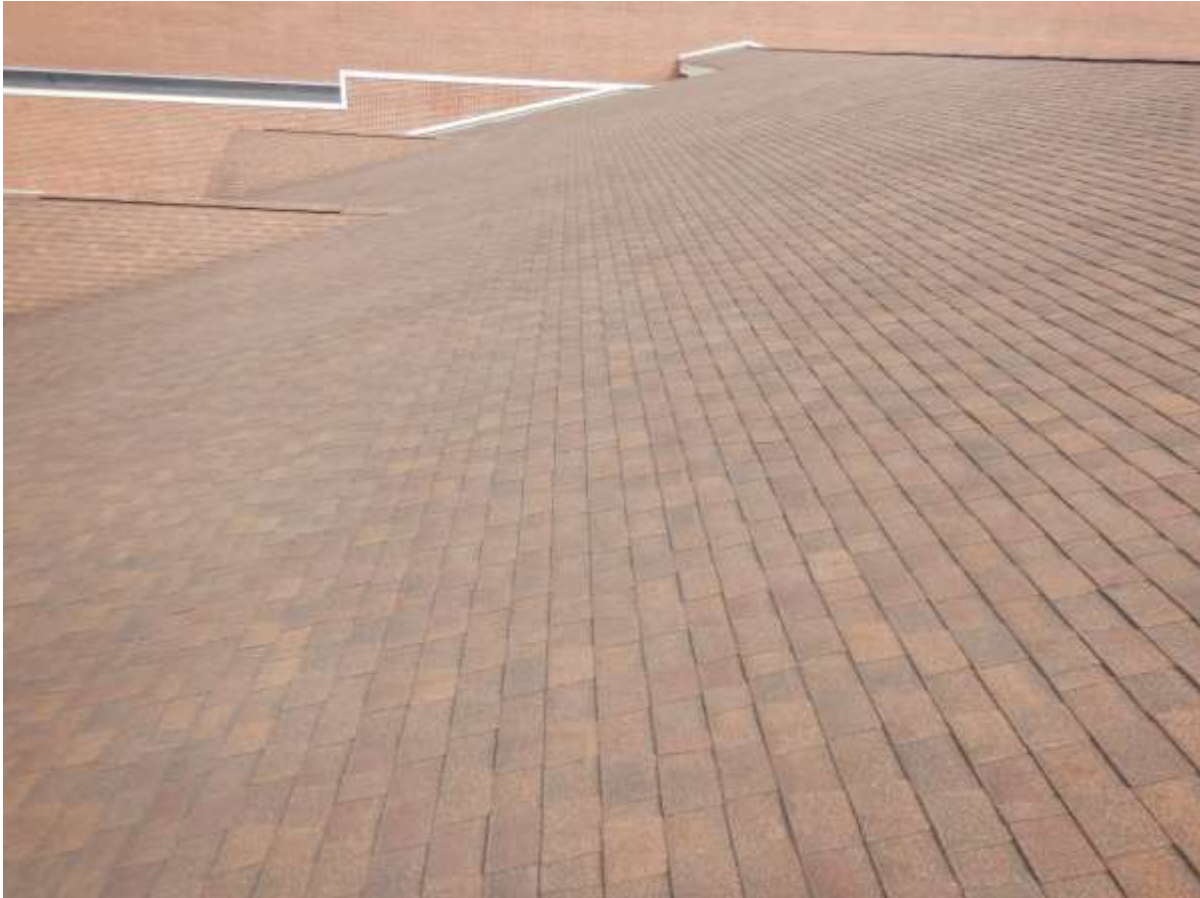
**PHOTO TWENTY**

**CONDITION:** An overview of the existing Dimensional Shingle Roof System on Section D2.

**RECOMMENDED ACTION:** For your information.
