## ***ROOF EVALUATION REPORT***

***FRANKLIN TOWNSHIP COMMUNITY SCHOOL CORPORATION  
SOUTH CREEK ELEMENTARY SCHOOL  
9010 EAST SOUTHPORT ROAD  
INDIANAPOLIS, INDIANA***

***REVISED APRIL 12, 2021***

**R.M.I. # 021-192  
*REVISED* APRIL 12, 2021**

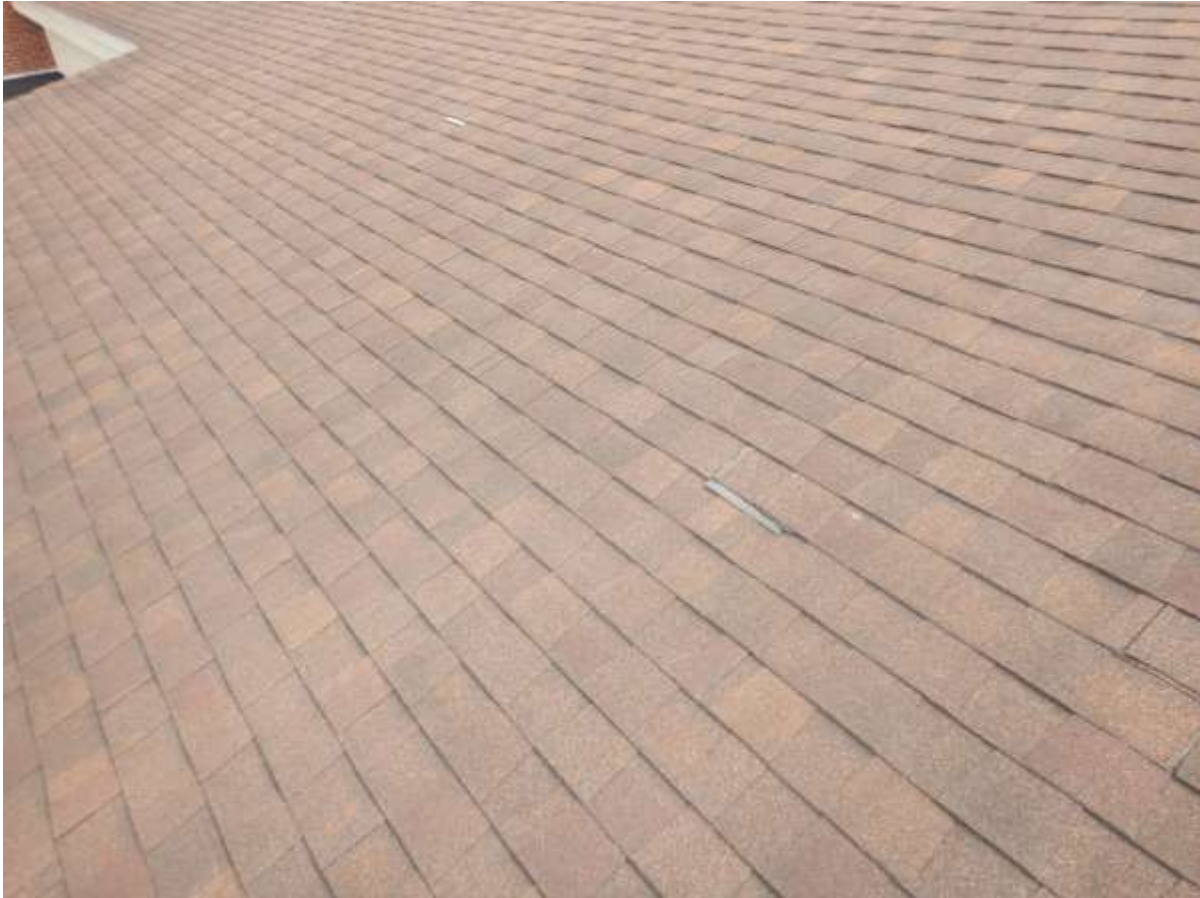
**PHOTO TWENTY-ONE**

**CONDITION:** Previous repairs were noted in random locations.

**RECOMMENDED ACTION:** This condition will be corrected during roof replacement.

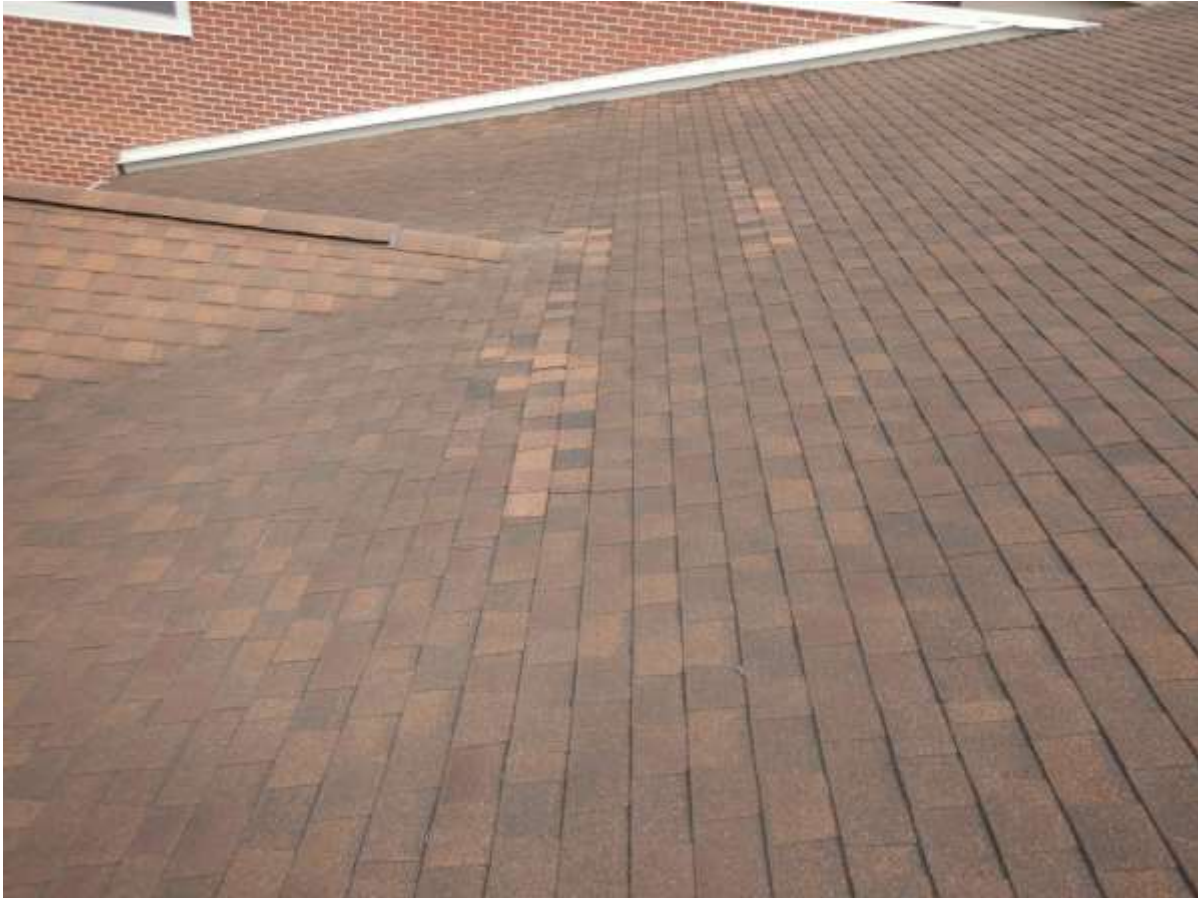
**PHOTO TWENTY-TWO**

**CONDITION:** Previous repairs were noted in random locations.

**RECOMMENDED ACTION:** This condition will be corrected during roof replacement.

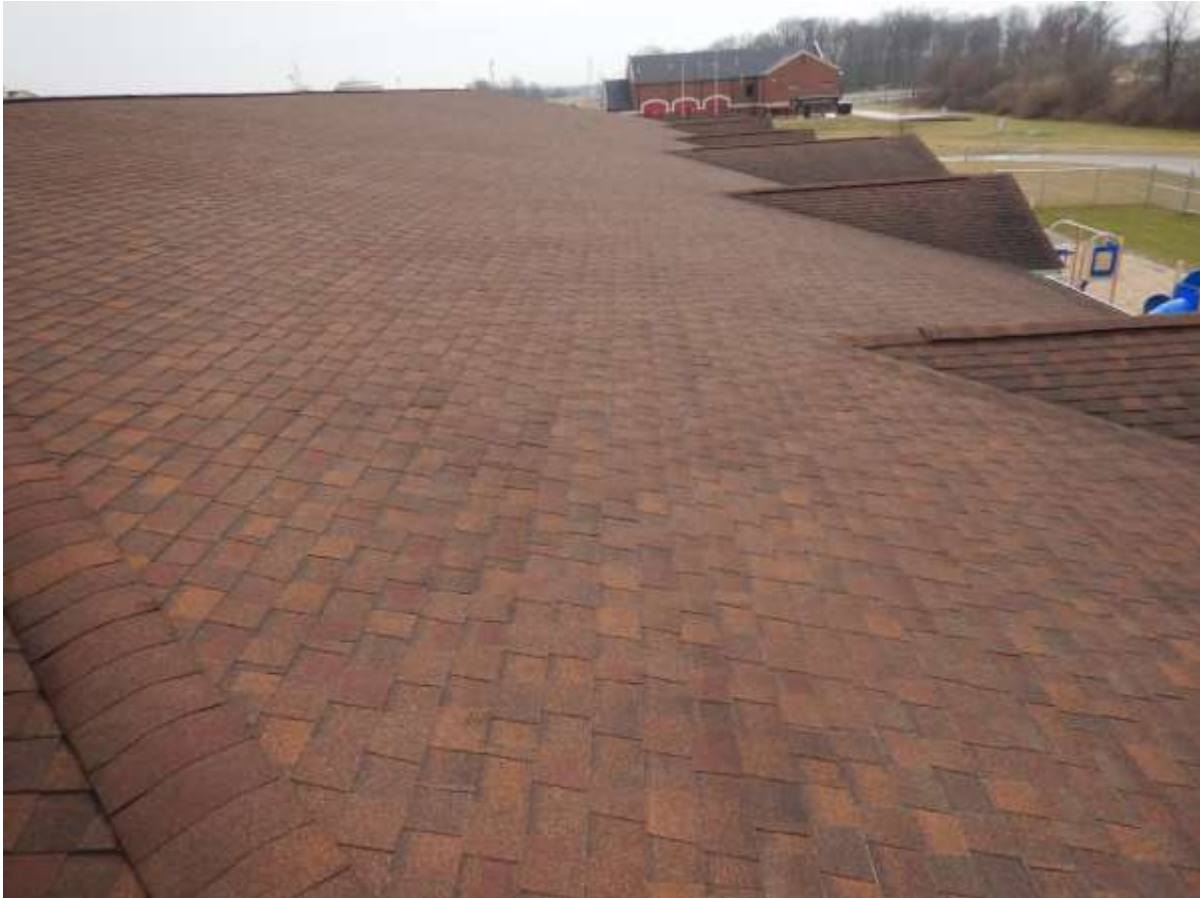
**PHOTO TWENTY-THREE**

**CONDITION:** An overview of the existing Dimensional Shingle Roof System on Section E1.

**RECOMMENDED ACTION:** For your information.

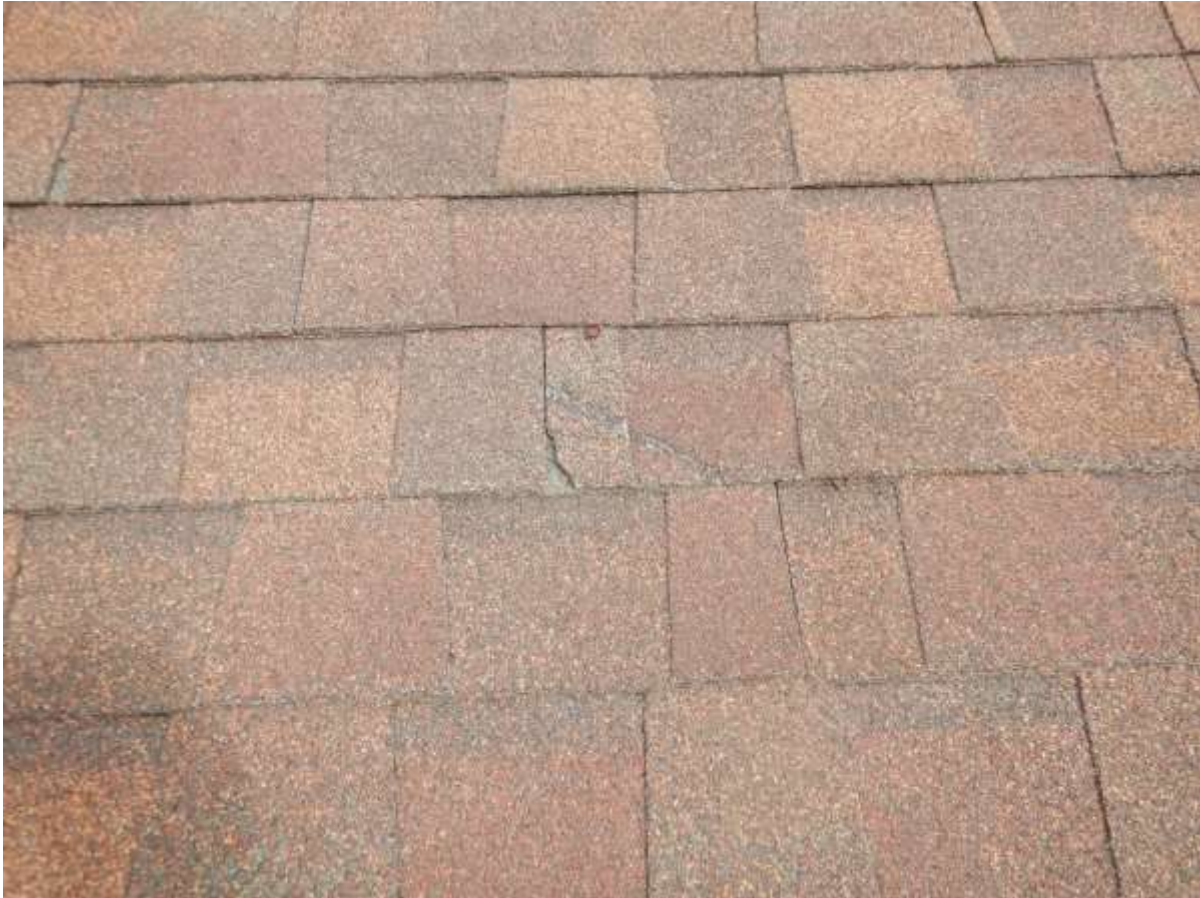
**PHOTO TWENTY-FOUR**

**CONDITION:**    Roofing nails are exposed in this area.

**RECOMMENDED ACTION:**    This condition will be corrected during roof replacement.

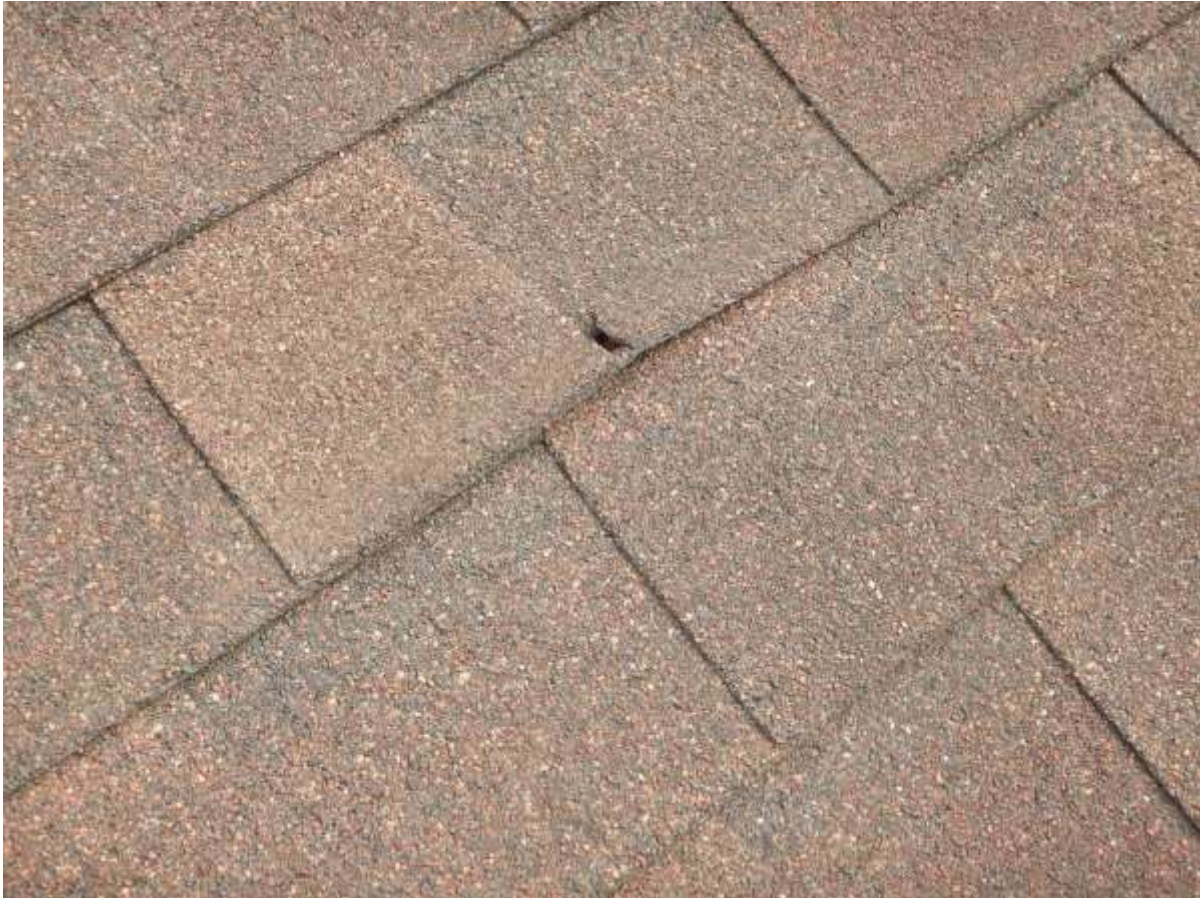
**PHOTO TWENTY-FIVE**

**CONDITION:** View of nail pop through the shingle.

**RECOMMENDED ACTION:** This condition will be corrected during roof replacement.

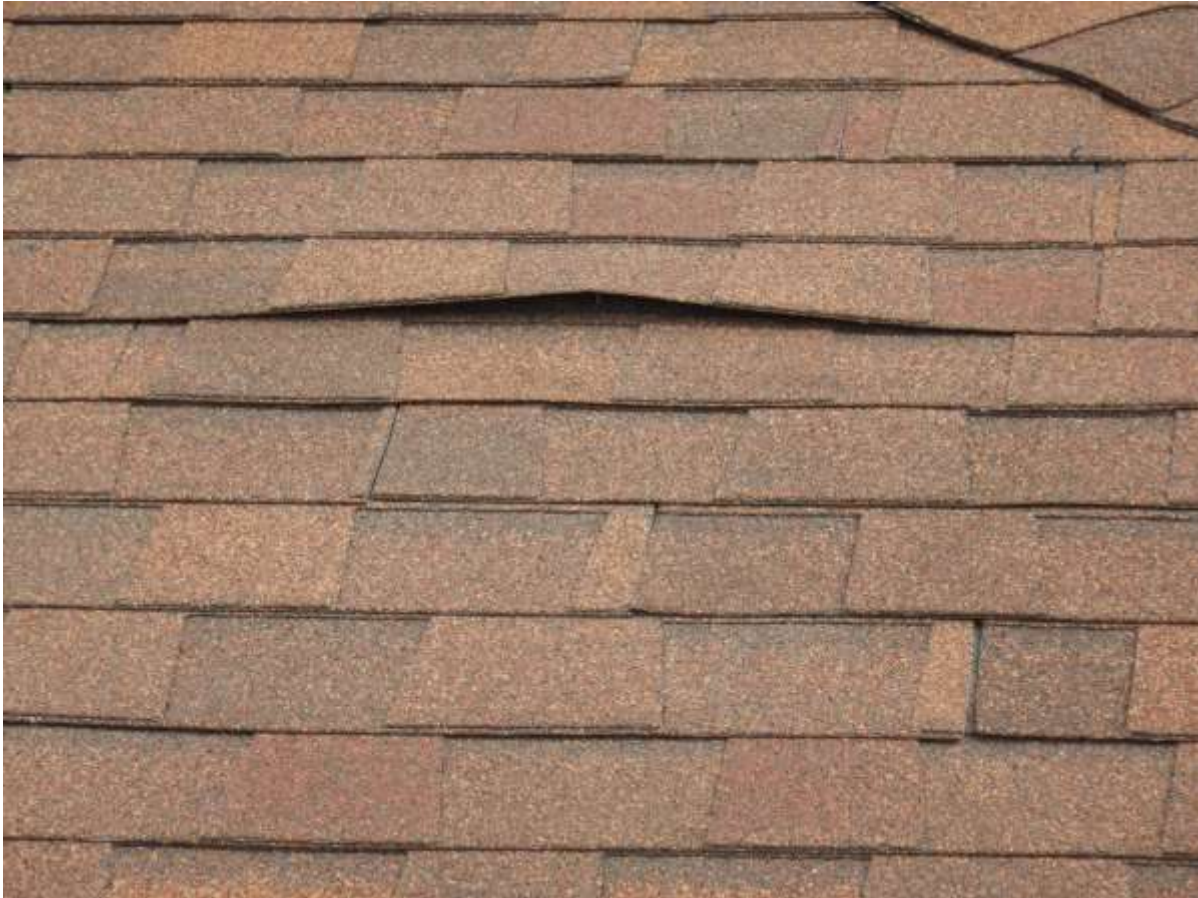
**PHOTO TWENTY-SIX**

**CONDITION:**    The shingle is raised from the protruding roofing nail.

**RECOMMENDED ACTION:**    This condition will be corrected during roof replacement.

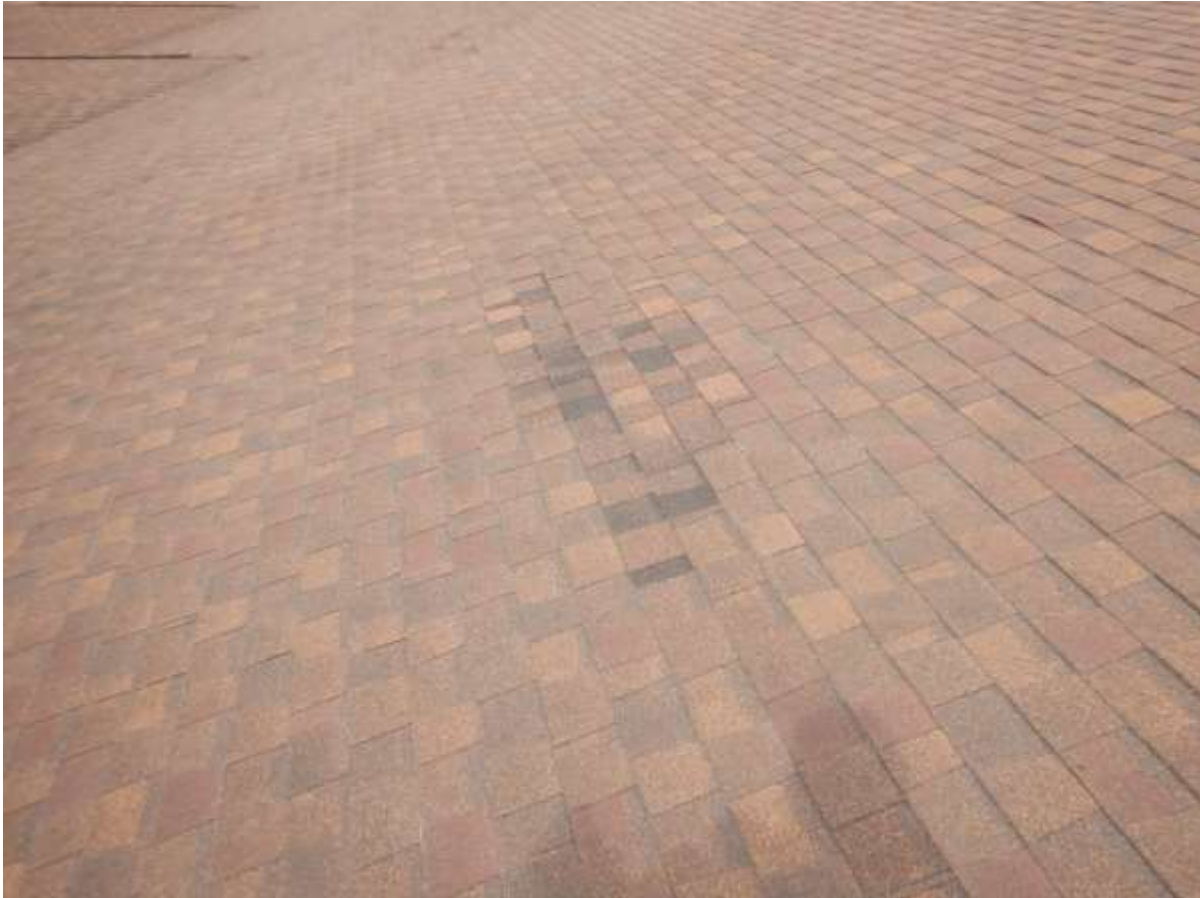
**PHOTO TWENTY-SEVEN**

**CONDITION:** Previous repairs were noted in random locations.

**RECOMMENDED ACTION:** This condition will be corrected during roof replacement.

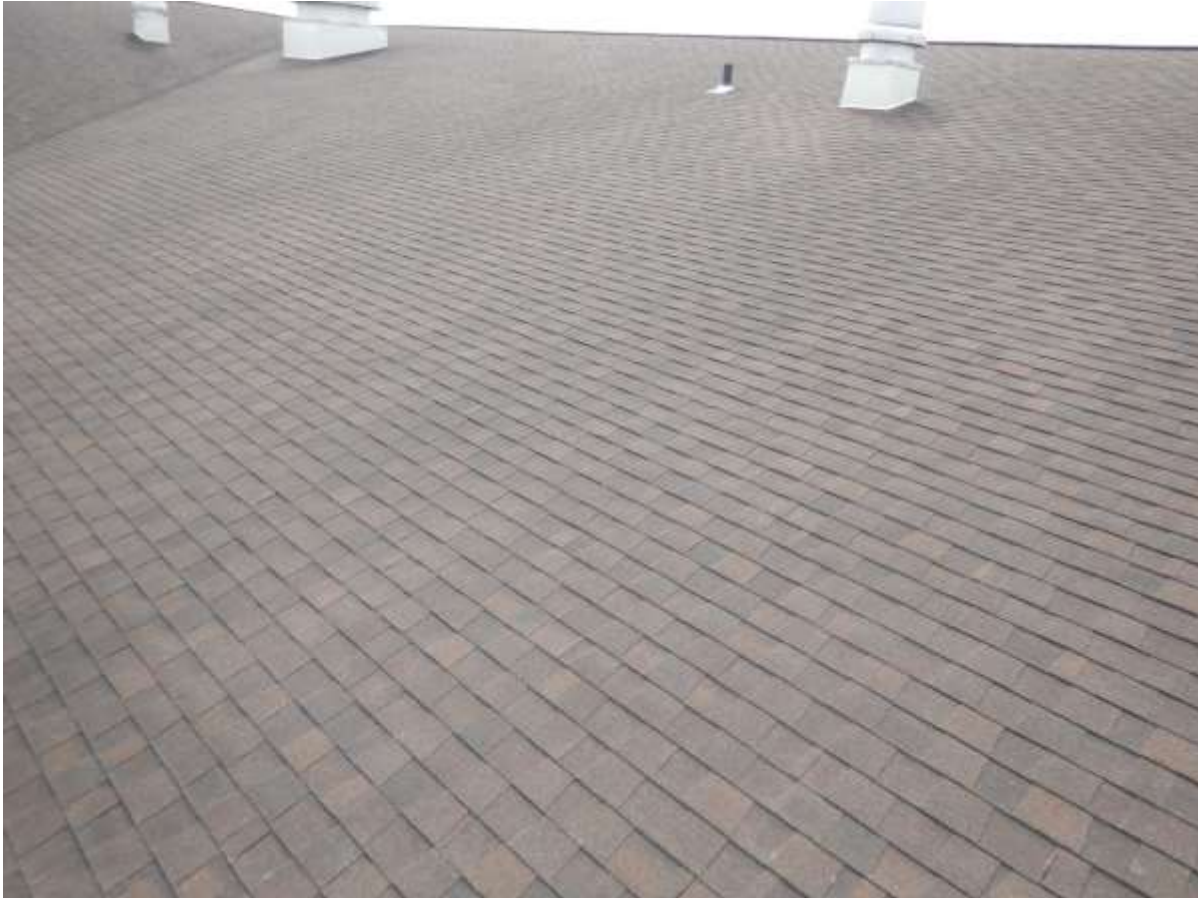
**PHOTO TWENTY-EIGHT**

**CONDITION:** An overview of the existing Dimensional Shingle Roof System on Section E2.

**RECOMMENDED ACTION:** For your information.

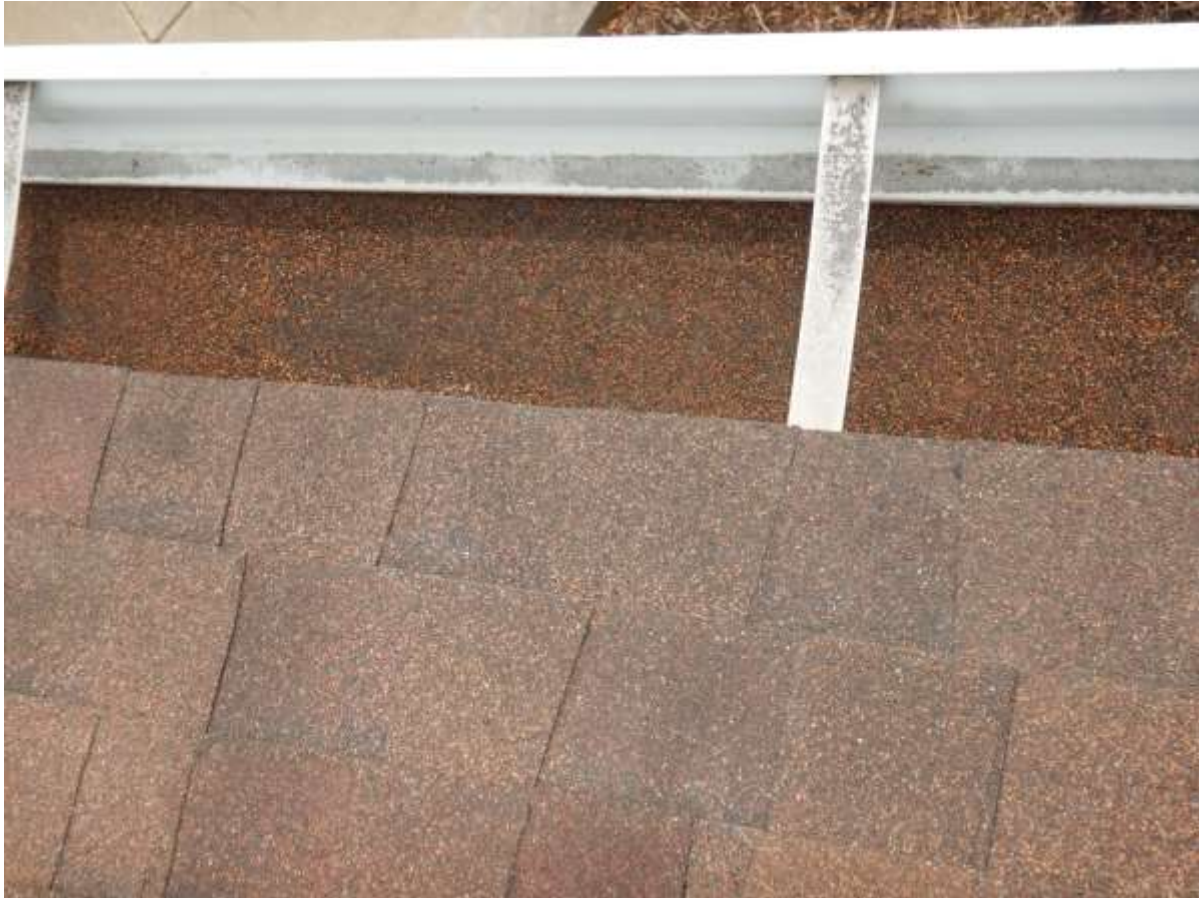
**PHOTO TWENTY-NINE**

**CONDITION:** Granules are collecting in the gutter system.

**RECOMMENDED ACTION:** This condition will be corrected during roof replacement.

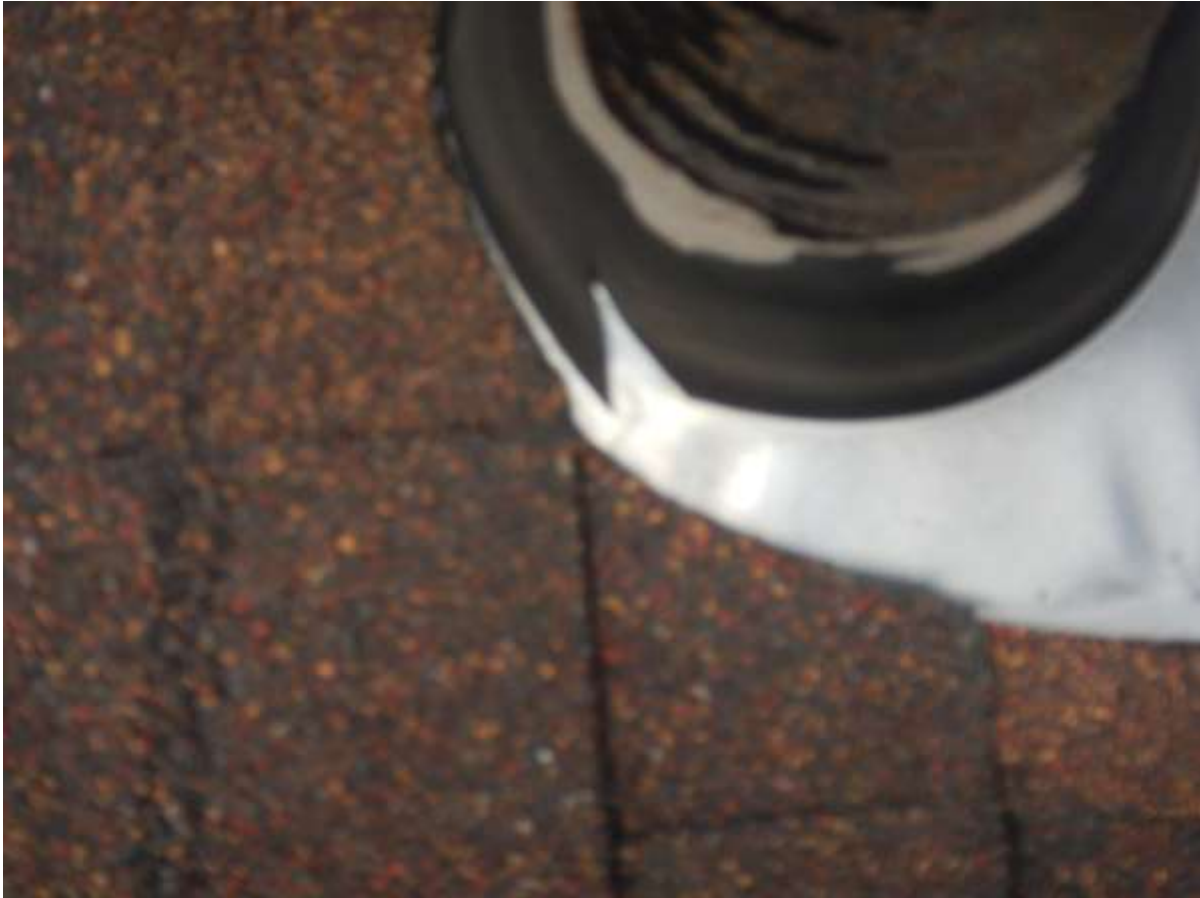
**PHOTO THIRTY**

**CONDITION:** The pre-molded pipe boot is split at this location.

**RECOMMENDED ACTION:** This condition will be corrected during roof replacement.

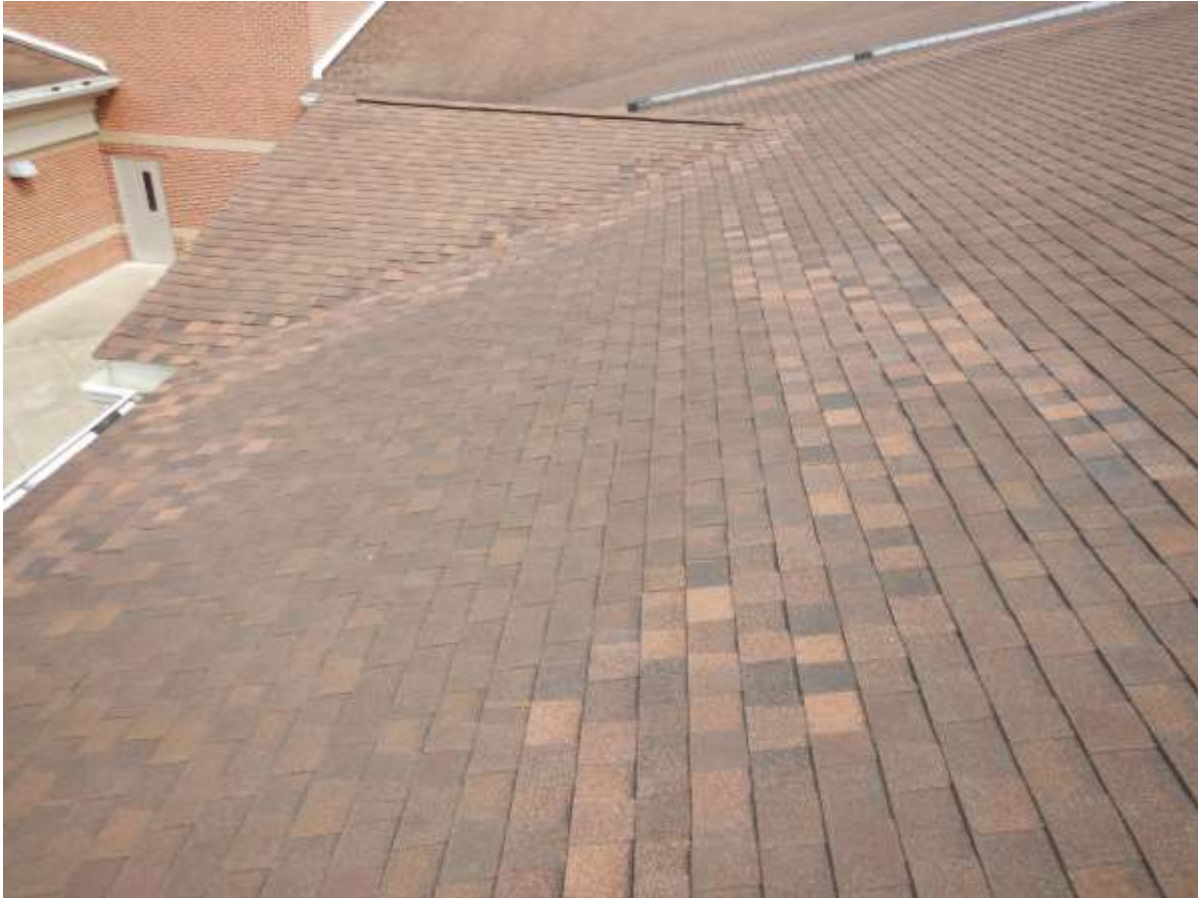
**PHOTO THIRTY-TWO**

**CONDITION:** Previous repairs were noted in random locations.

**RECOMMENDED ACTION:** This condition will be corrected during roof replacement.

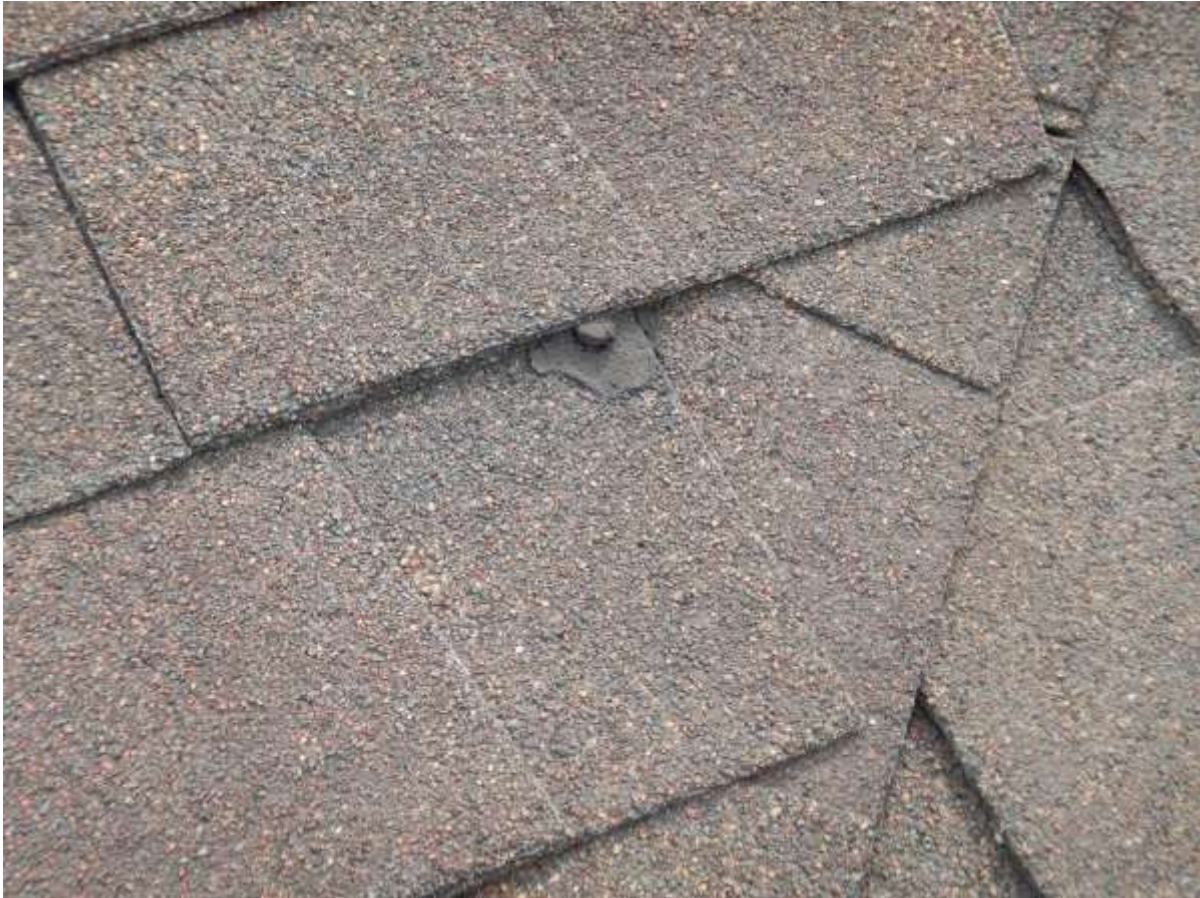
**PHOTO THIRTY-THREE**

**CONDITION:** There is a void in the previous repair attempt at this location.

**RECOMMENDED ACTION:** This condition will be corrected during roof replacement.

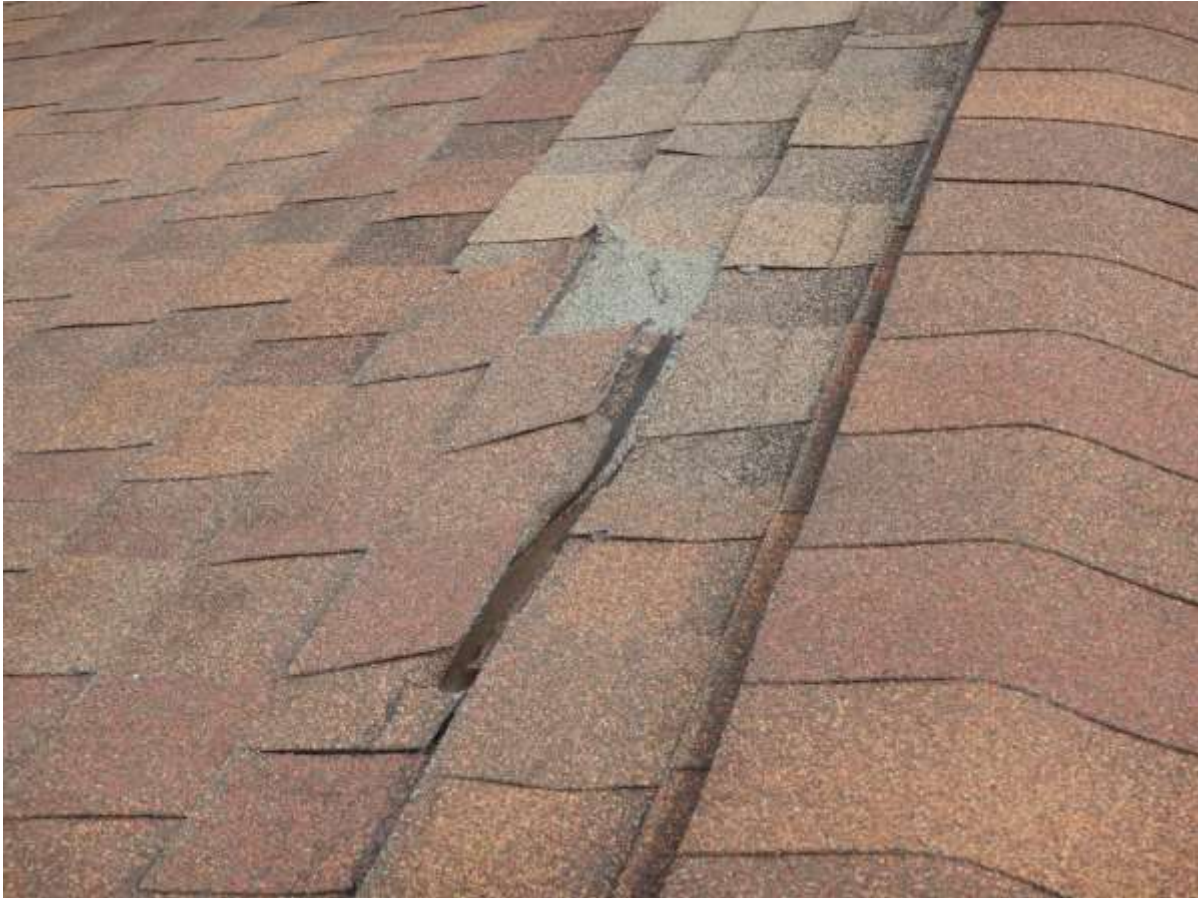
**PHOTO THIRTY-FOUR**

**CONDITION:** The Dimensional Shingles are damaged in this area.

**RECOMMENDED ACTION:** This condition will be corrected during roof replacement.

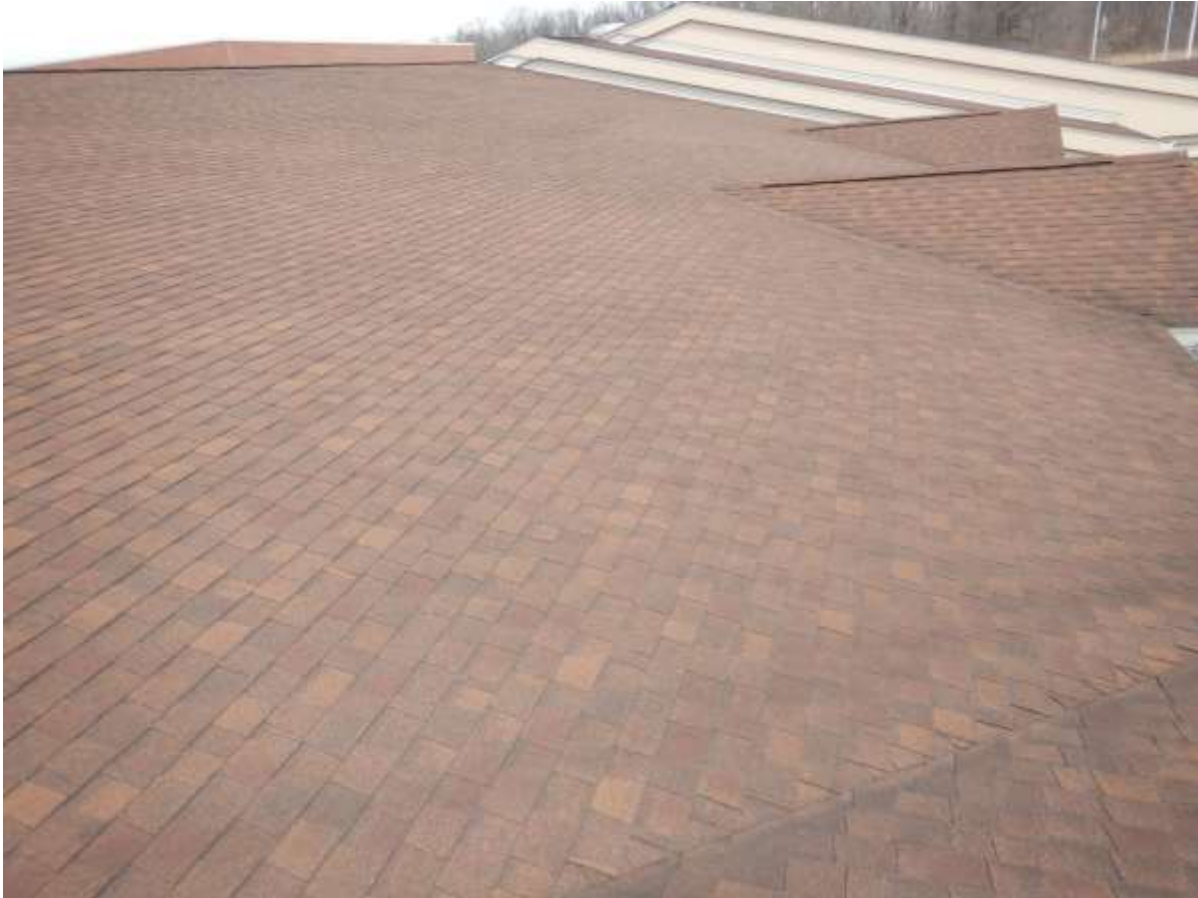
**PHOTO THIRTY-FIVE**

**CONDITION:** An overview of the existing Dimensional Shingle Roof System on Section F2.

**RECOMMENDED ACTION:** For your information.

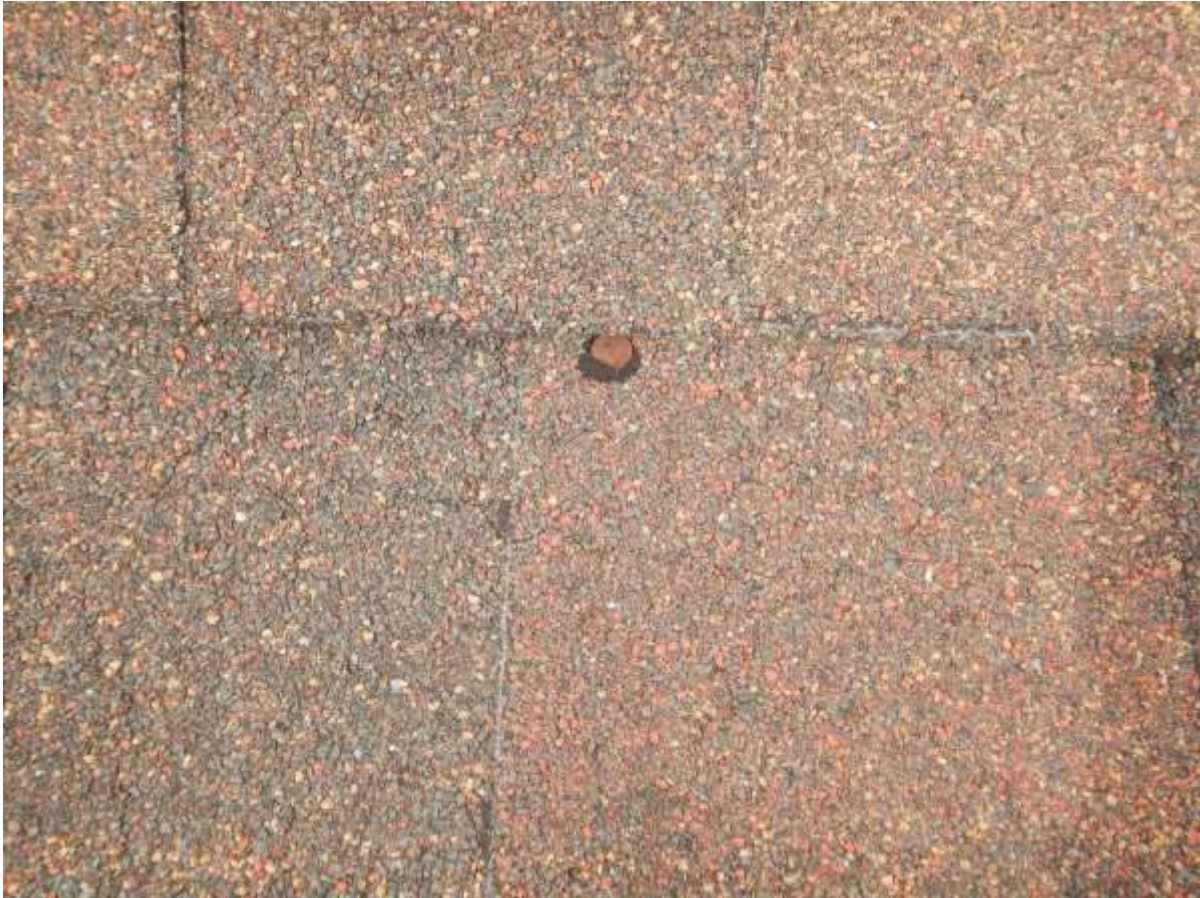
**PHOTO THIRTY-SIX**

**CONDITION:** A view of a nail pop through the shingle at this location.

**RECOMMENDED ACTION:** This condition will be corrected during roof replacement.

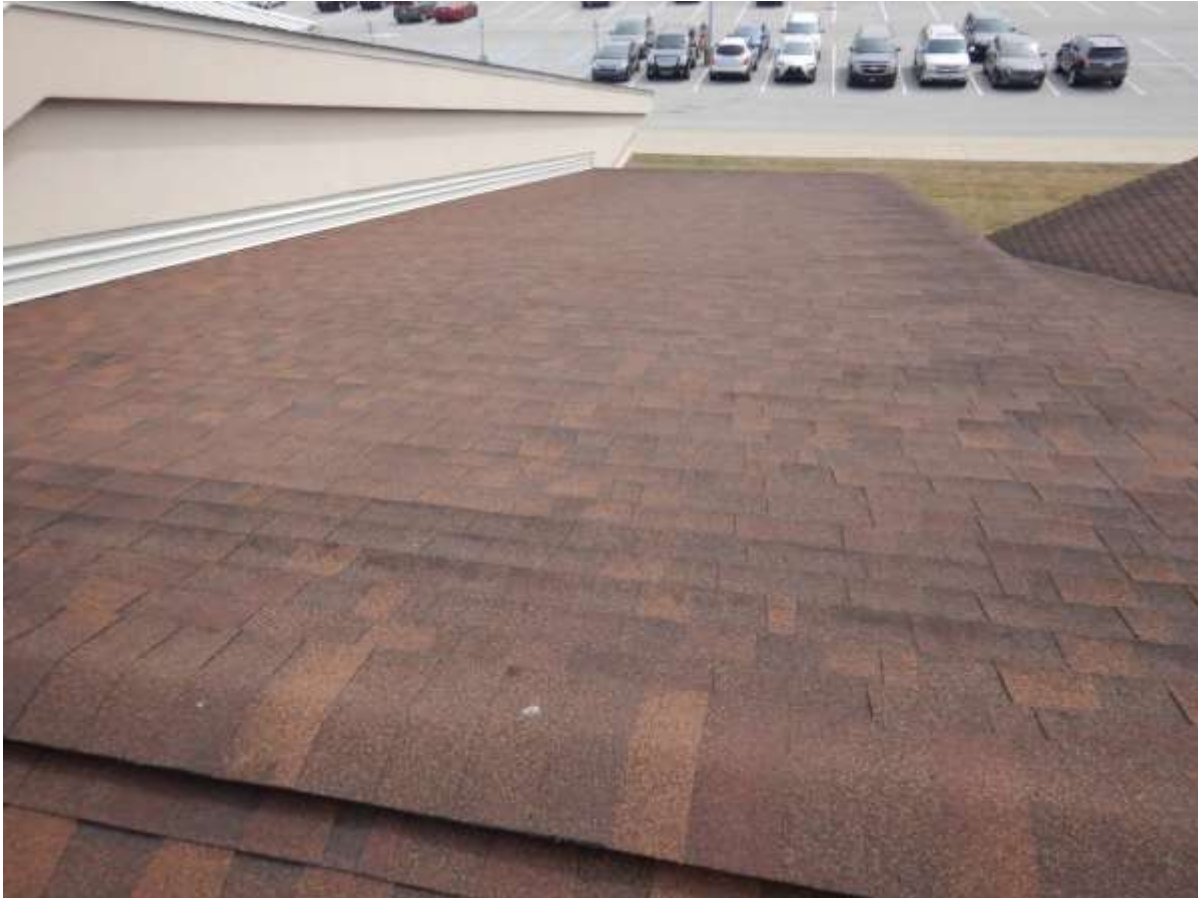
**PHOTO THIRTY-SEVEN**

**CONDITION:** An overview of the existing Dimensional Shingle Roof System on Section F3.

**RECOMMENDED ACTION:** For your information.

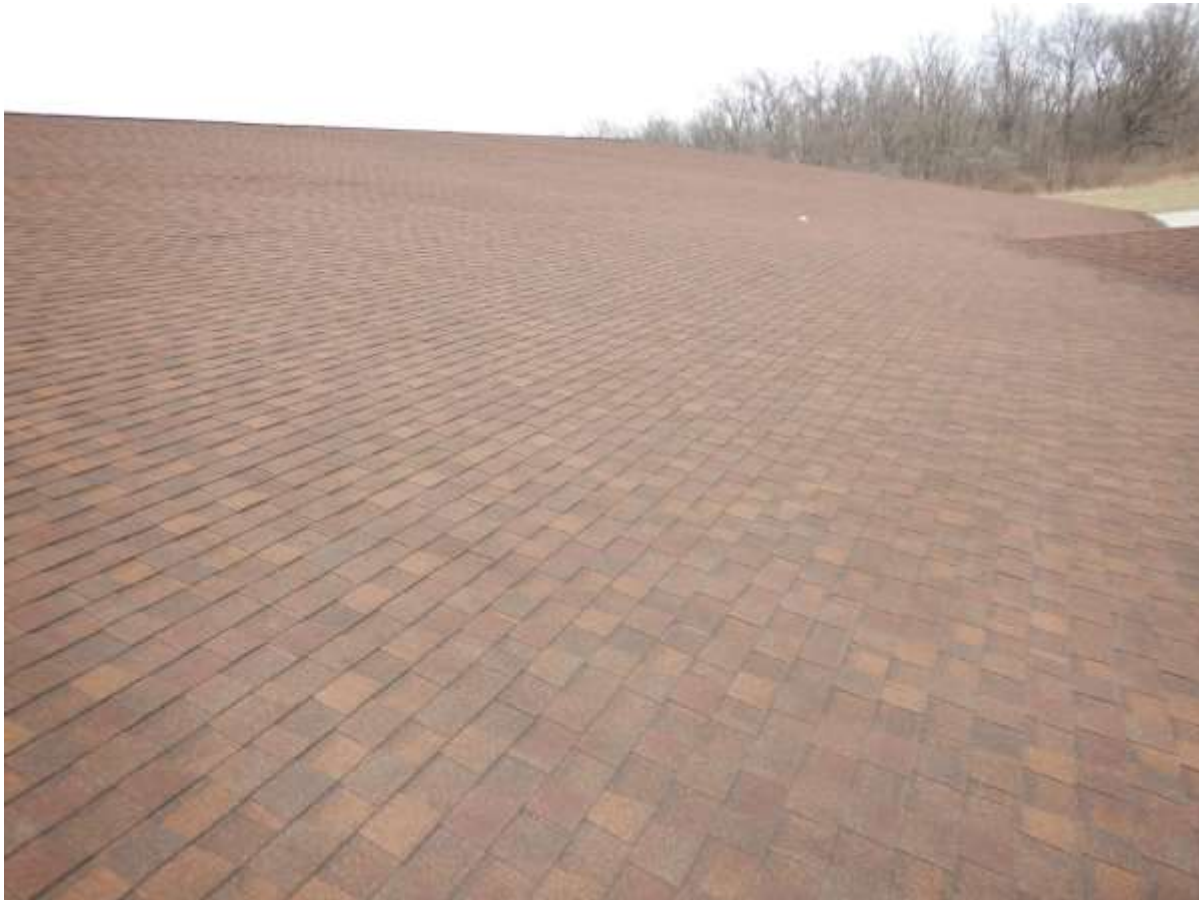
**PHOTO THIRTY-EIGHT**

**CONDITION:** An overview of the existing Dimensional Shingle Roof System on Section G1.

**RECOMMENDED ACTION:** For your information.

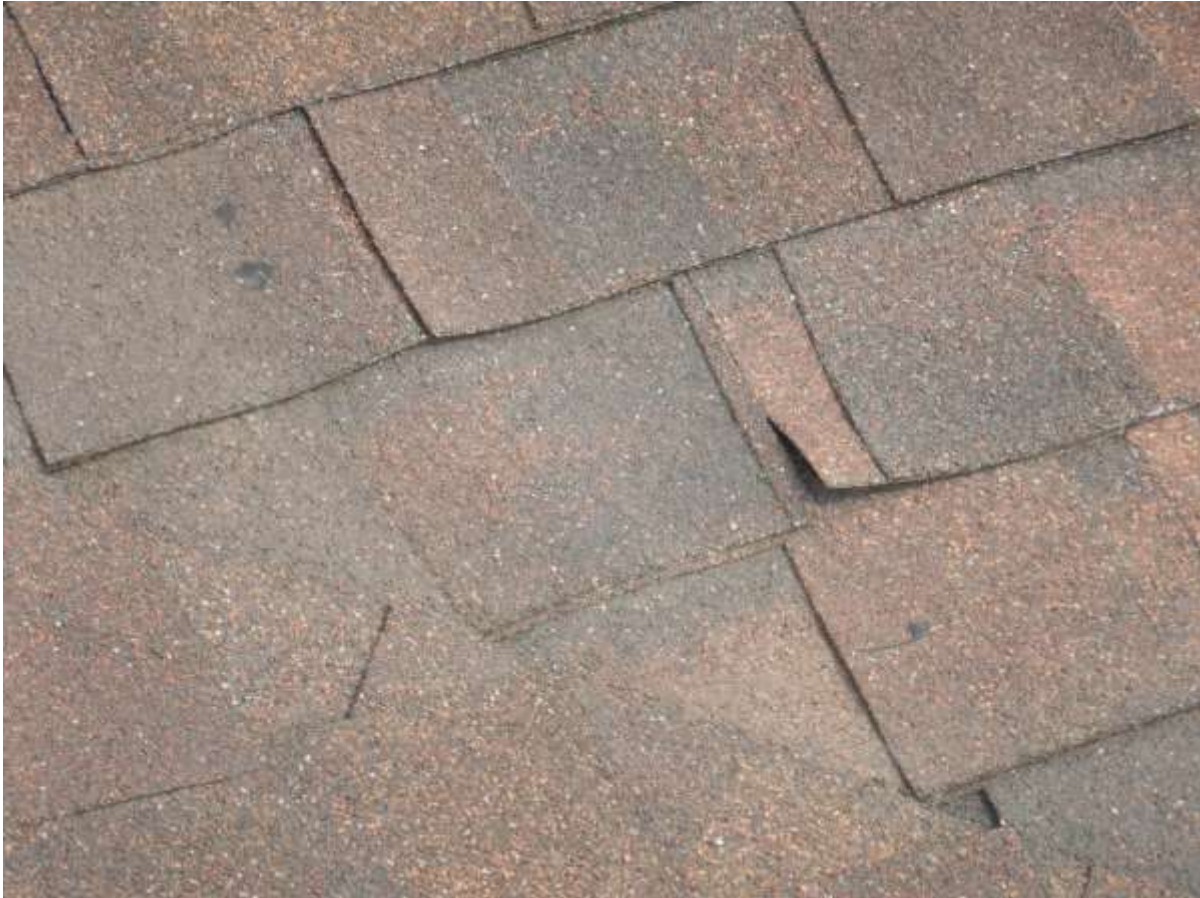
**PHOTO THIRTY-NINE**

**CONDITION:** The shingles are buckled in this area.

**RECOMMENDED ACTION:** This condition will be corrected during roof replacement.

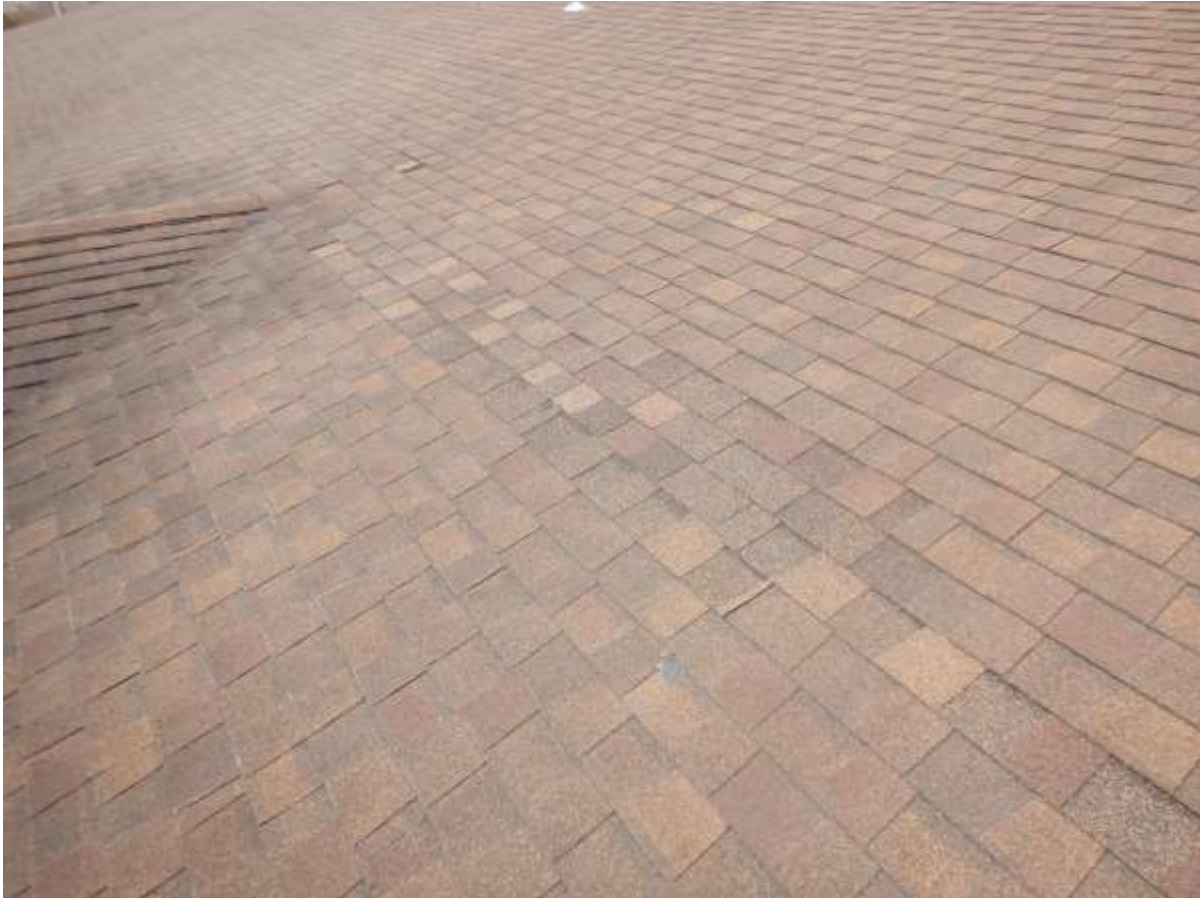
**PHOTO FORTY**

**CONDITION:** Previous repairs were noted in random locations.

**RECOMMENDED ACTION:** This condition will be corrected during roof replacement.

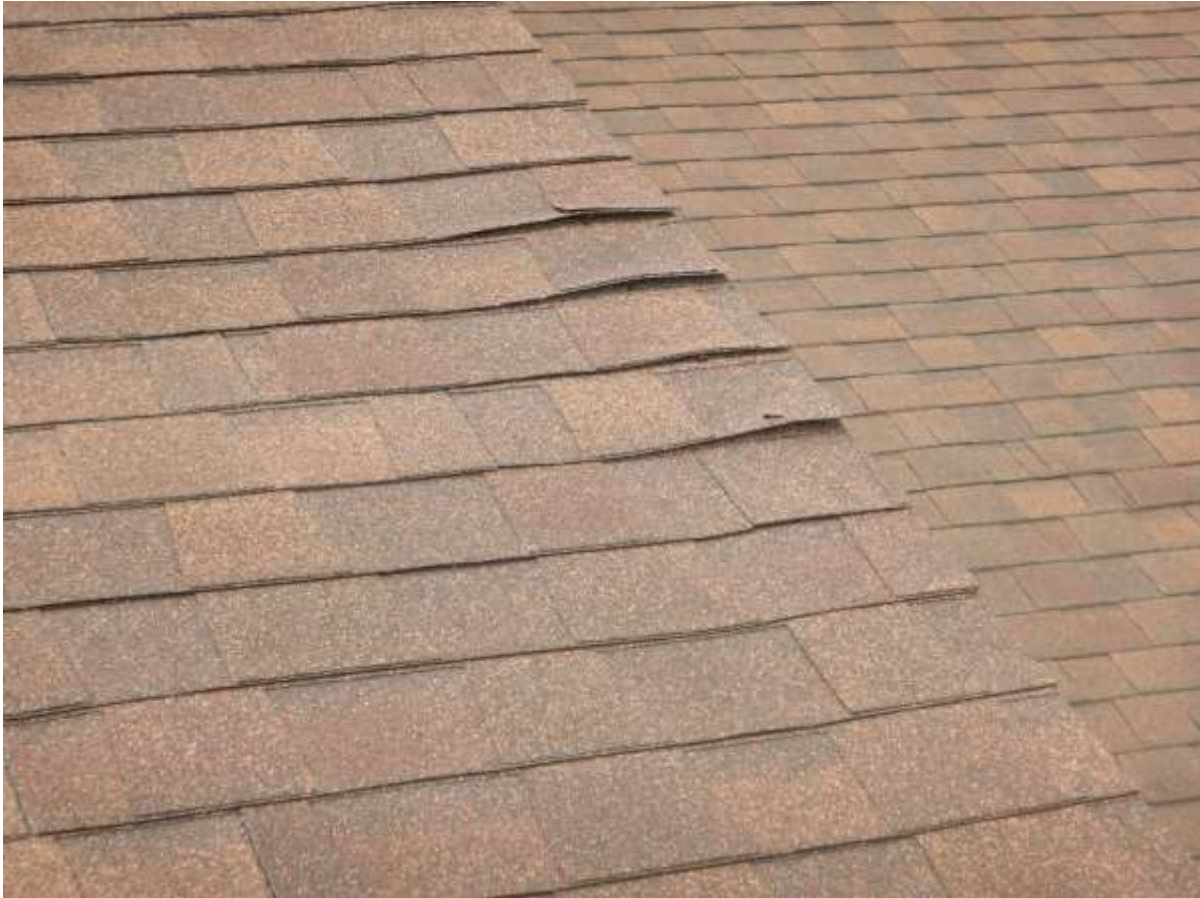
**PHOTO FORTY-ONE**

**CONDITION:** The shingles are raised at the perimeter edge.

**RECOMMENDED ACTION:** This condition will be corrected during roof replacement.
