## ***ROOF EVALUATION REPORT***

***FRANKLIN TOWNSHIP COMMUNITY SCHOOL CORPORATION  
SOUTH CREEK ELEMENTARY SCHOOL  
9010 EAST SOUTHPORT ROAD  
INDIANAPOLIS, INDIANA***

***REVISED APRIL 12, 2021***

**R.M.I. # 021-192  
*REVISED* APRIL 12, 2021**

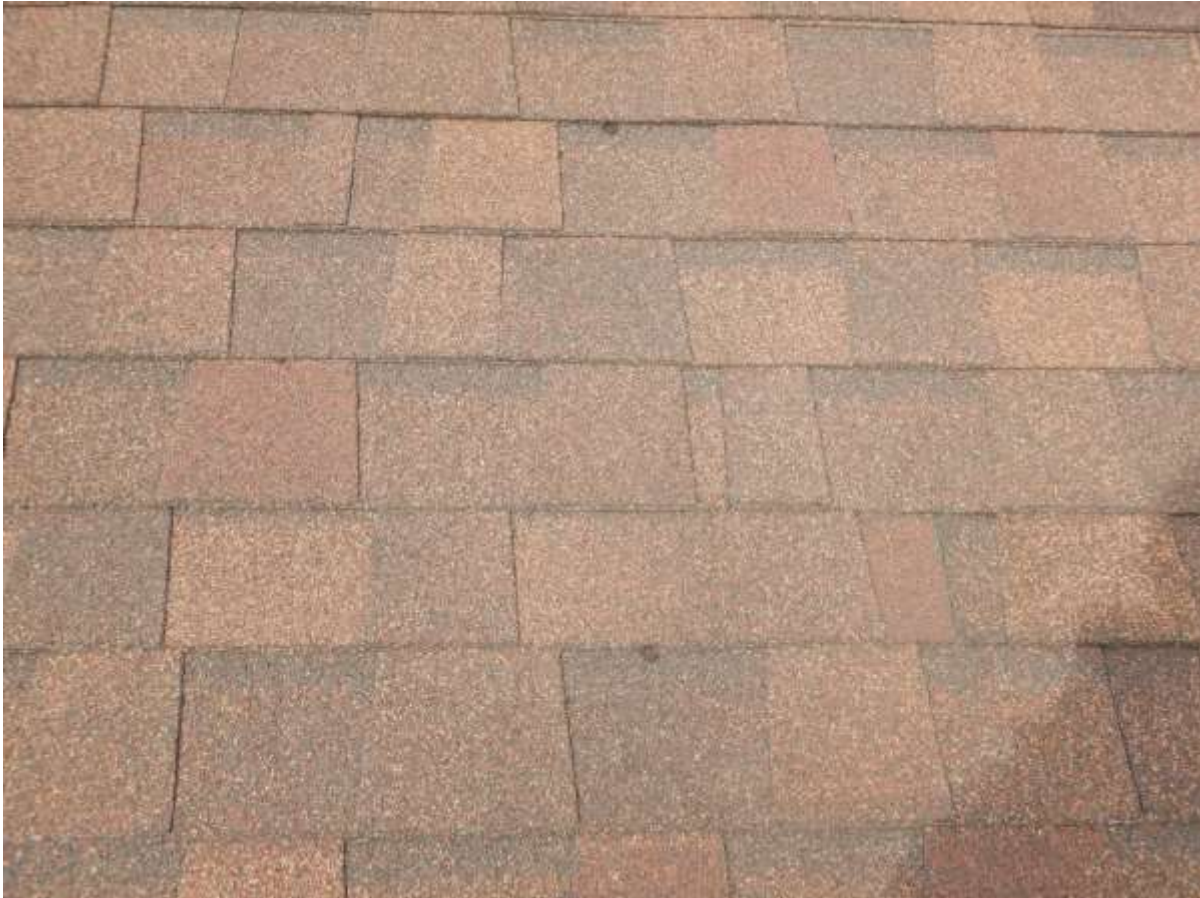
**PHOTO FORTY-TWO**

**CONDITION:     Roofing nails are exposed at random location.**

**RECOMMENDED ACTION:     This condition will be corrected during roof replacement.**

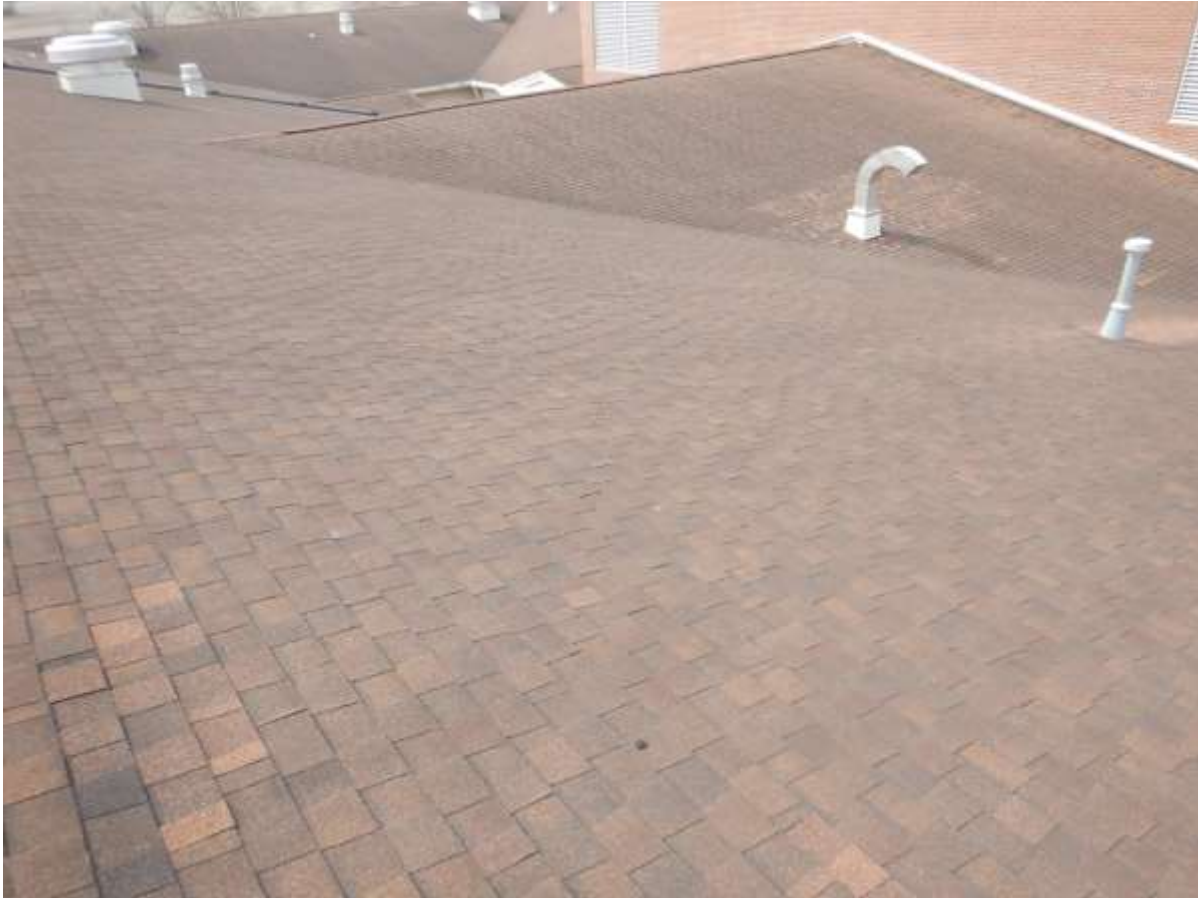
**PHOTO FORTY-THREE**

**CONDITION:**    An overview of the existing Dimensional Shingle Roof System on Section G2.

**RECOMMENDED ACTION:**    For your information.

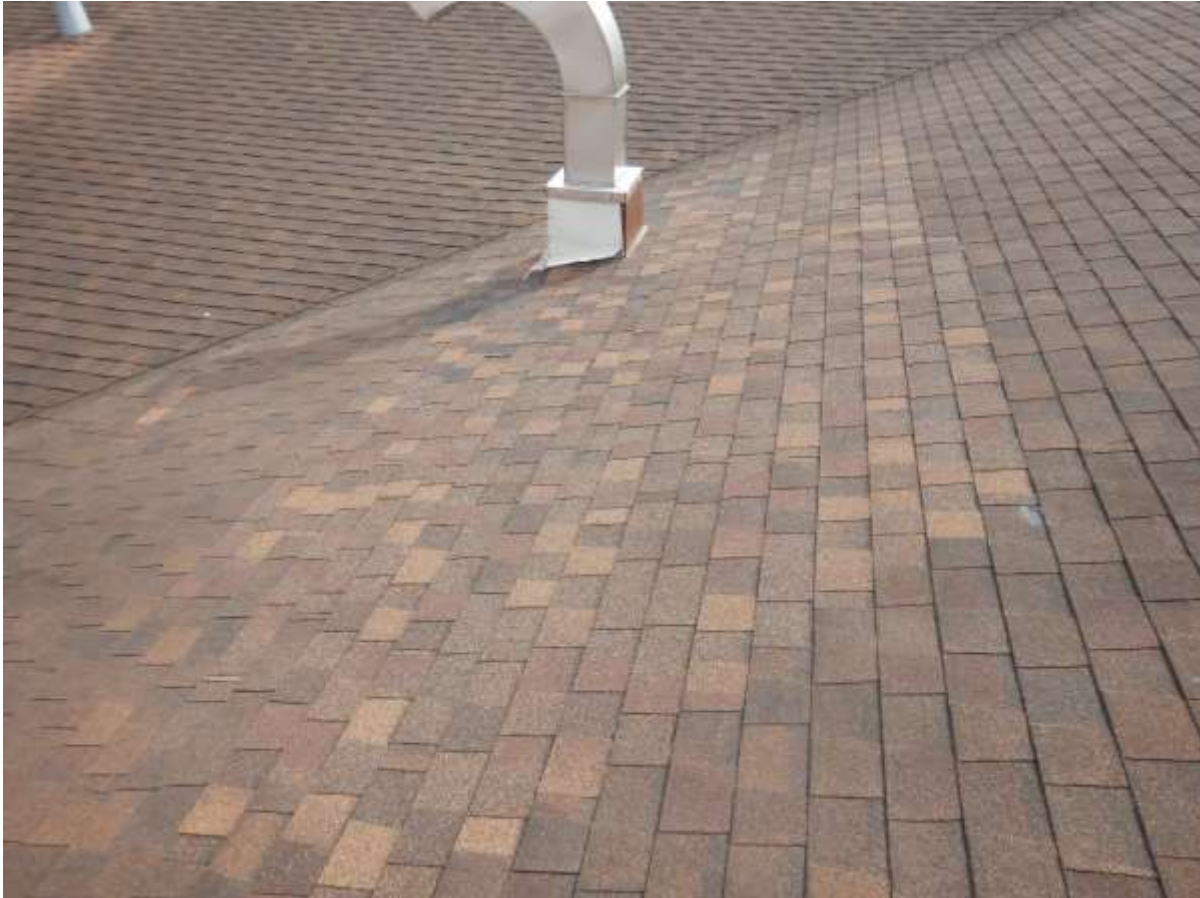
**PHOTO FORTY-FIVE**

**CONDITION:** Previous repairs were noted in random locations.

**RECOMMENDED ACTION:** This condition will be corrected during roof replacement.

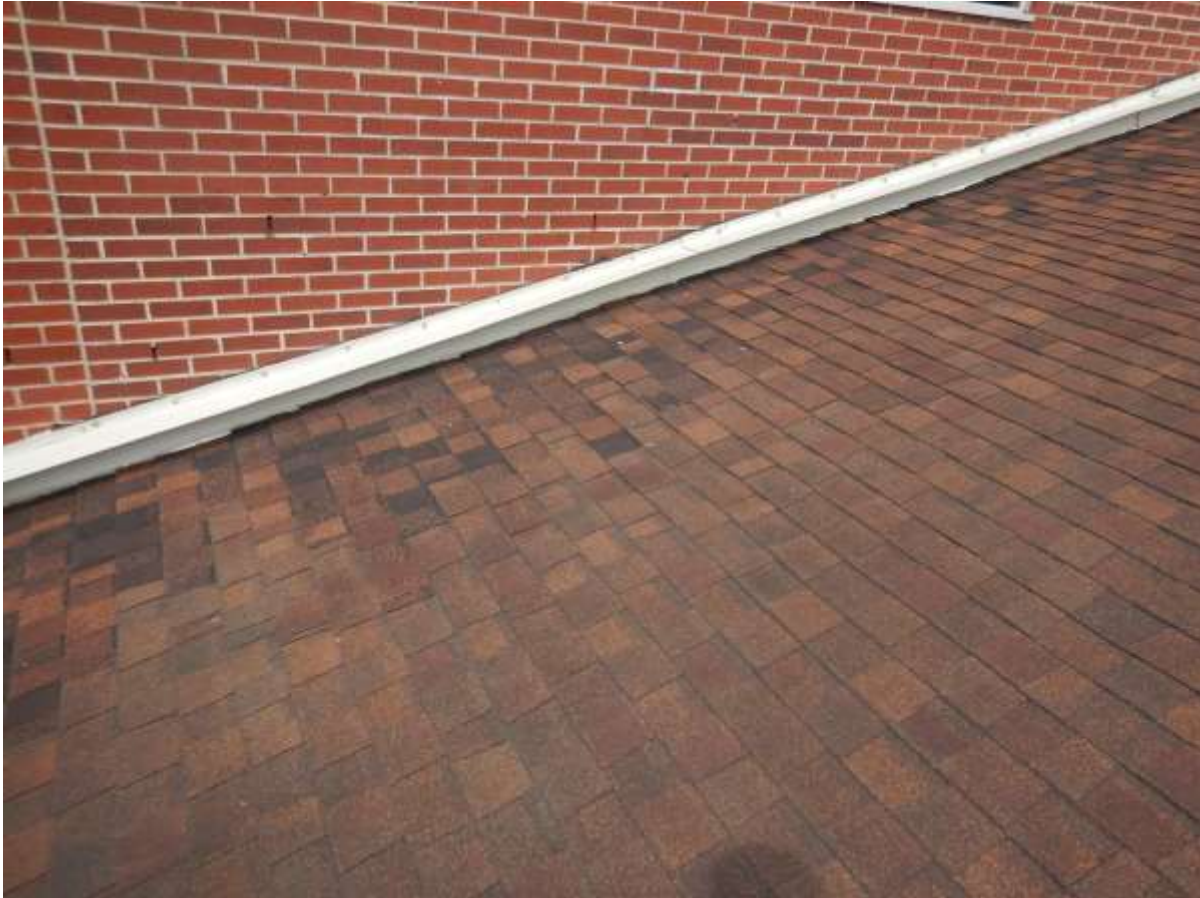
**PHOTO FORTY-SIX**

**CONDITION:** Previous repairs were noted in random locations.

**RECOMMENDED ACTION:** This condition will be corrected during roof replacement.

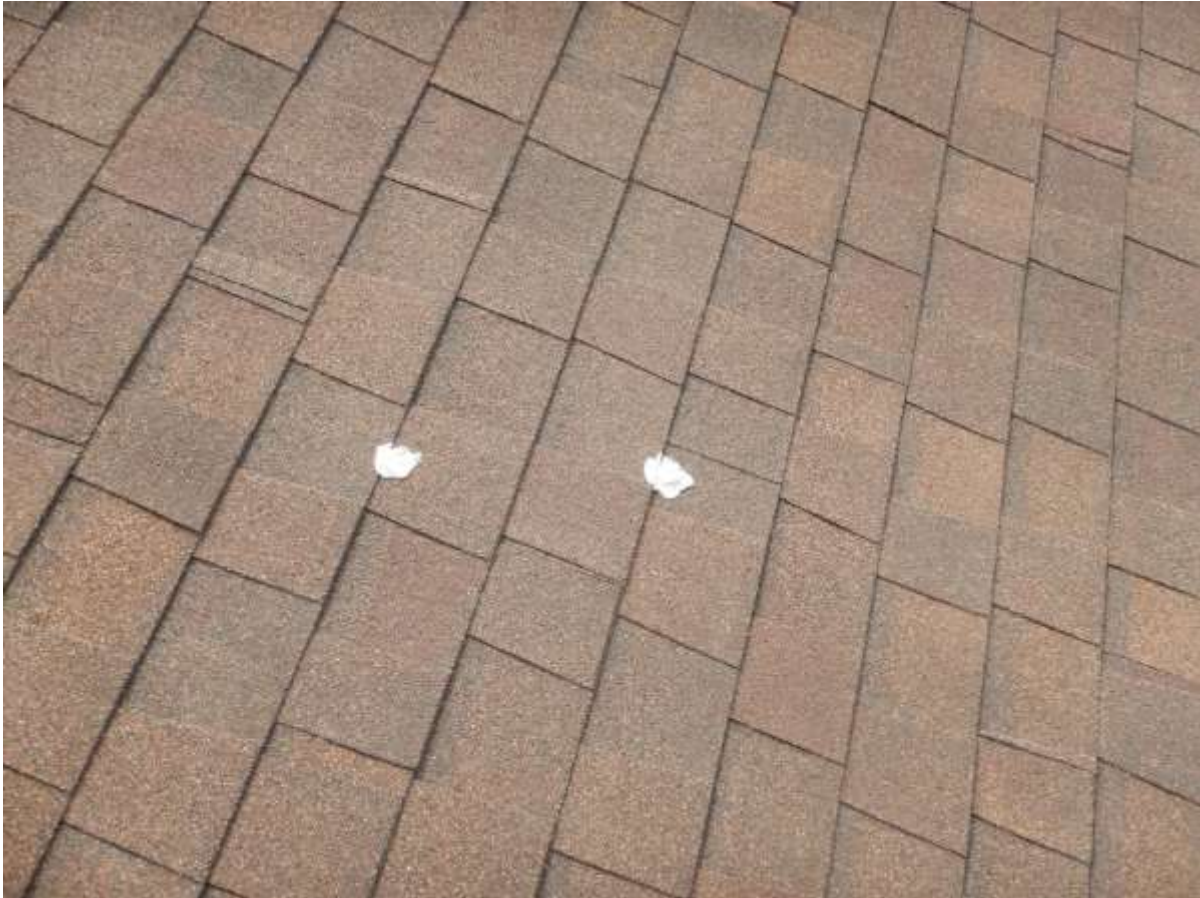
**PHOTO FORTY-EIGHT**

**CONDITION:** A view of caulk repairs in this area.

**RECOMMENDED ACTION:** This condition will be corrected during roof replacement.

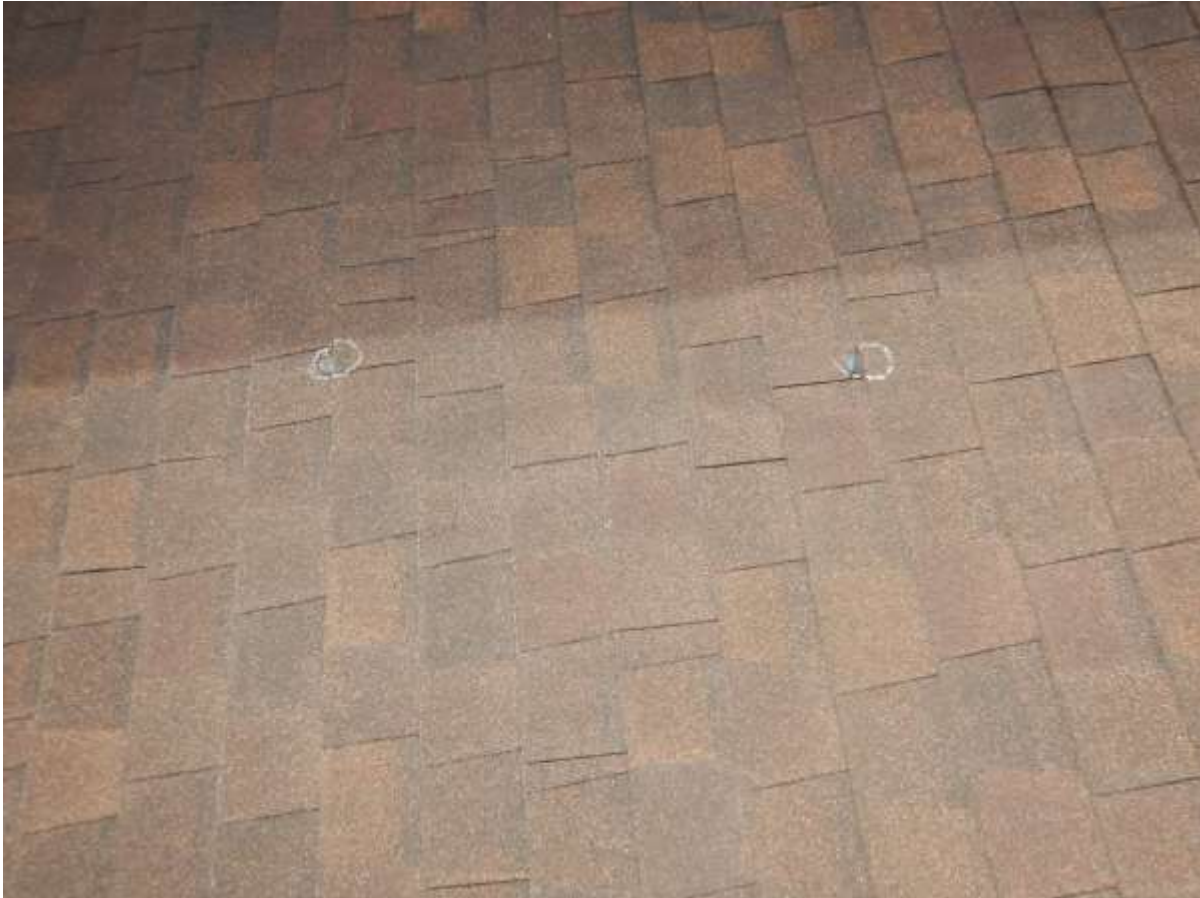
**PHOTO FIFTY**

**CONDITION:** A view of caulk repairs in this area.

**RECOMMENDED ACTION:** This condition will be corrected during roof replacement.

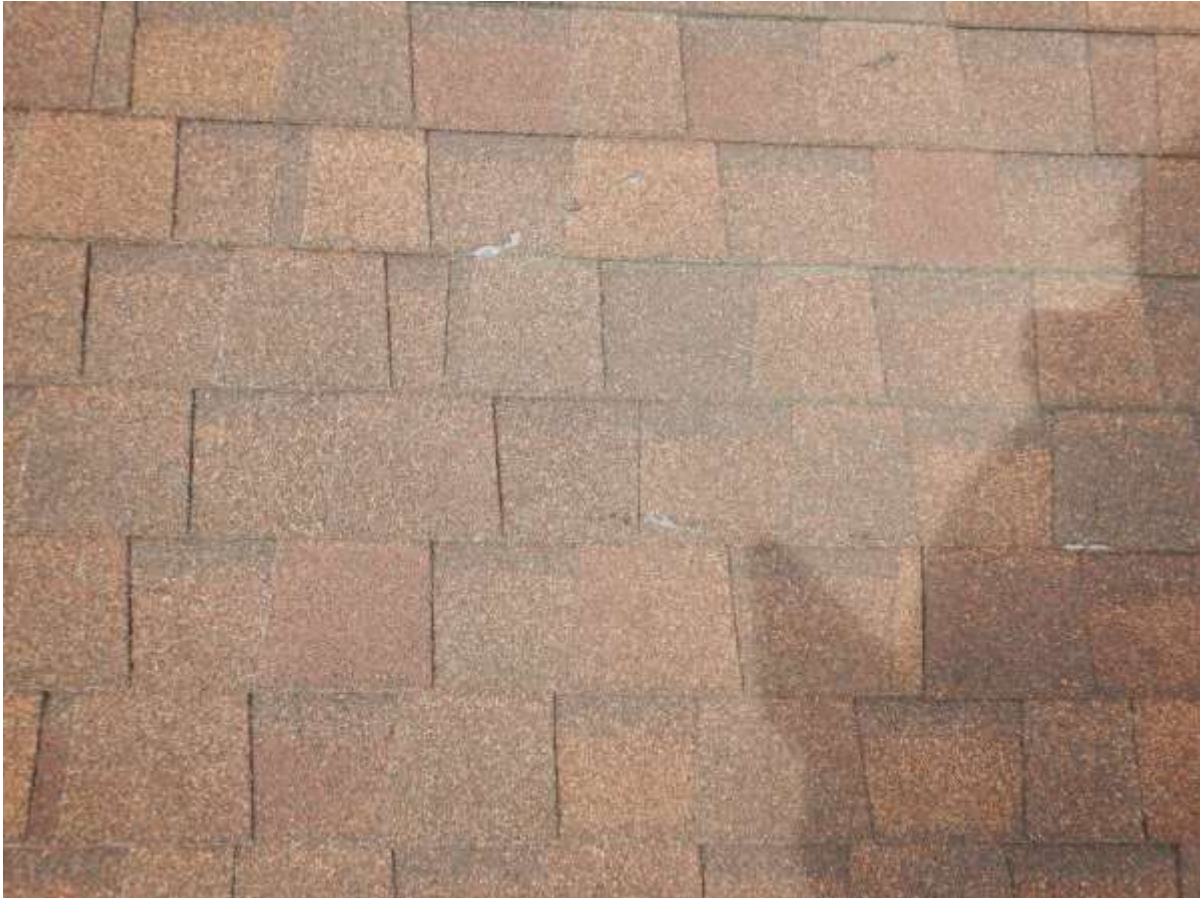
**PHOTO FIFTY-ONE**

**CONDITION:** The shingles are damaged in this area.

**RECOMMENDED ACTION:** This condition will be corrected during roof replacement.

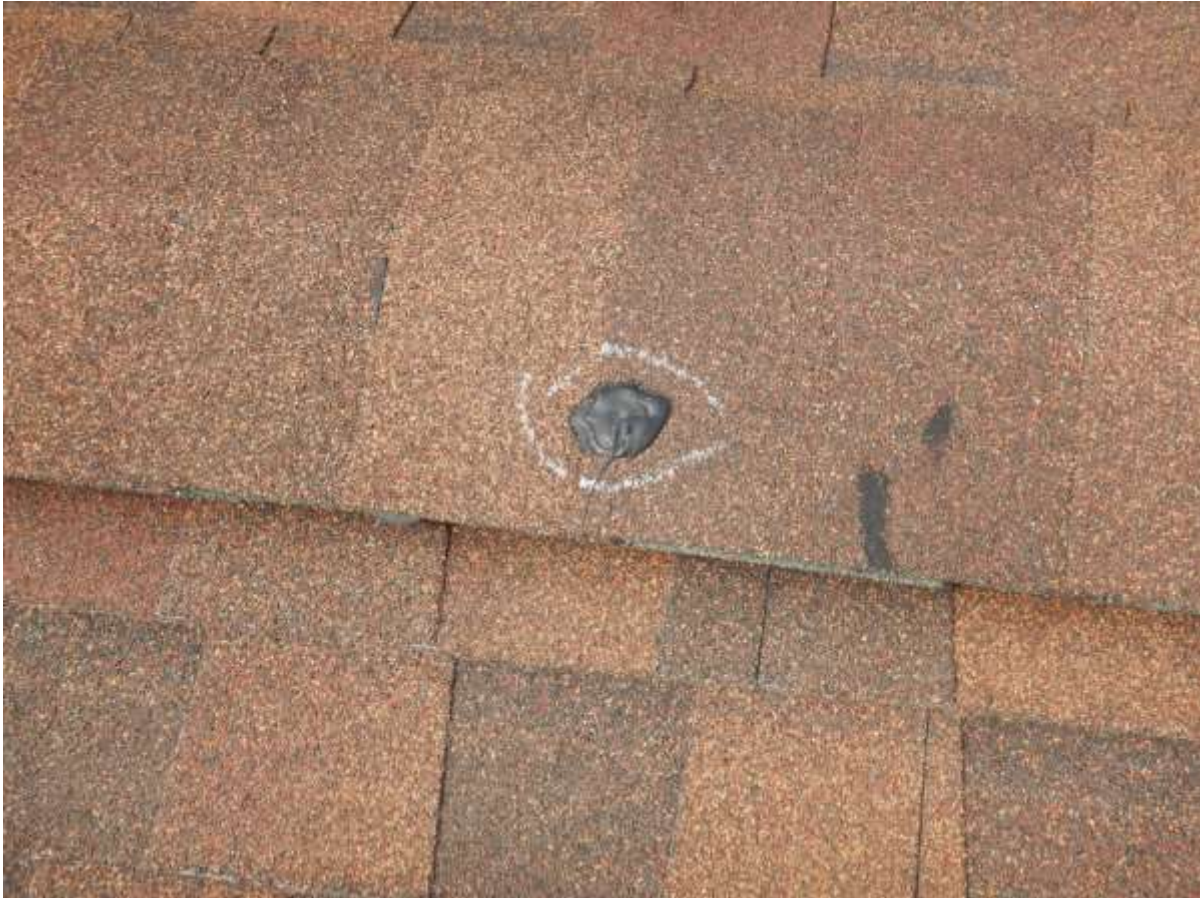
**PHOTO FIFTY-TWO**

**CONDITION:** Previous repairs were noted in random locations.

**RECOMMENDED ACTION:** This condition will be corrected during roof replacement.

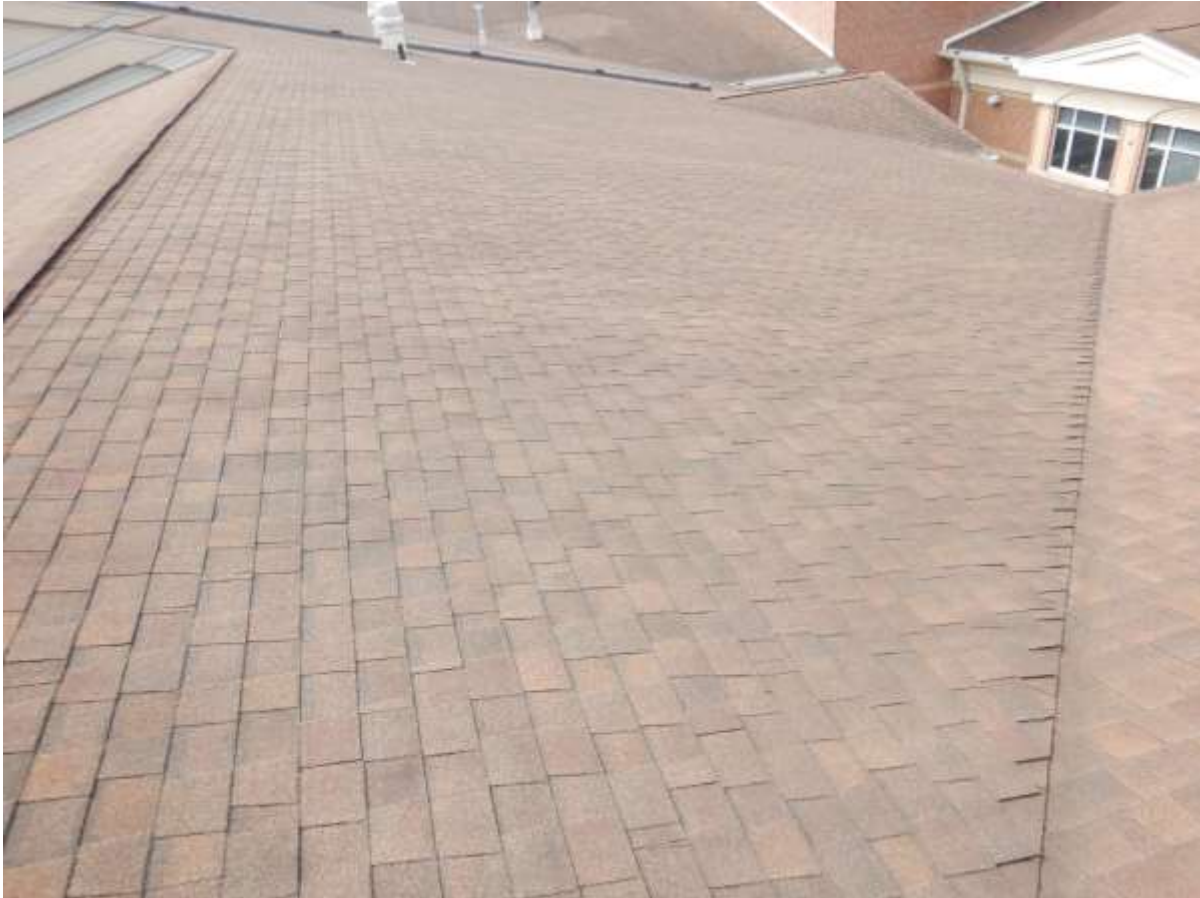
**PHOTO FIFTY-THREE**

**CONDITION:** Another overview of the existing Dimensional Shingle Roof System on Section H1.

**RECOMMENDED ACTION:** For your information.

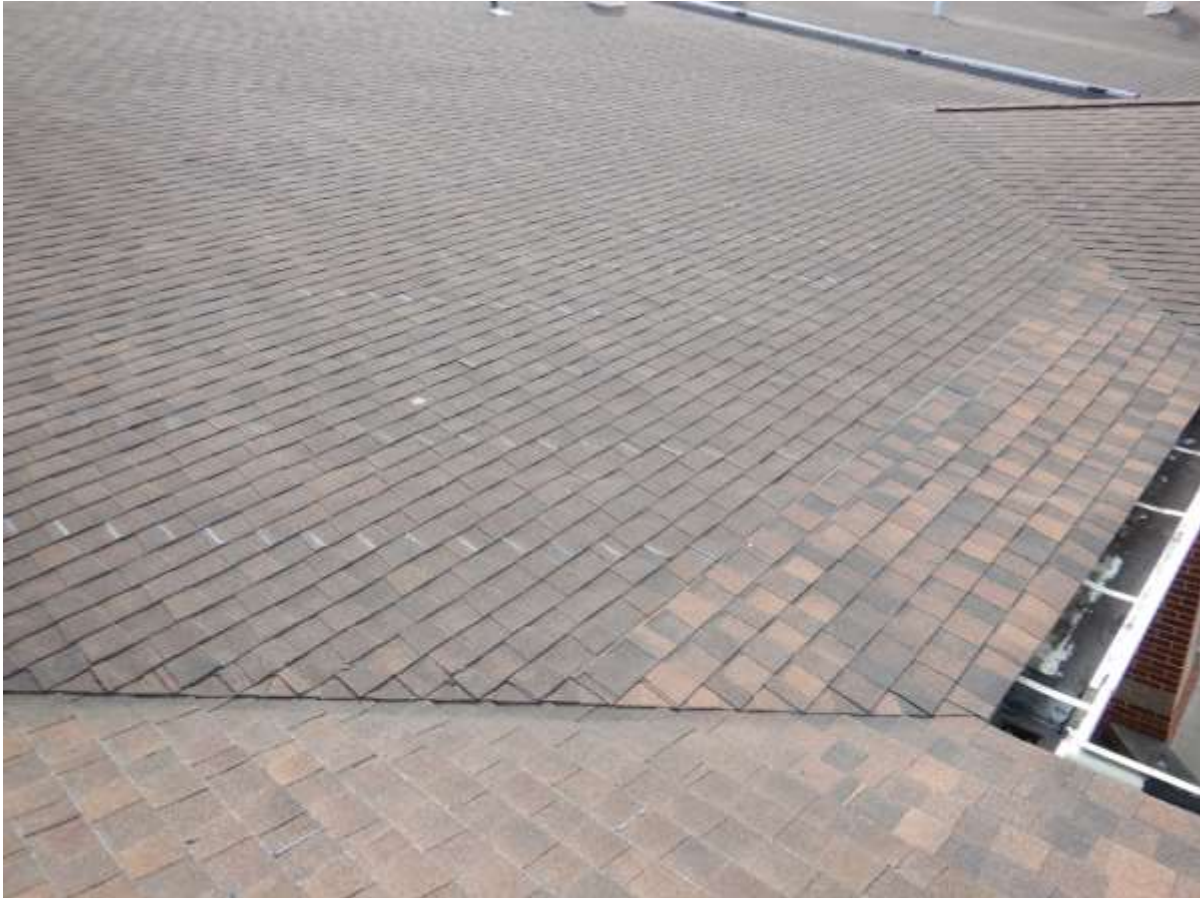
**PHOTO FIFTY-FOUR**

**CONDITION:** Previous repairs were noted in widespread locations.

**RECOMMENDED ACTION:** This condition will be corrected during roof replacement.

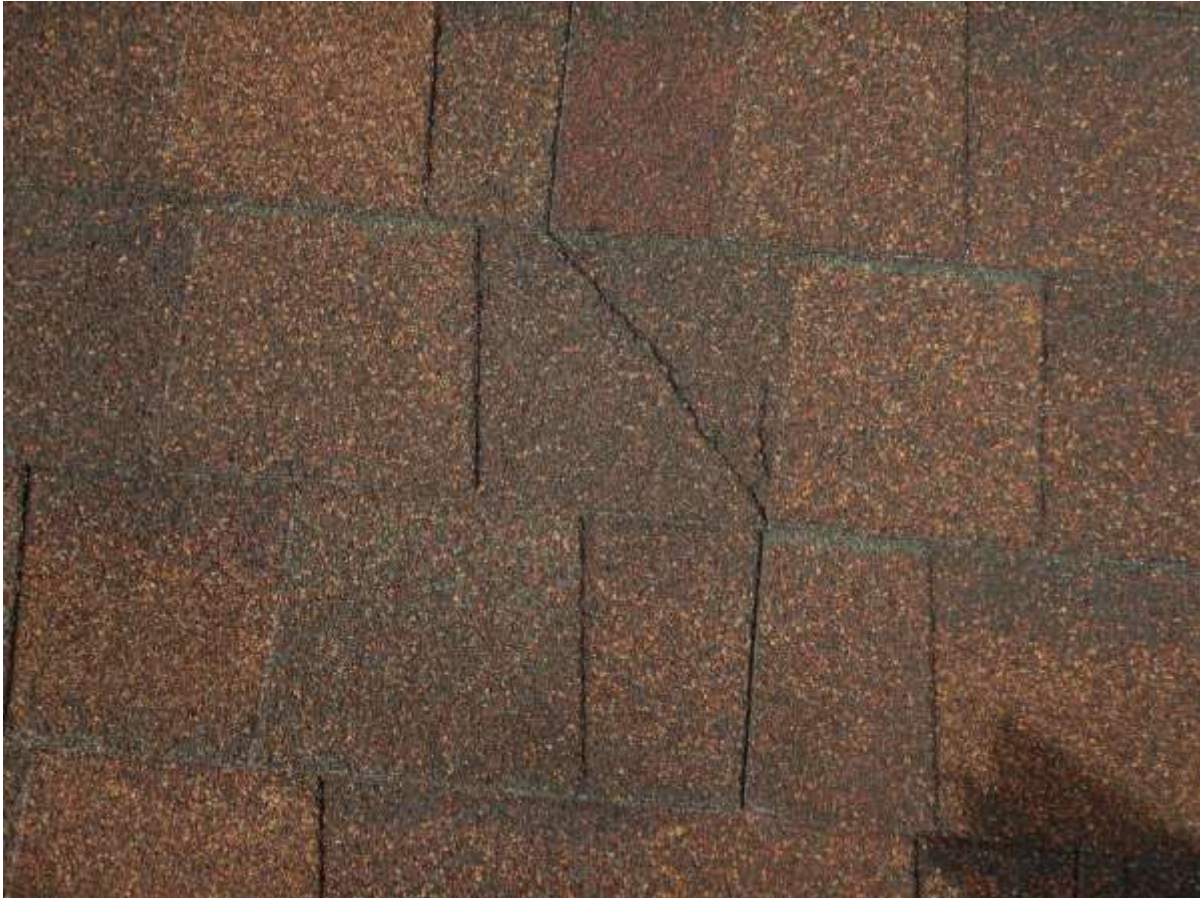
**PHOTO FIFTY-NINE**

**CONDITION:** The shingle is damaged at this location.

**RECOMMENDED ACTION:** This condition will be corrected during roof replacement.

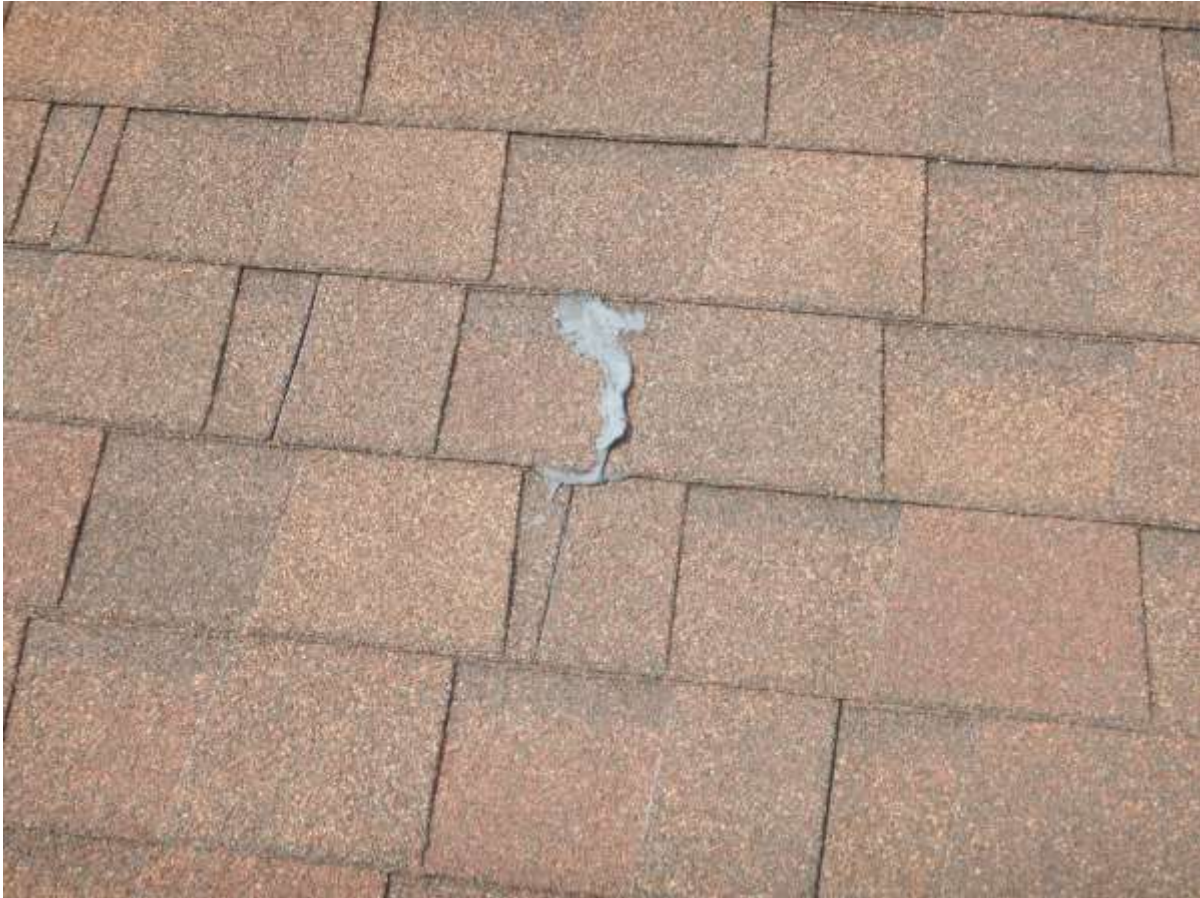
**PHOTO SIXTY**

**CONDITION:** A view of caulk repair in this area.

**RECOMMENDED ACTION:** This condition will be corrected during roof replacement.

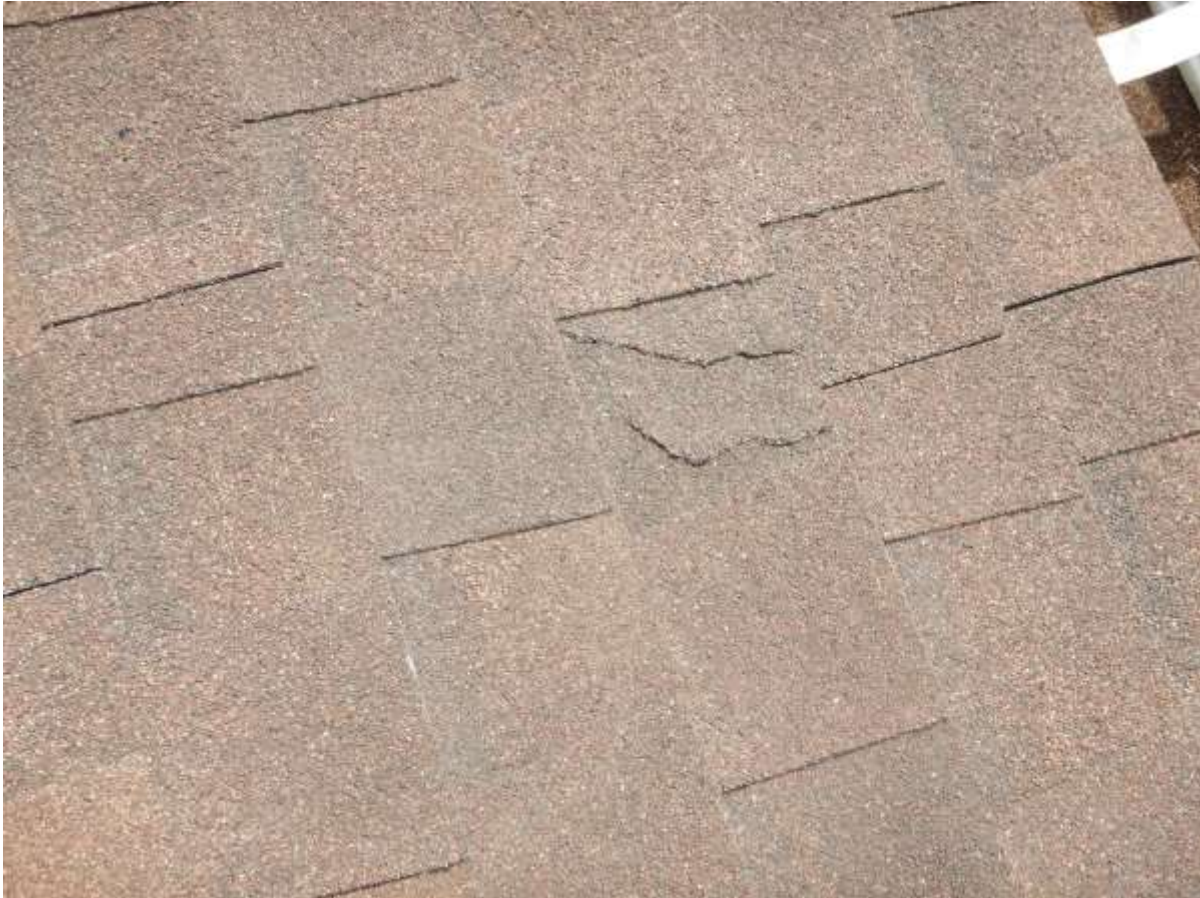
**PHOTO SIXTY-TWO**

**CONDITION:** The shingle is damaged at this location.

**RECOMMENDED ACTION:** This condition will be corrected during roof replacement.

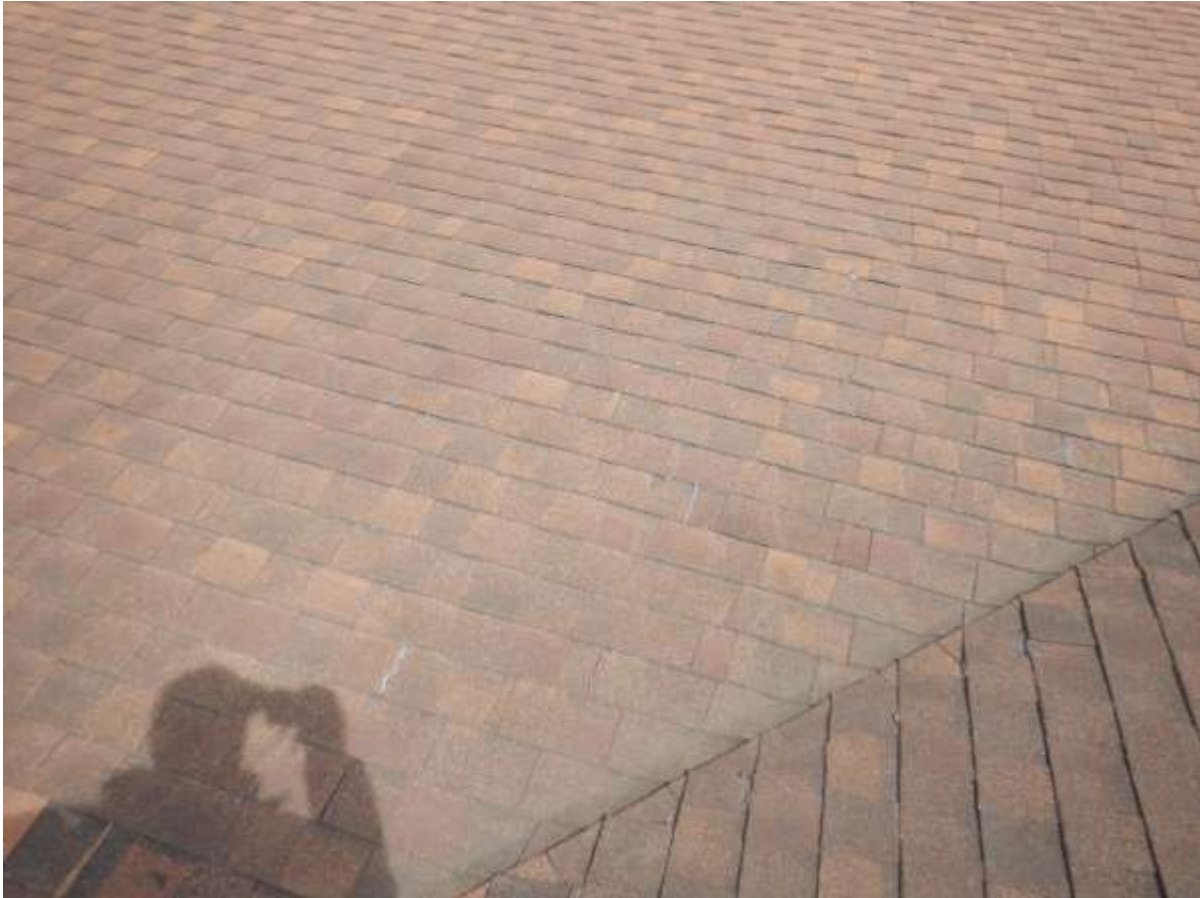
**PHOTO SIXTY-THREE**

**CONDITION:** A view of widespread caulk repairs in this area.

**RECOMMENDED ACTION:** This condition will be corrected during roof replacement.

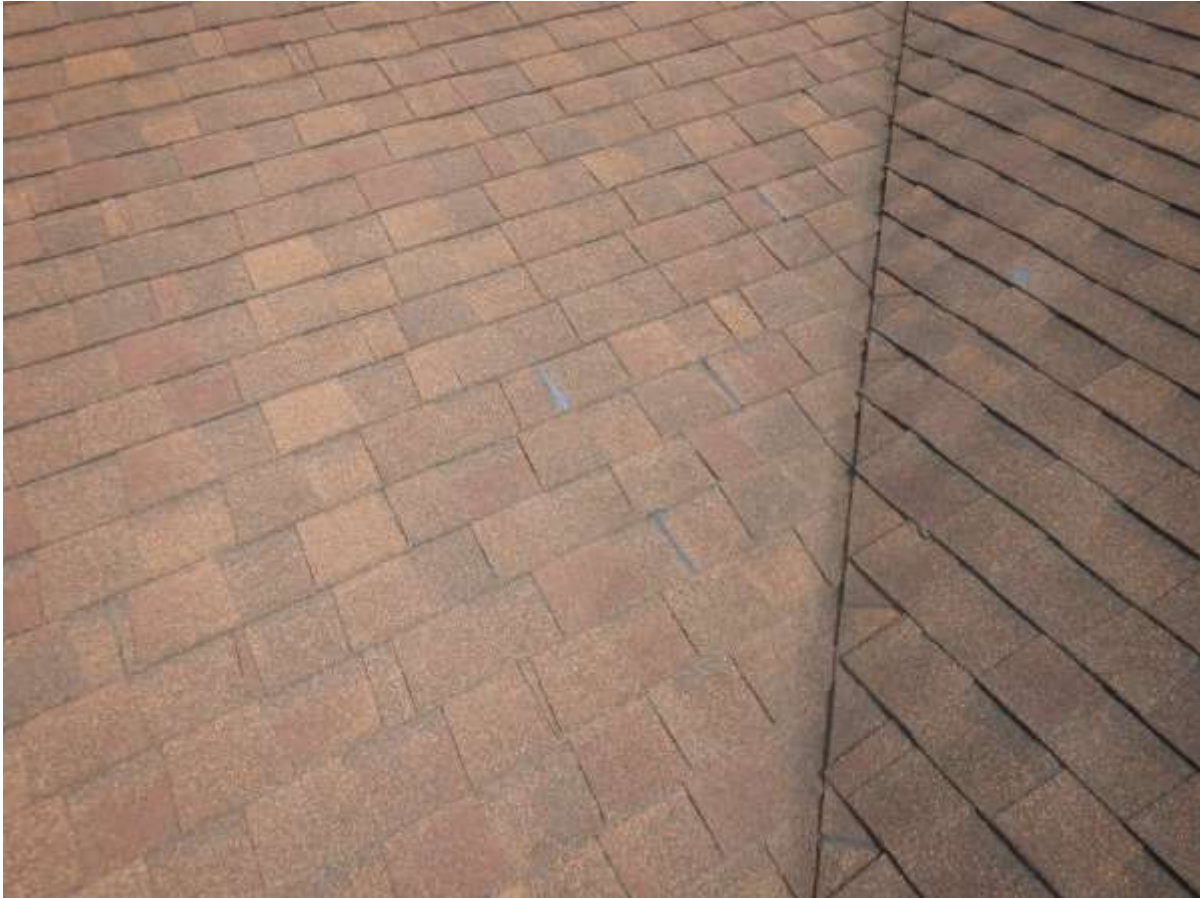
**PHOTO SIXTY-FIVE**

**CONDITION:** A view of widespread caulk repairs in this area.

**RECOMMENDED ACTION:** This condition will be corrected during roof replacement.

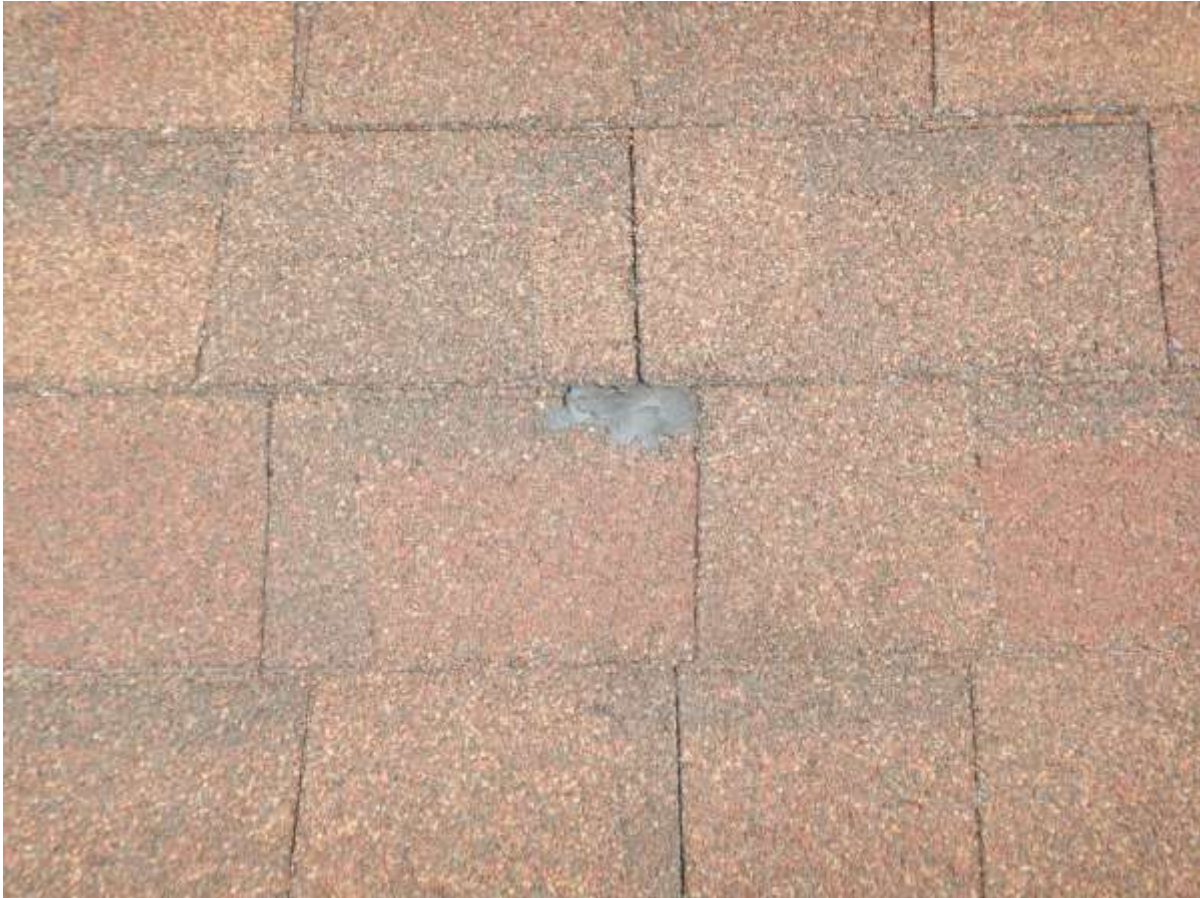
**PHOTO SIXTY-SIX**

**CONDITION:** A view of caulk repairs in this area.

**RECOMMENDED ACTION:** This condition will be corrected during roof replacement.

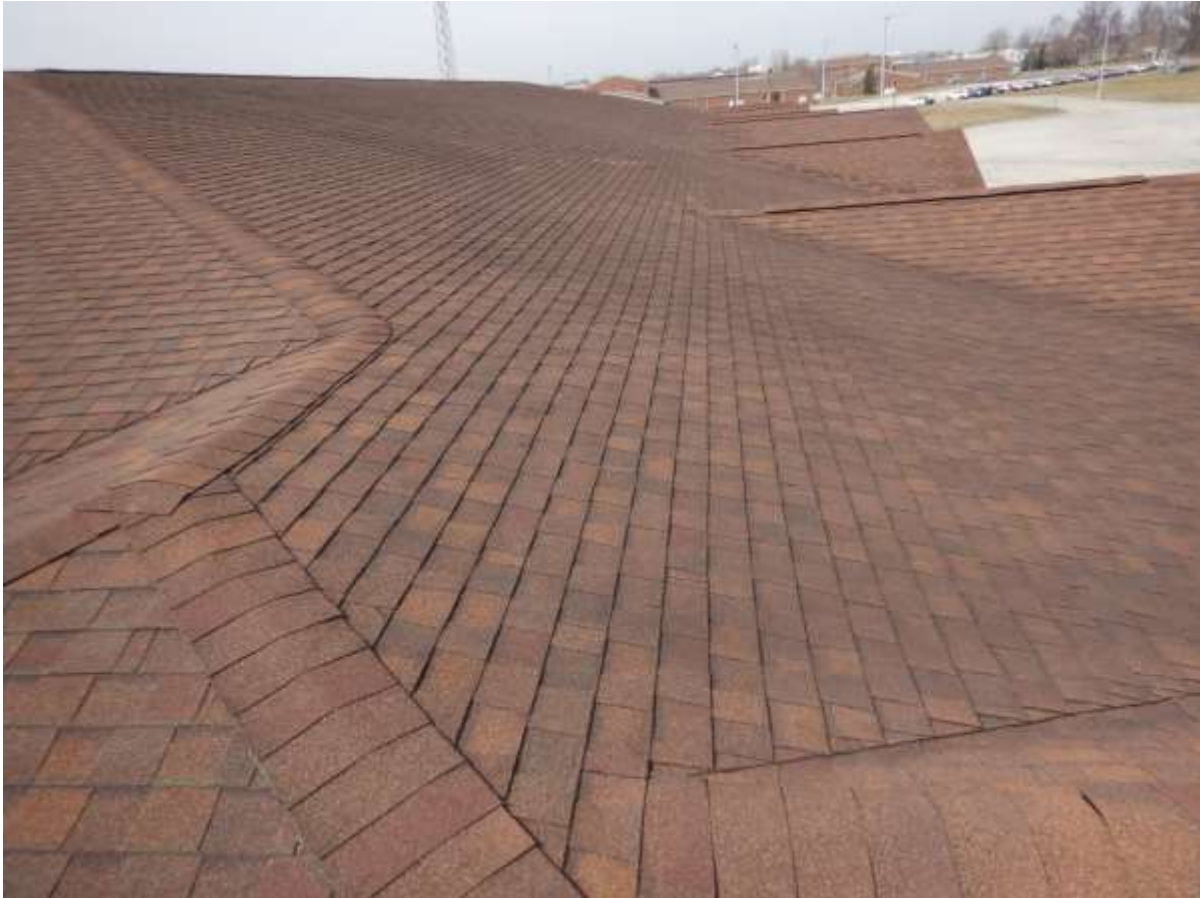
**PHOTO SIXTY-SEVEN**

**CONDITION:** An overview of the existing Dimensional Shingle Roof System on Section I2.

**RECOMMENDED ACTION:** For your information.

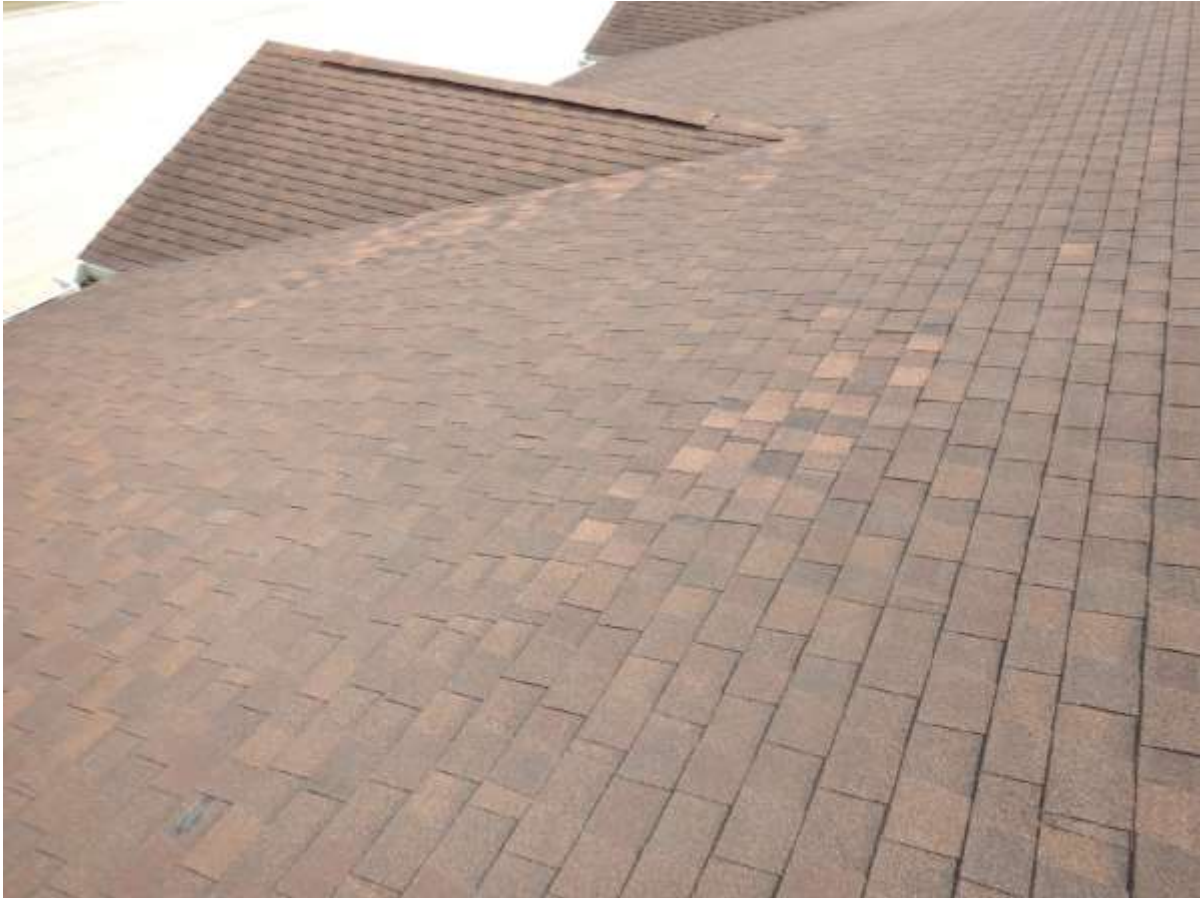
**PHOTO SIXTY-EIGHT**

**CONDITION:** Previous repairs were noted in random locations.

**RECOMMENDED ACTION:** This condition will be corrected during roof replacement.

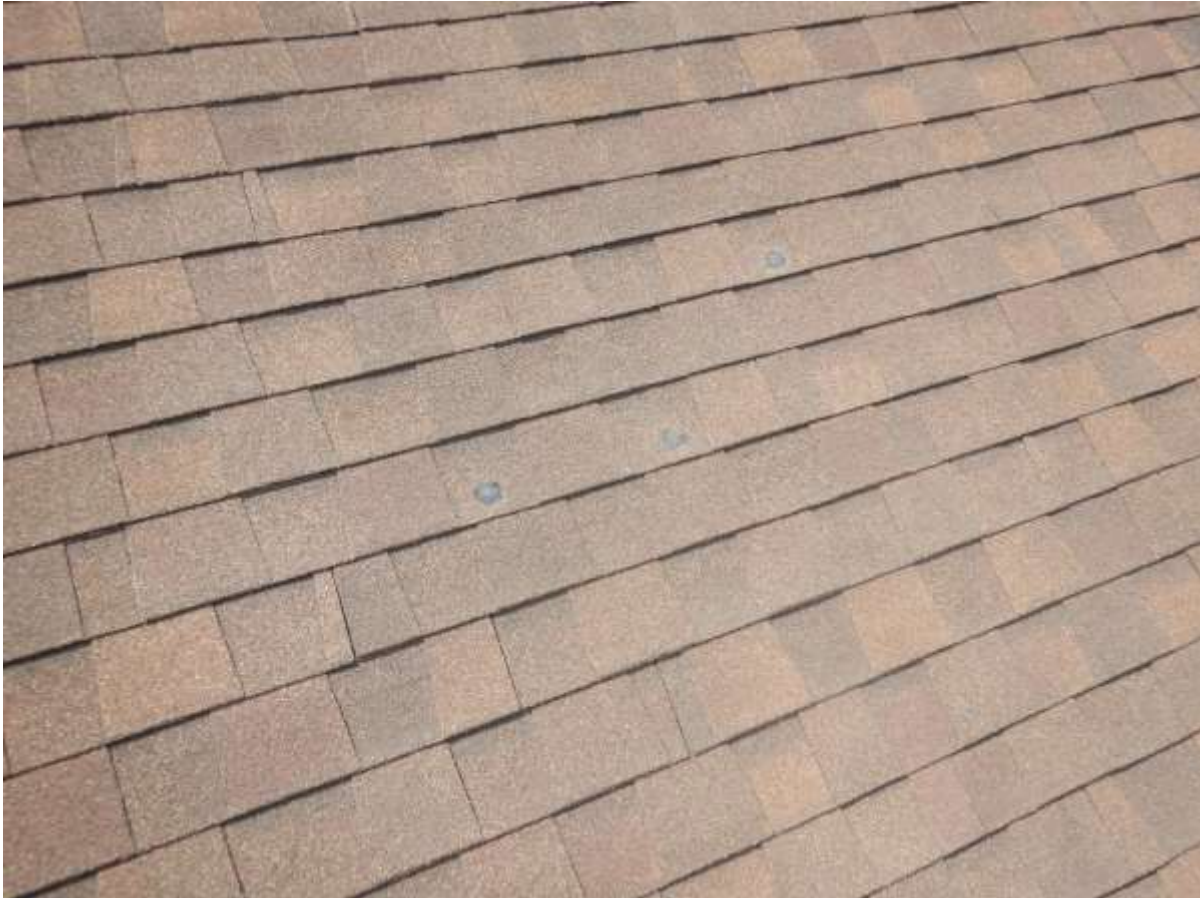
**PHOTO SIXTY-NINE**

**CONDITION:** A view of caulk repairs in this area.

**RECOMMENDED ACTION:** This condition will be corrected during roof replacement.

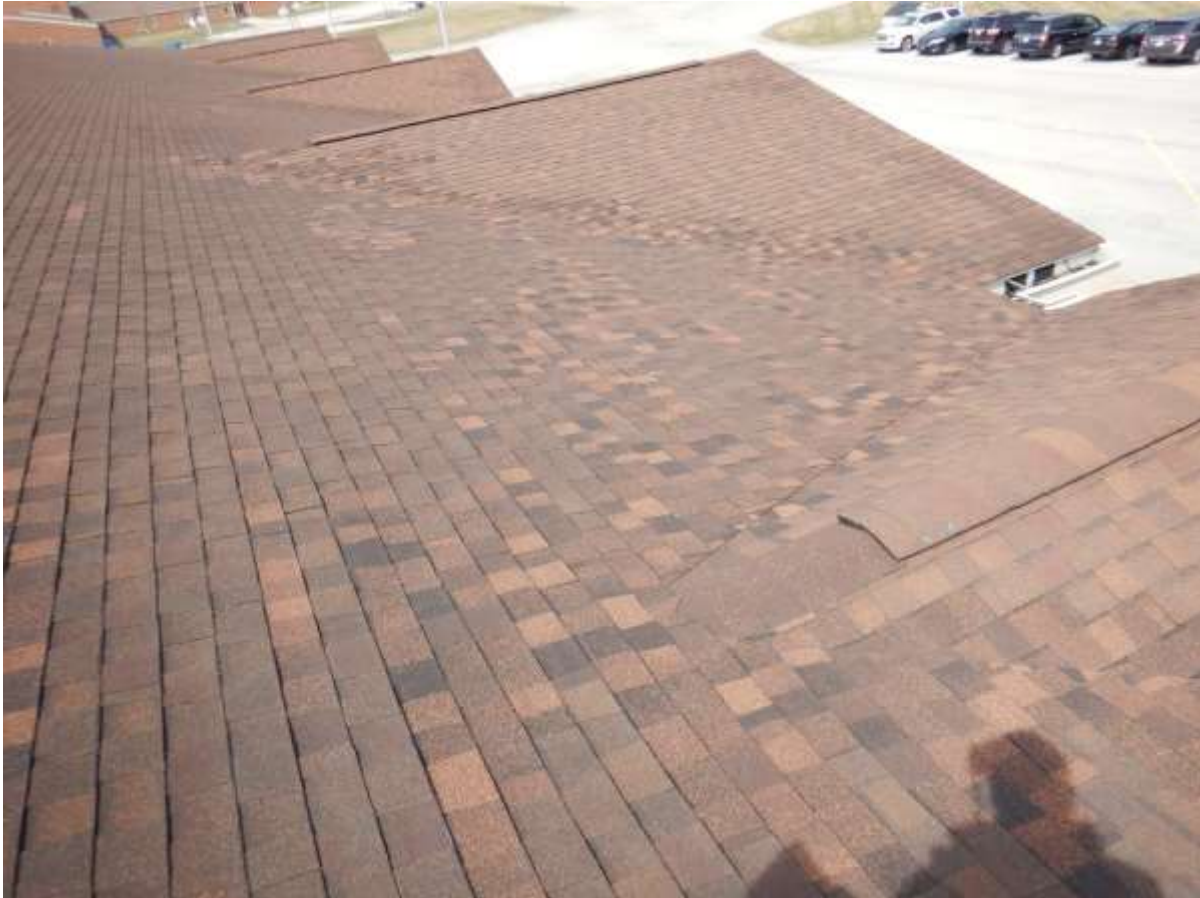
**PHOTO SEVENTY**

**CONDITION:** Previous repairs were noted in widespread locations.

**RECOMMENDED ACTION:** This condition will be corrected during roof replacement.
