## ***ROOF EVALUATION REPORT***

***FRANKLIN TOWNSHIP COMMUNITY SCHOOL CORPORATION  
SOUTH CREEK ELEMENTARY SCHOOL  
9010 EAST SOUTHPORT ROAD  
INDIANAPOLIS, INDIANA***

***REVISED APRIL 12, 2021***

**R.M.I. # 021-192  
*REVISED* APRIL 12, 2021**

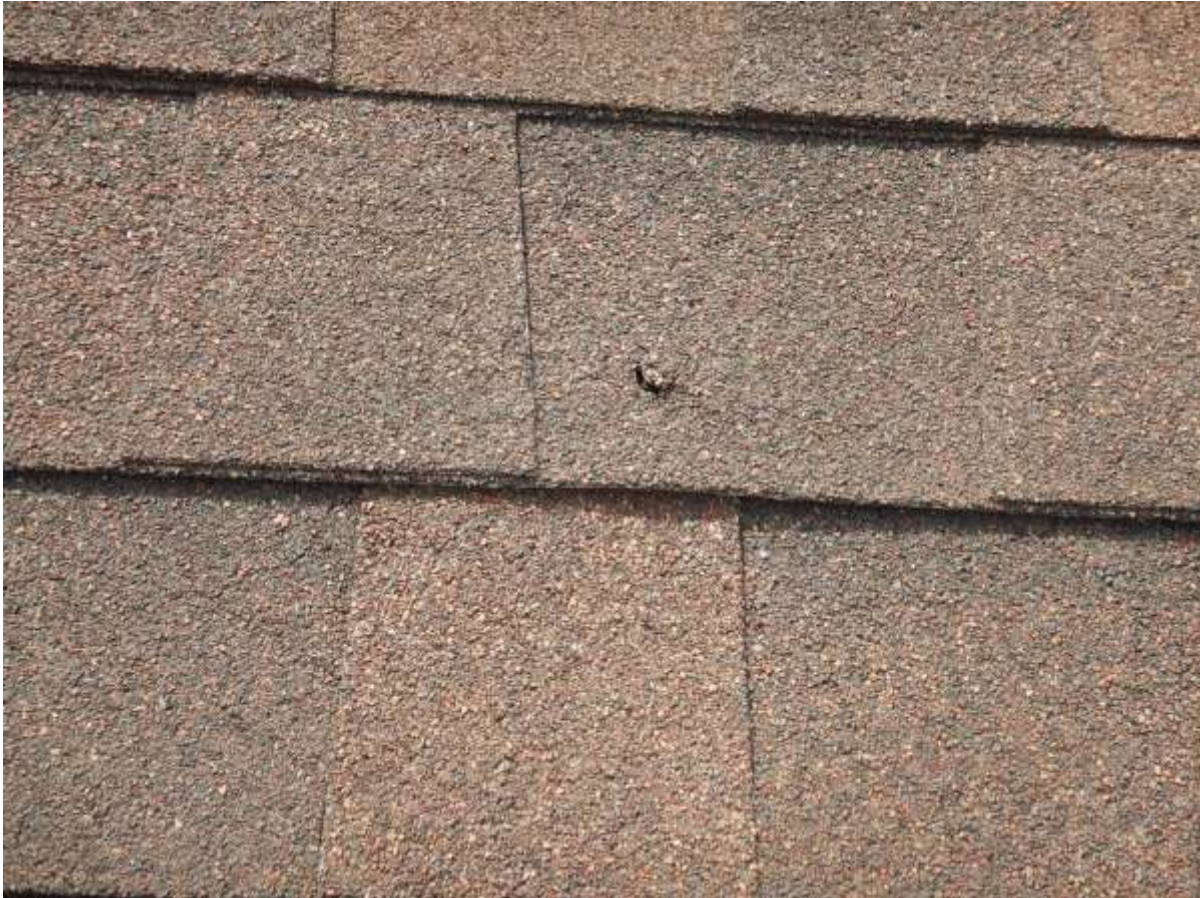
**PHOTO SEVENTY-ONE**

**CONDITION:** View of a nail pop which is a random condition.

**RECOMMENDED ACTION:** This condition will be corrected during roof replacement.

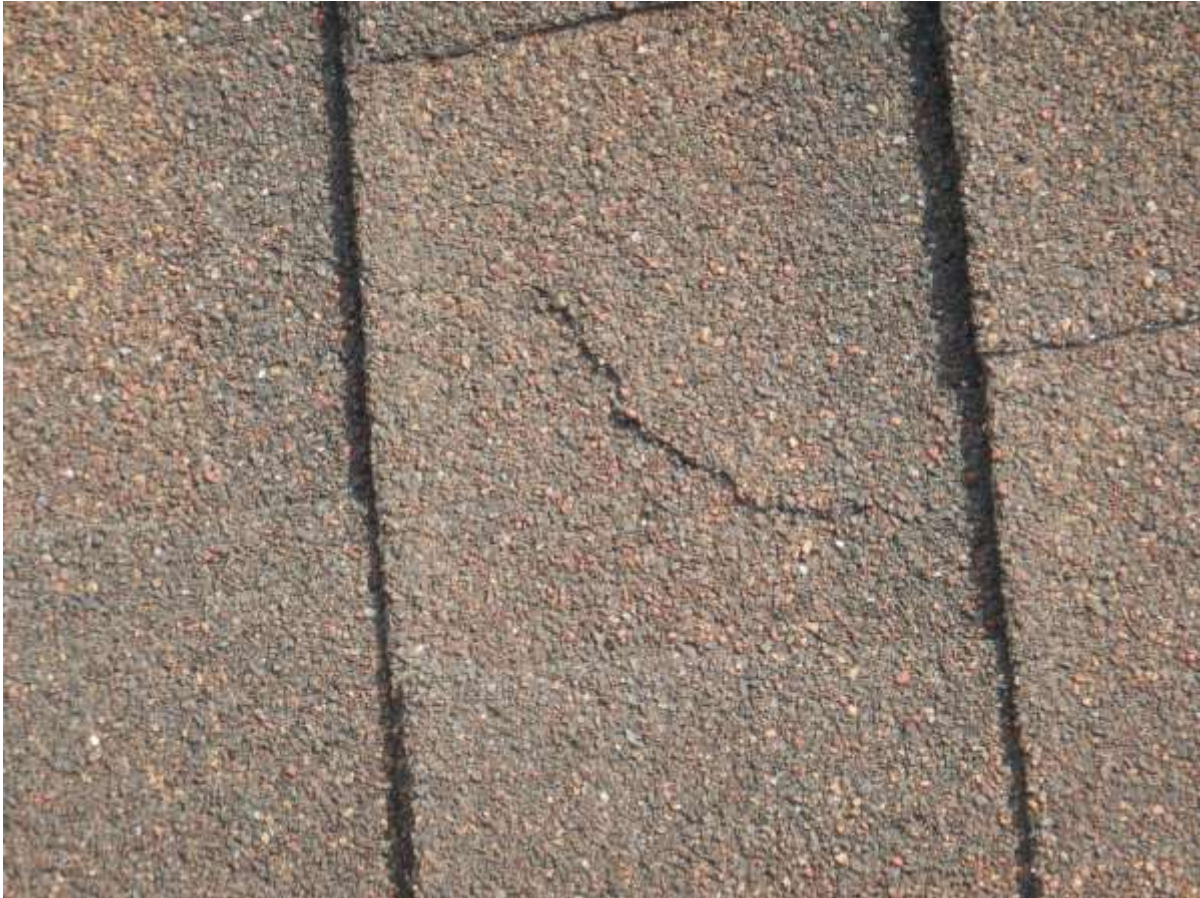
**PHOTO SEVENTY-TWO**

**CONDITION:**    The shingle is damaged at this location.

**RECOMMENDED ACTION:**    This condition will be corrected during roof replacement.

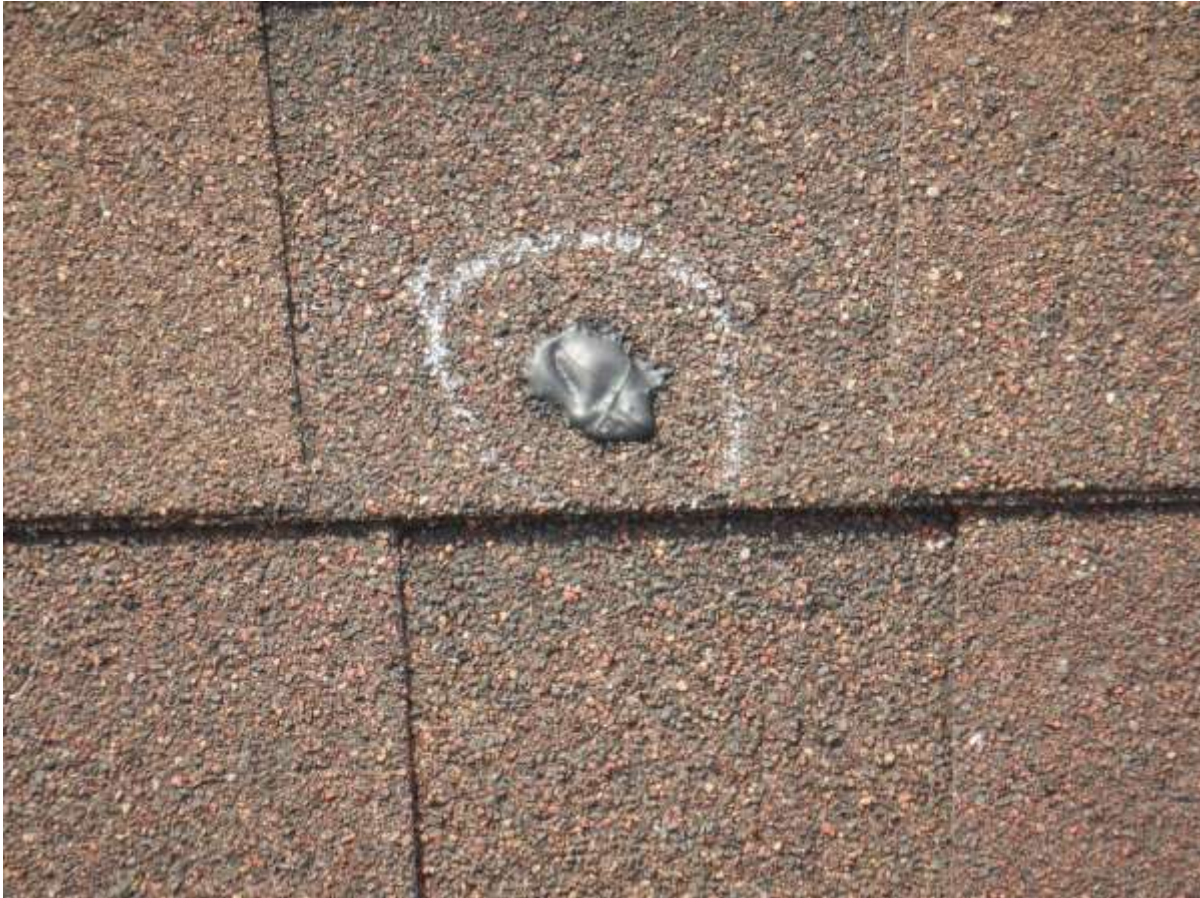
**PHOTO SEVENTY-THREE**

**CONDITION:** A view of caulk repairs in this area.

**RECOMMENDED ACTION:** This condition will be corrected during roof replacement.

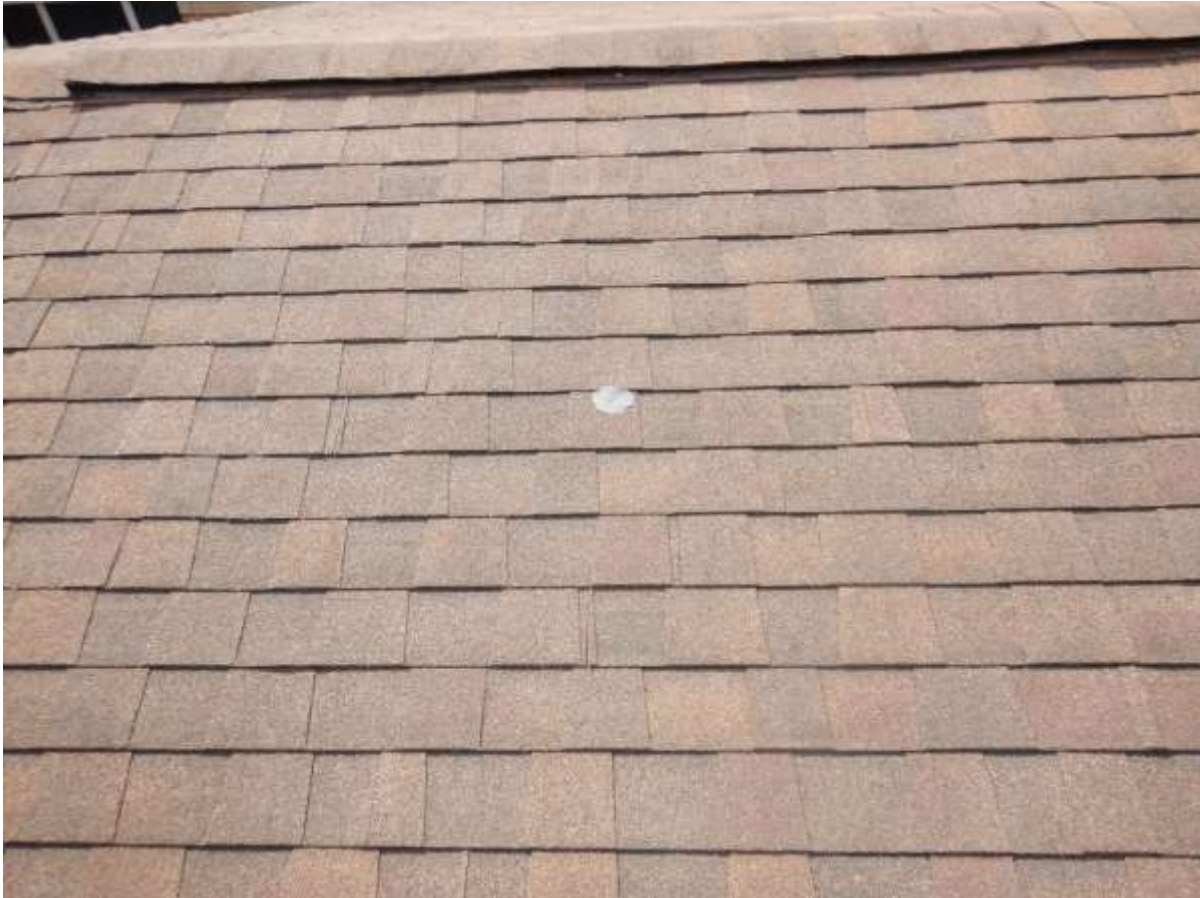
**PHOTO SEVENTY-FIVE**

**CONDITION:** A view of caulk repairs in this area.

**RECOMMENDED ACTION:** This condition will be corrected during roof replacement.

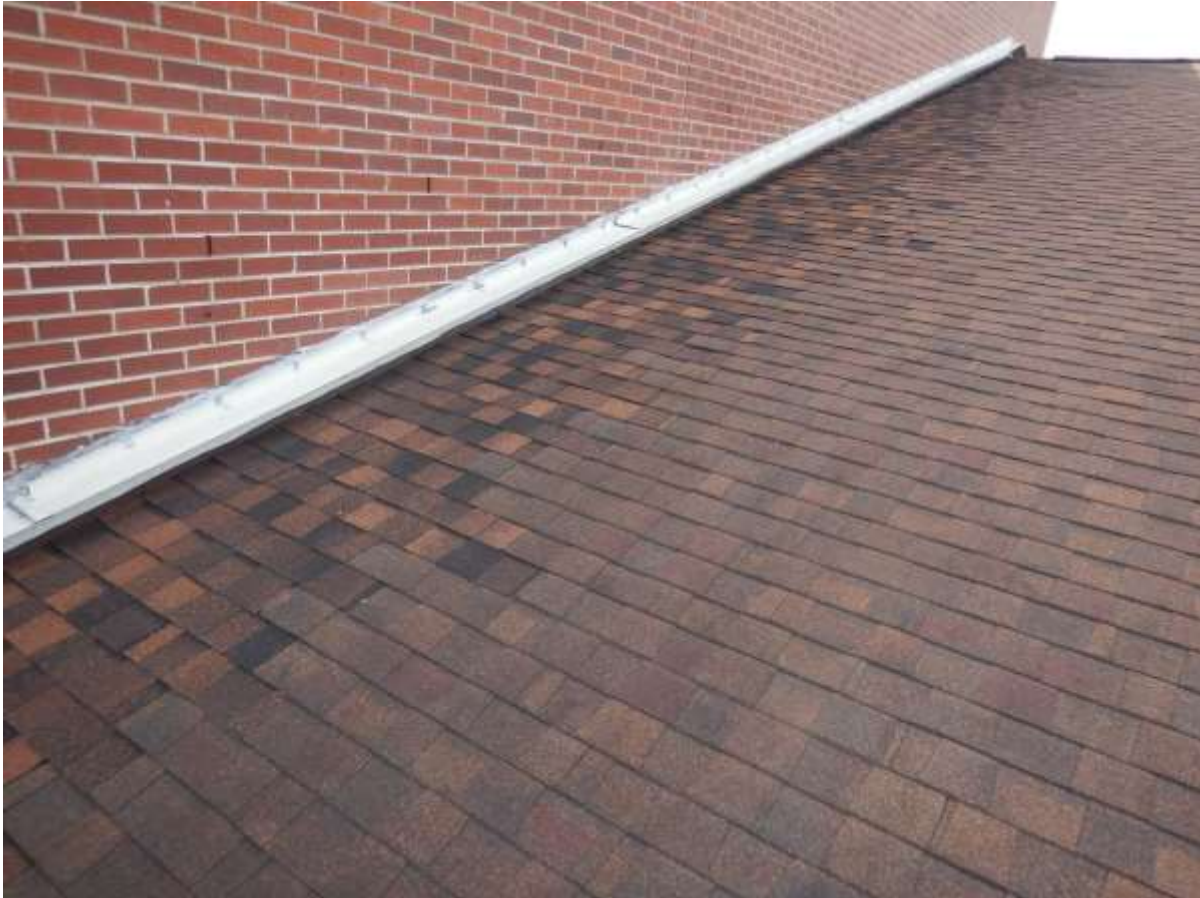
**PHOTO SEVENTY-SIX**

**CONDITION:** Previous repairs were noted in widespread locations.

**RECOMMENDED ACTION:** This condition will be corrected during roof replacement.

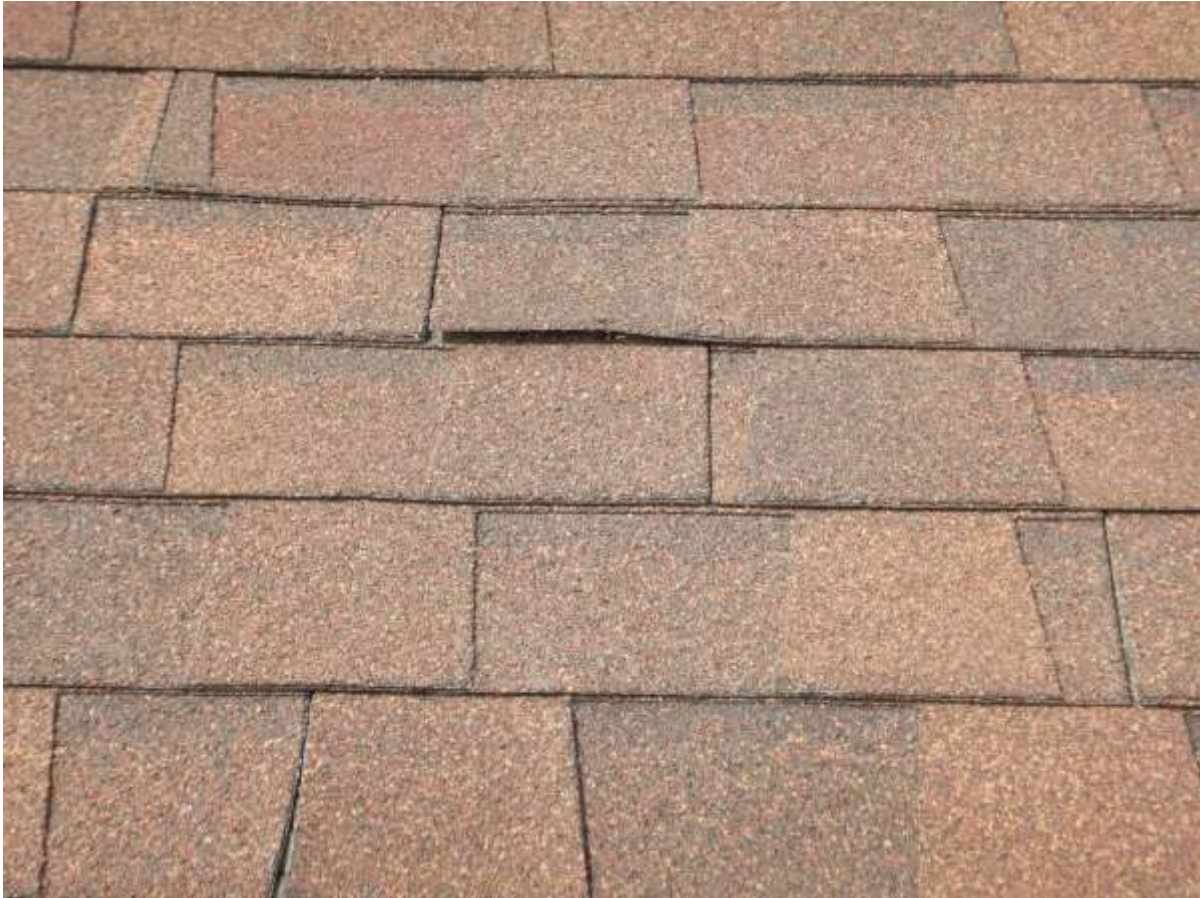
**PHOTO SEVENTY-SEVEN**

**CONDITION:** The shingle is raised from the nail pop at this location.

**RECOMMENDED ACTION:** This condition will be corrected during roof replacement.

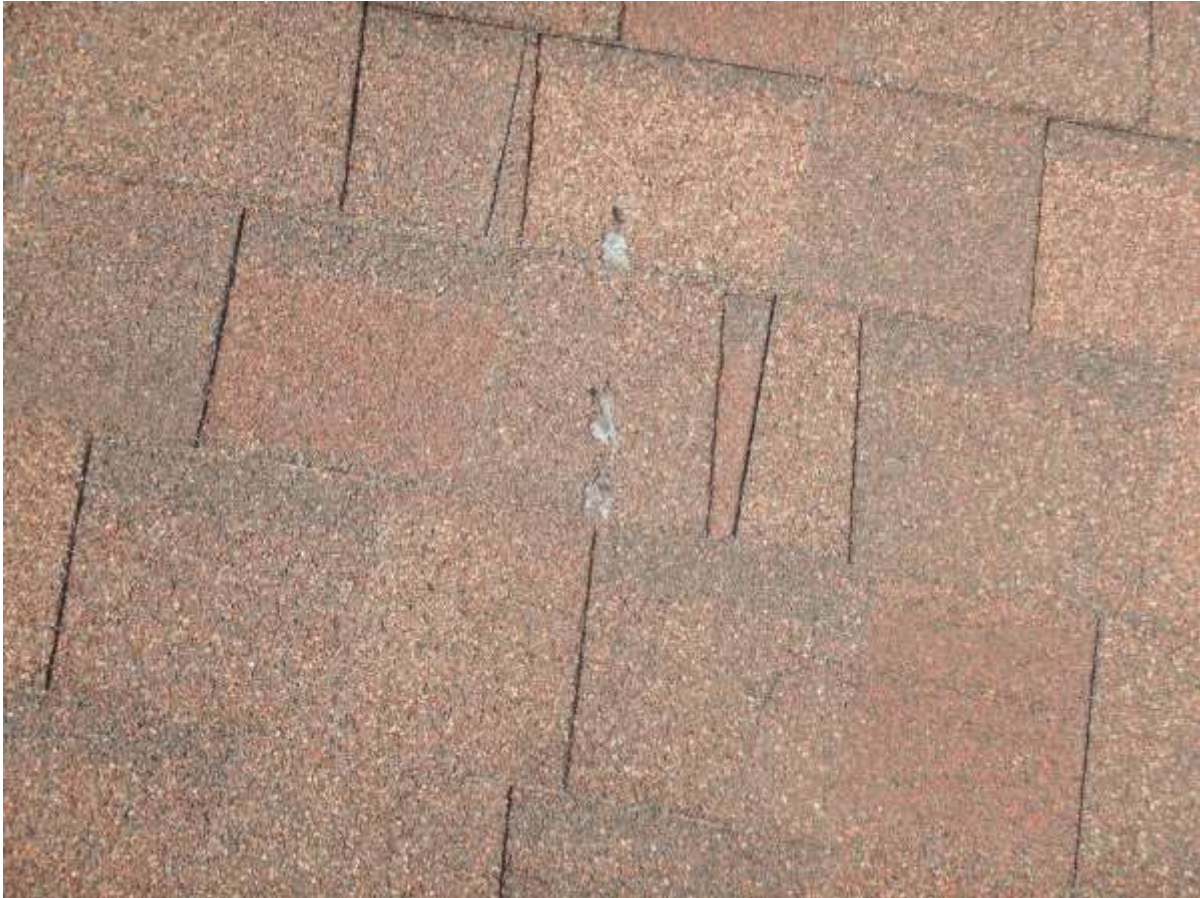
**PHOTO SEVENTY-EIGHT**

**CONDITION:** The shingle is damaged at this location.

**RECOMMENDED ACTION:** This condition will be corrected during roof replacement.

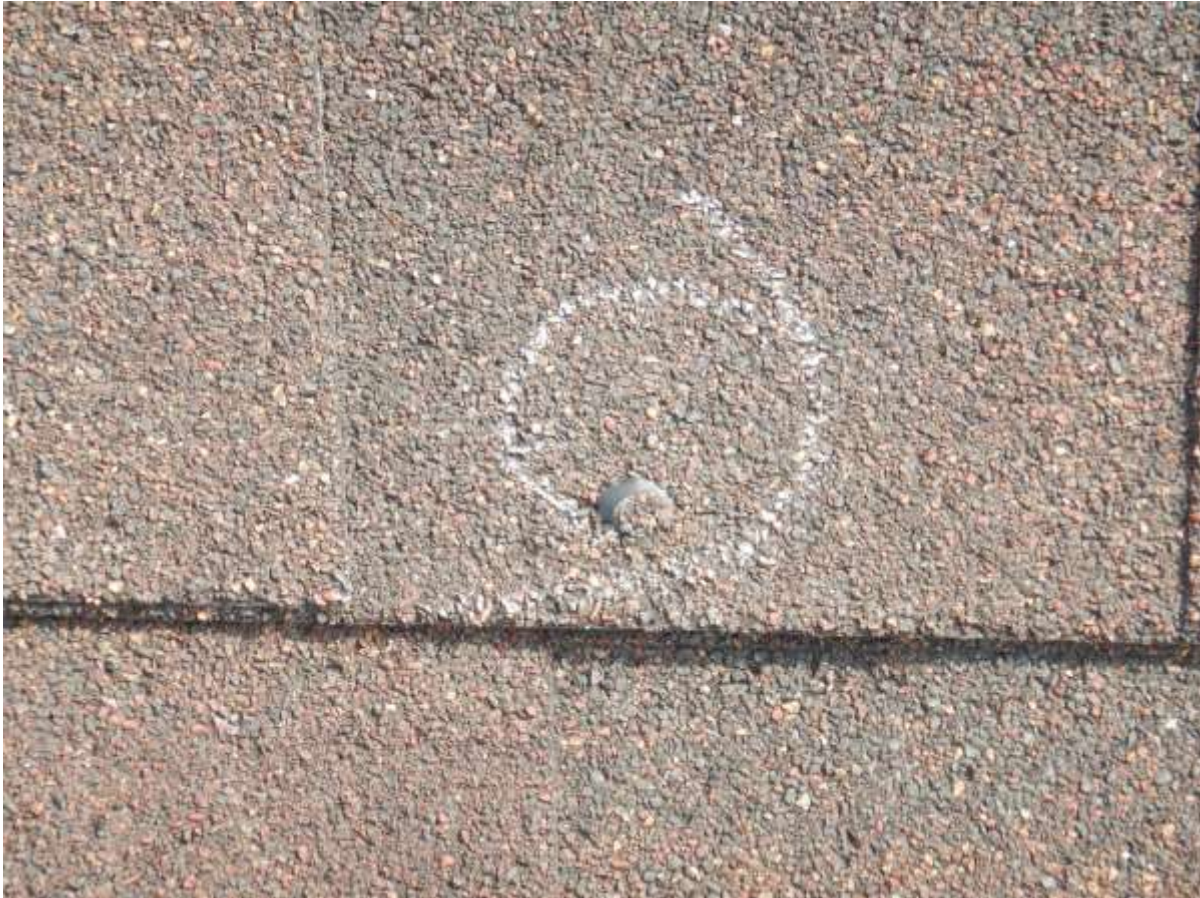
**PHOTO EIGHTY**

**CONDITION:** There is a void in the previous repair attempt at this location.

**RECOMMENDED ACTION:** This condition will be corrected during roof replacement.

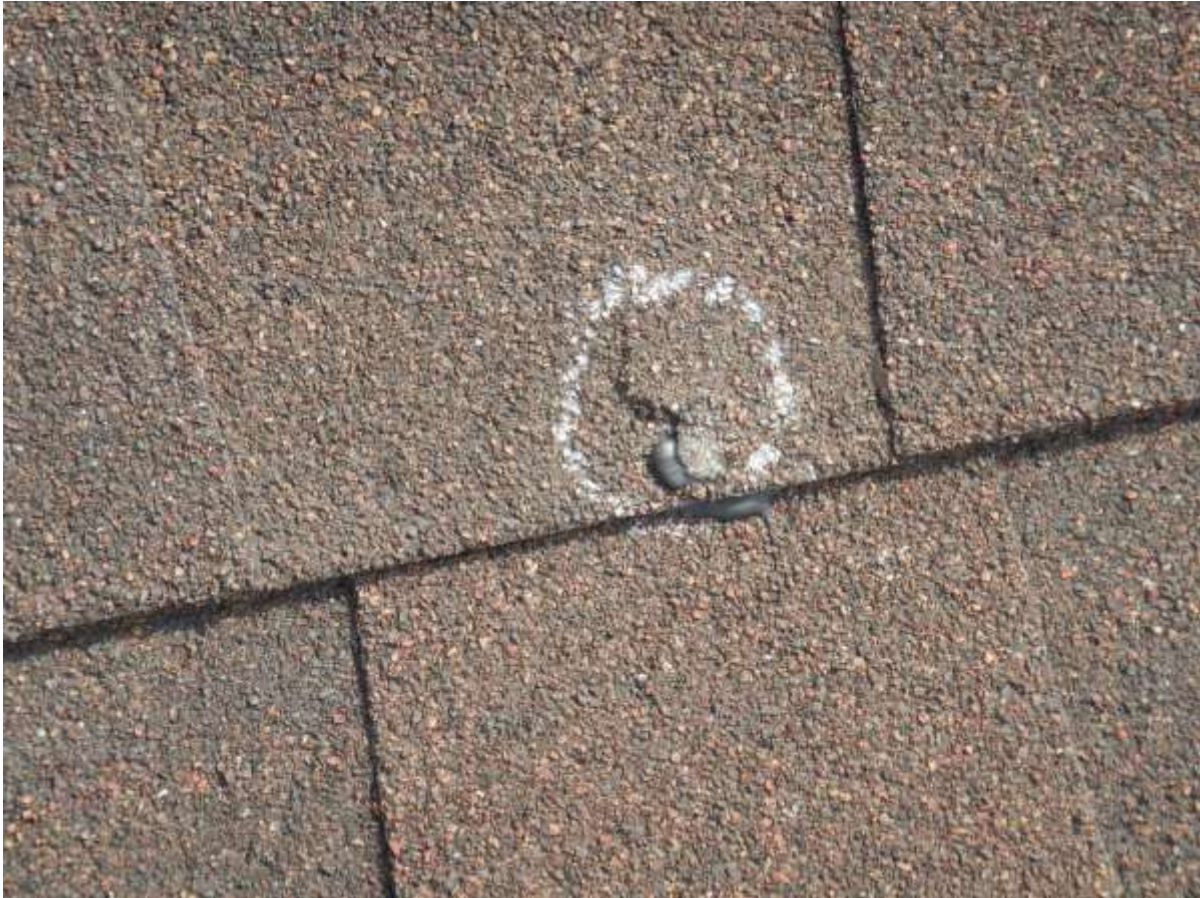
**PHOTO EIGHTY-ONE**

**CONDITION:** There is a void in the previous repair attempt at this location.

**RECOMMENDED ACTION:** This condition will be corrected during roof replacement.
