ROOF EVALUATION REPORT

***FRANKLIN TOWNSHIP COMM. SCHOOL CORPORATION
THOMPSON CROSSING ELEMENTARY SCHOOL
7525 EAST THOMPSON ROAD
INDIANAPOLIS, INDIANA***

MARCH 17, 2021

**R.M.I. # 021-193
MARCH 17, 2021**

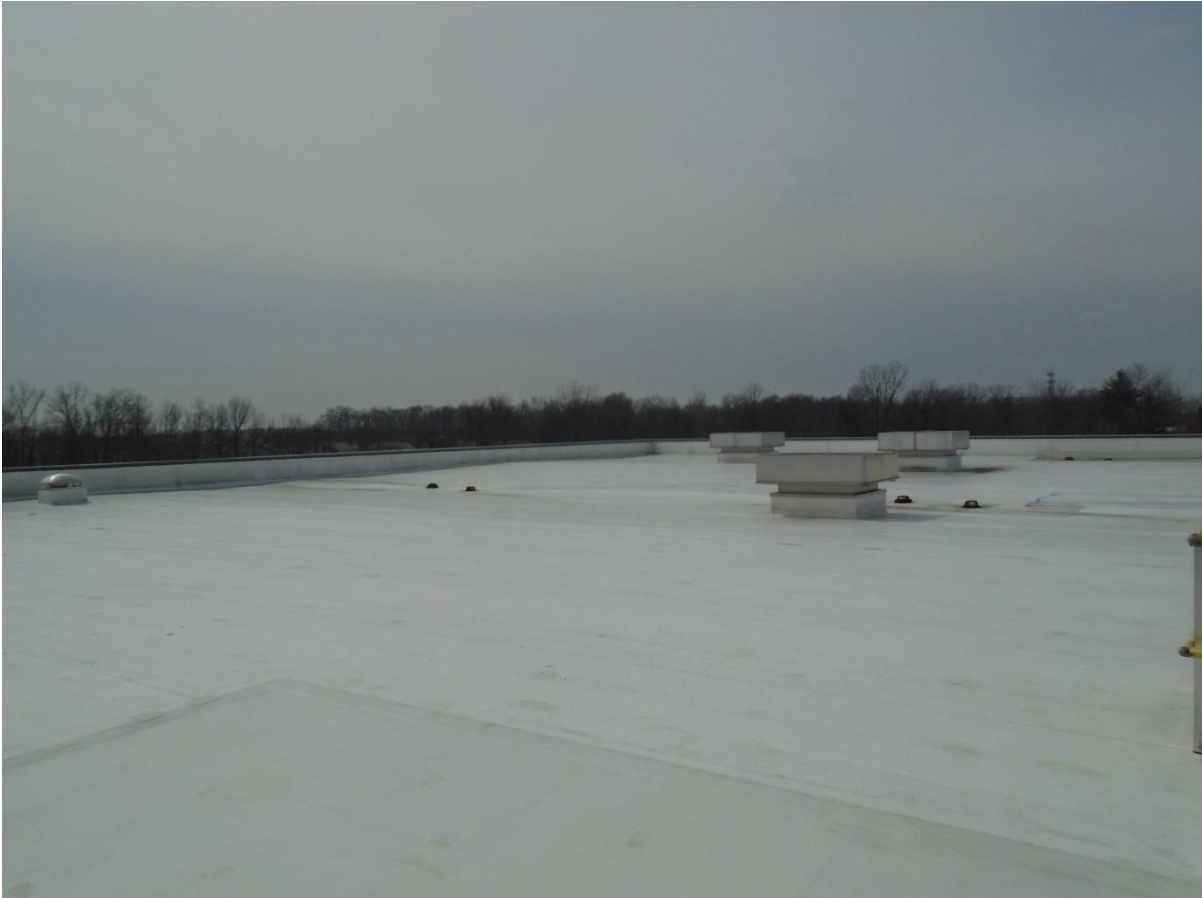
PHOTO ONE

CONDITION: **An overview of the Mechanically Attached Thermoplastic Roof System on Section A.**

RECOMMENDED ACTION: **For your information.**

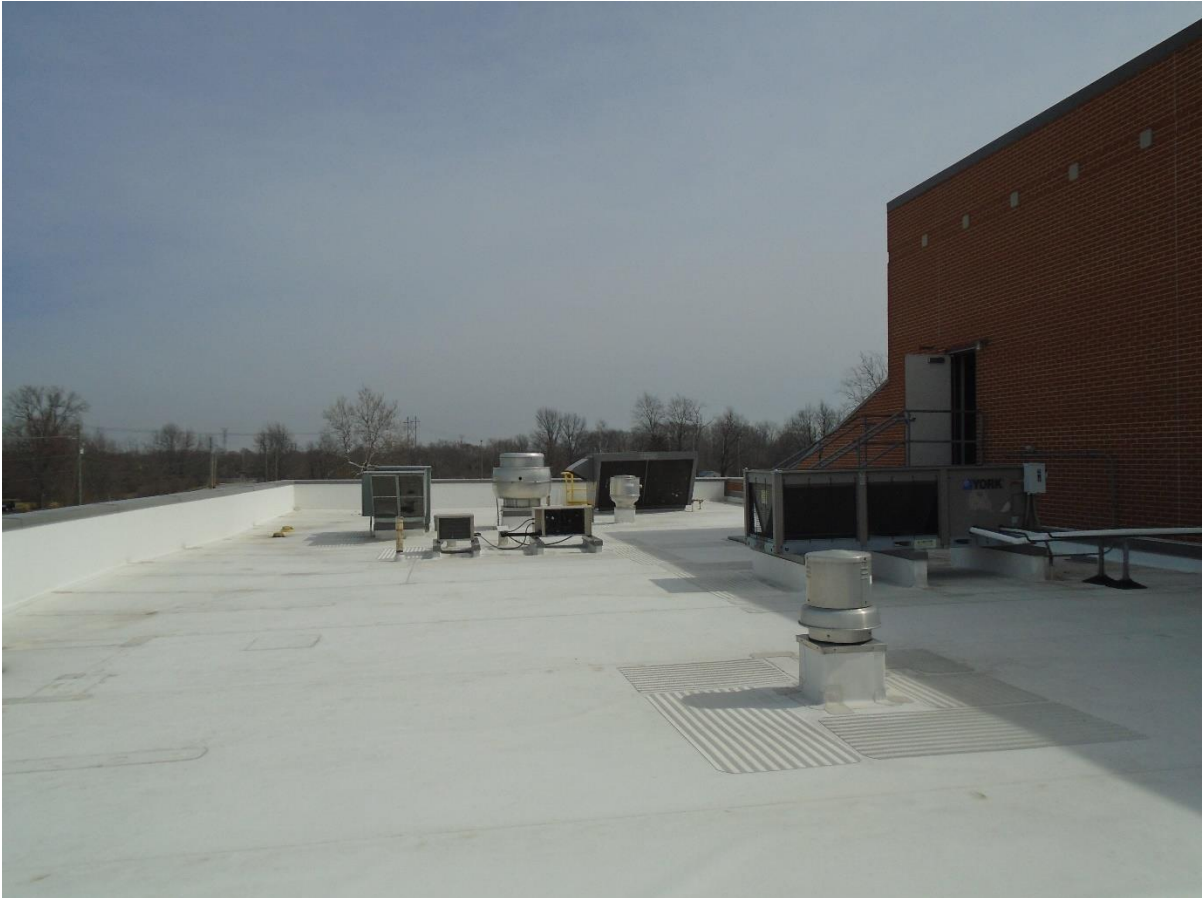
PHOTO FOURTEEN

CONDITION: **An overview of the Mechanically Attached Thermoplastic Roof System on Section B.**

RECOMMENDED ACTION: **For your information.**

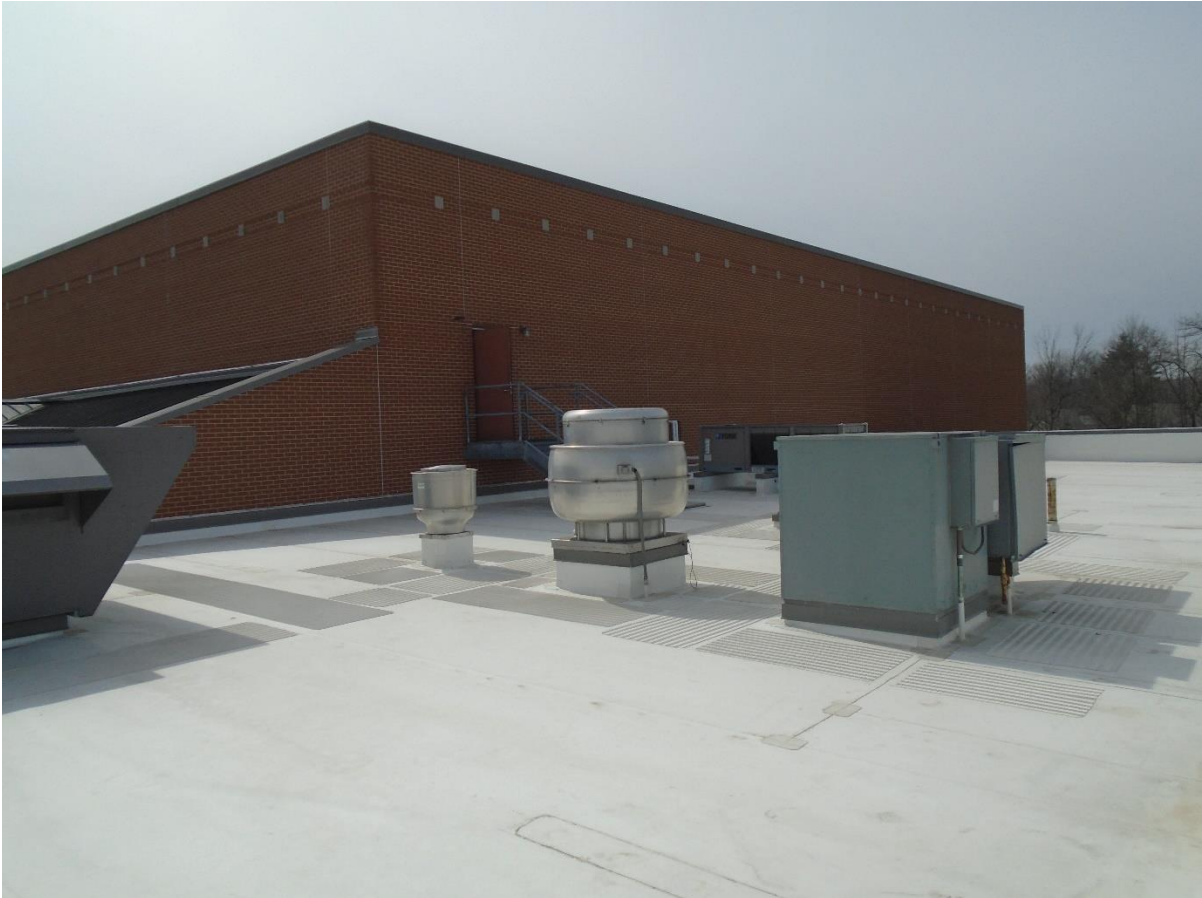
PHOTO FIFTEEN

CONDITION: An overview of the Mechanically Attached Thermoplastic Roof System on Section B.

RECOMMENDED ACTION: For your information.

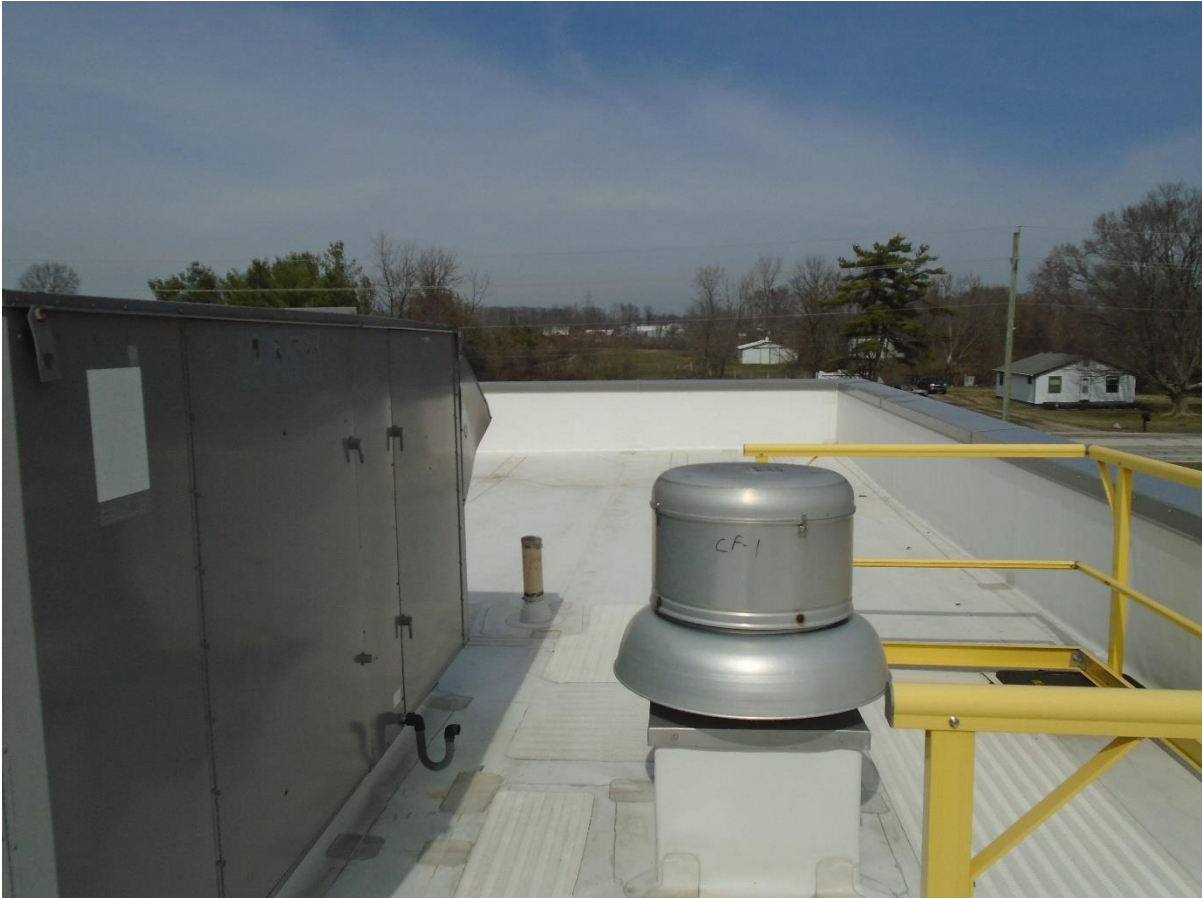
PHOTO SIXTEEN

CONDITION: An overview of the Mechanically Attached Thermoplastic Roof System on Section B.

RECOMMENDED ACTION: For your information.

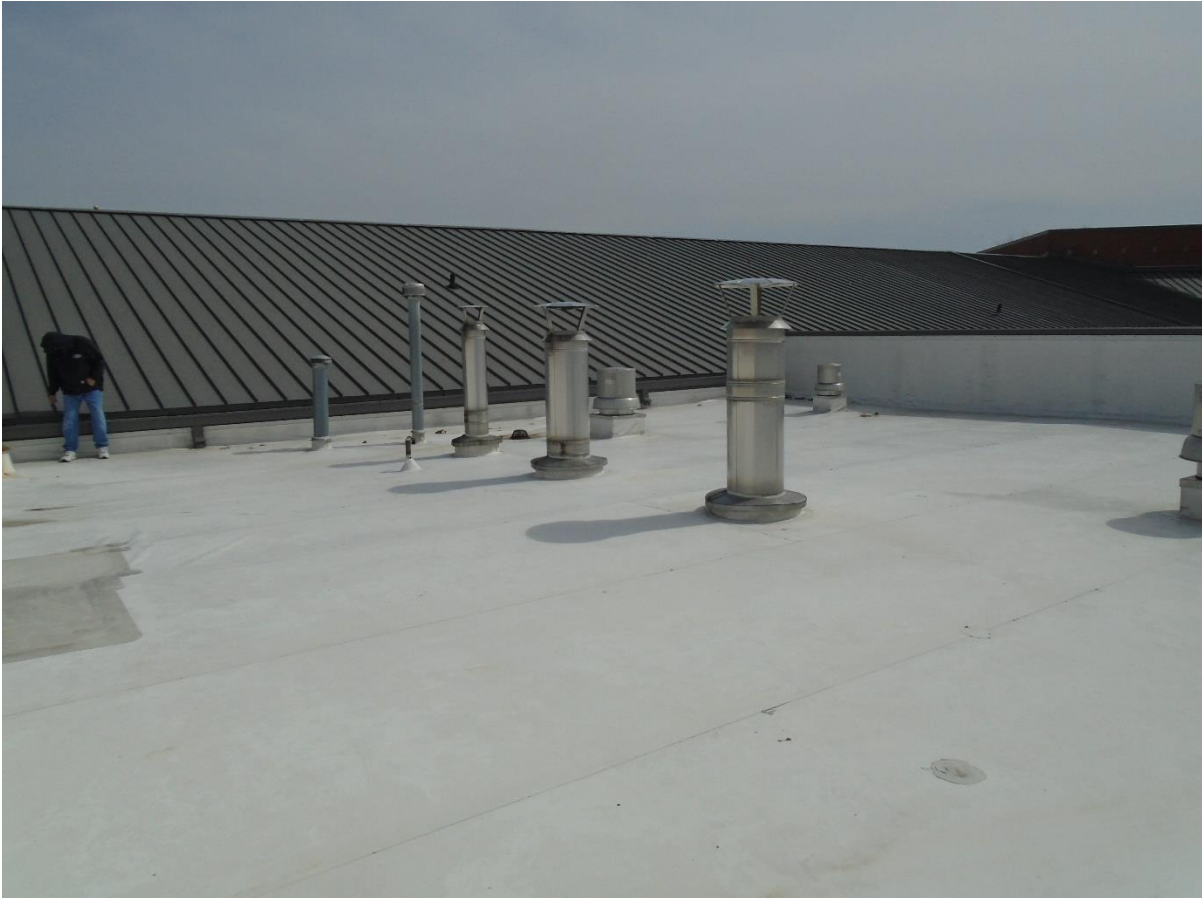
PHOTO SEVENTEEN

CONDITION: An overview of the Mechanically Attached Thermoplastic Roof System on Section C.

RECOMMENDED ACTION: For your information.

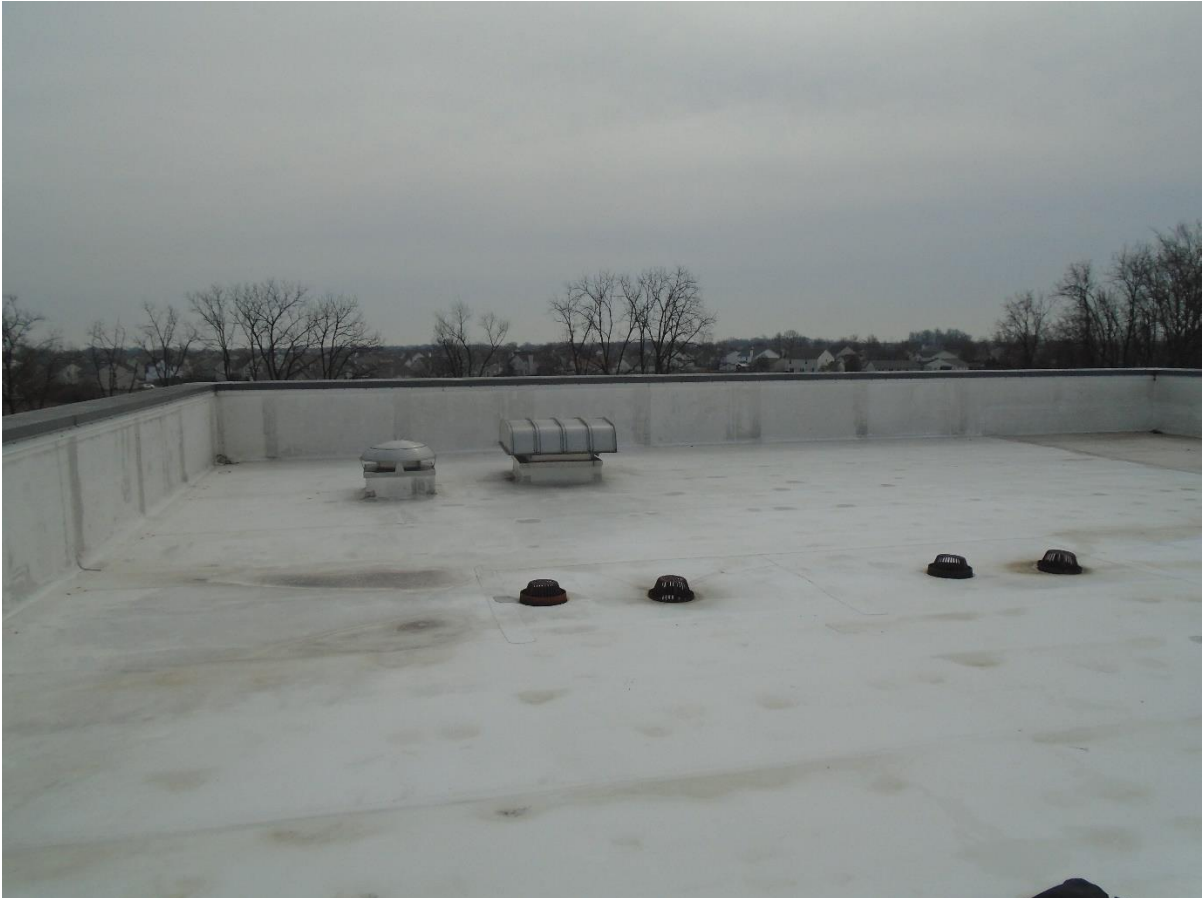
PHOTO TWENTY

CONDITION: **An overview of the Mechanically Attached Thermoplastic Roof System on Section D.**

RECOMMENDED ACTION: **For your information.**

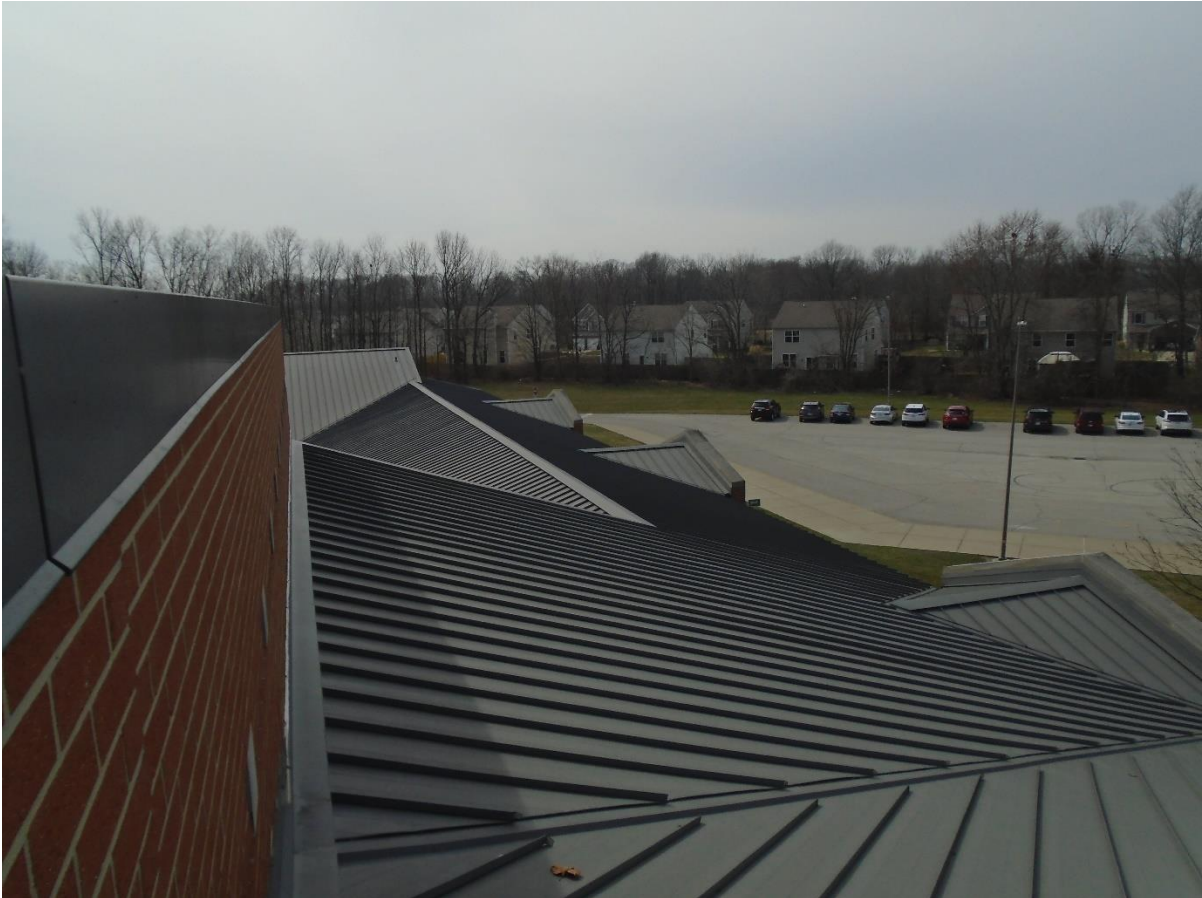
PHOTO TWENTY-THREE

CONDITION: An overview of the Metal Roof System on Section E.

RECOMMENDED ACTION: For your information.

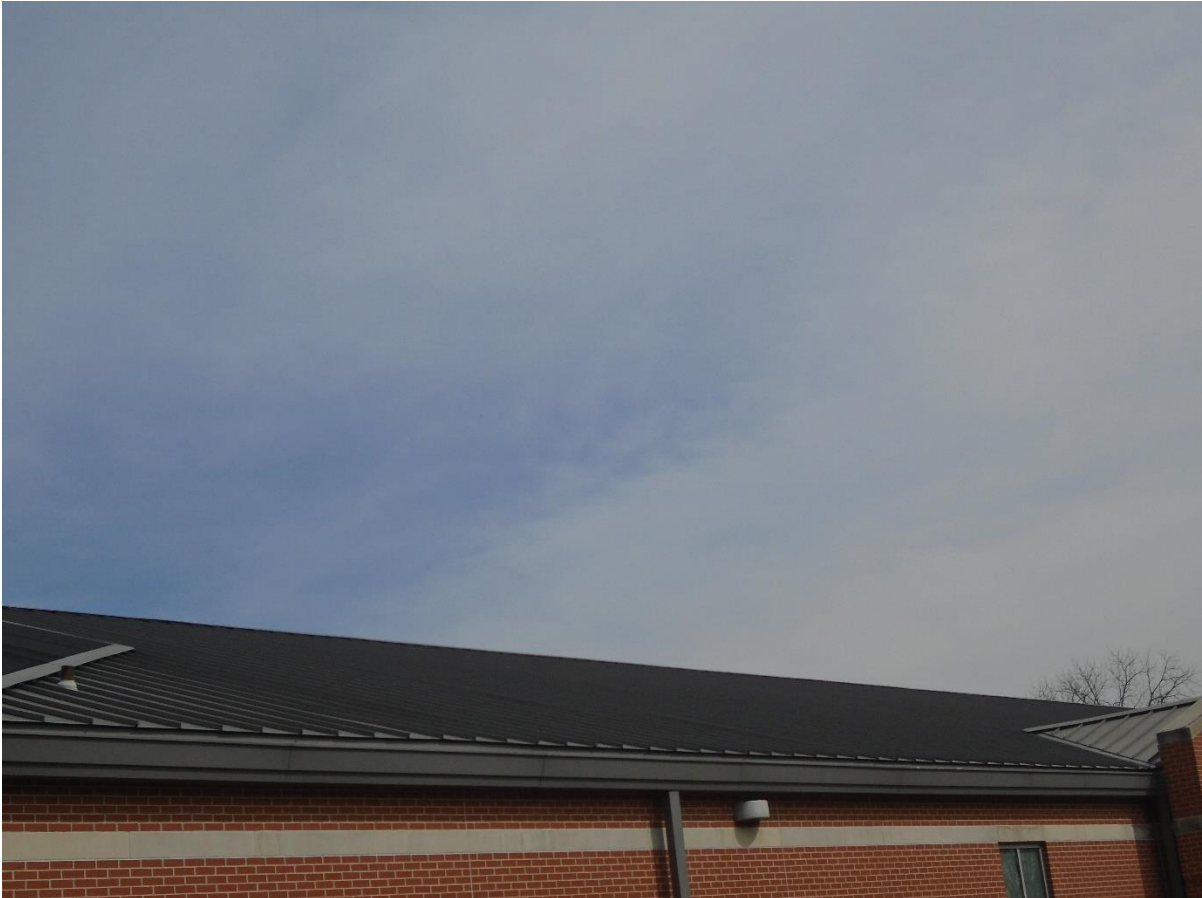
PHOTO TWENTY-FOUR

CONDITION: An overview of the Metal Roof System on Section F.

RECOMMENDED ACTION: For your information.

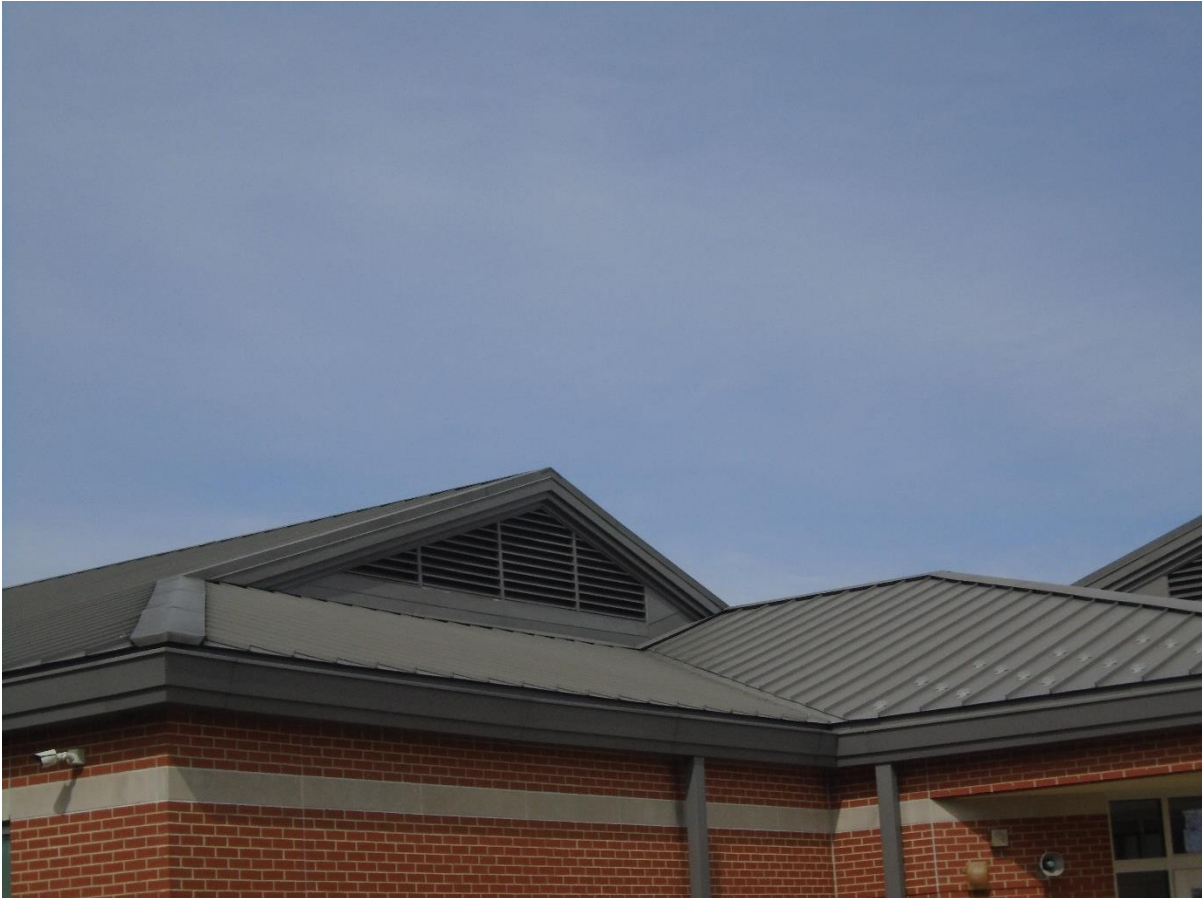
PHOTO TWENTY-FIVE

CONDITION: An overview of the Metal Roof System on Section F.

RECOMMENDED ACTION: For your information.

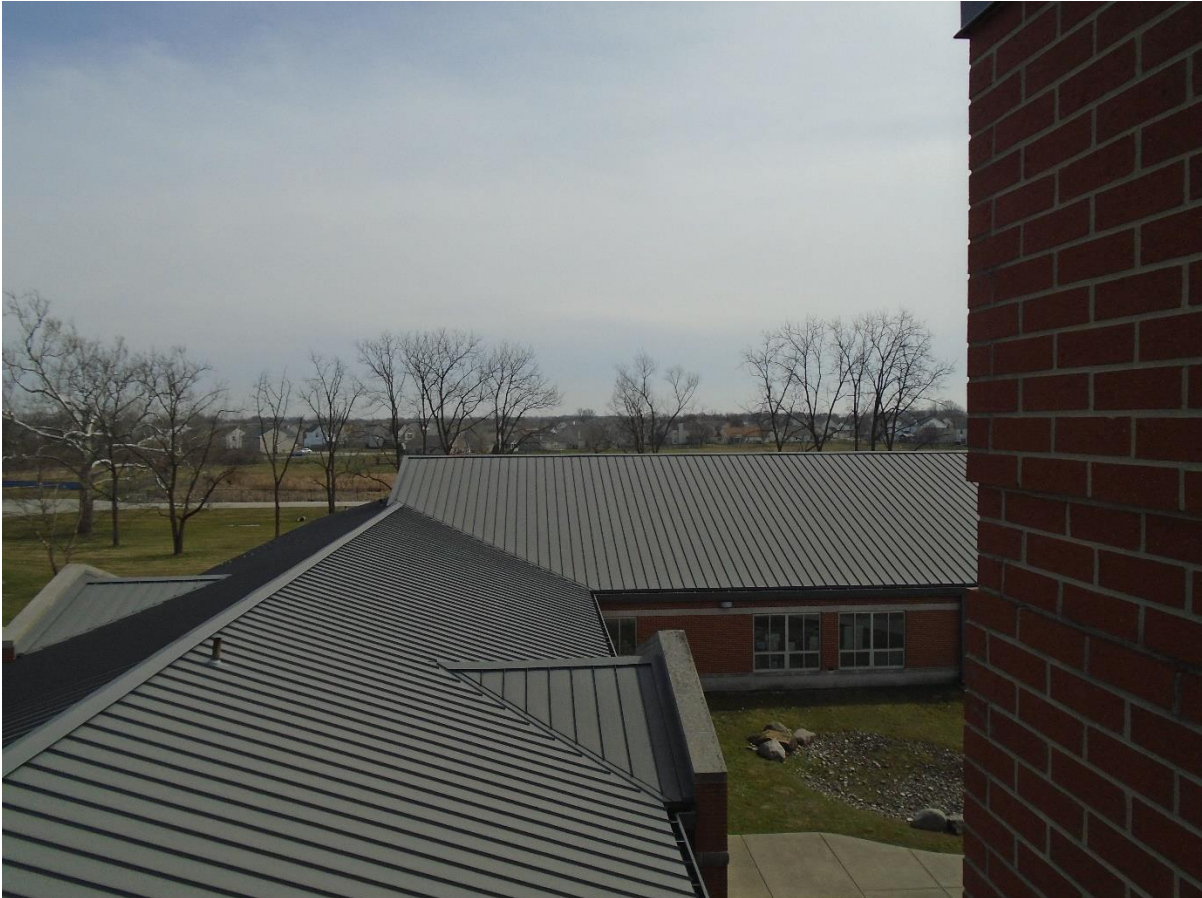
PHOTO TWENTY-SIX

CONDITION: An overview of the Metal Roof System on Section G and H.

RECOMMENDED ACTION: For your information.

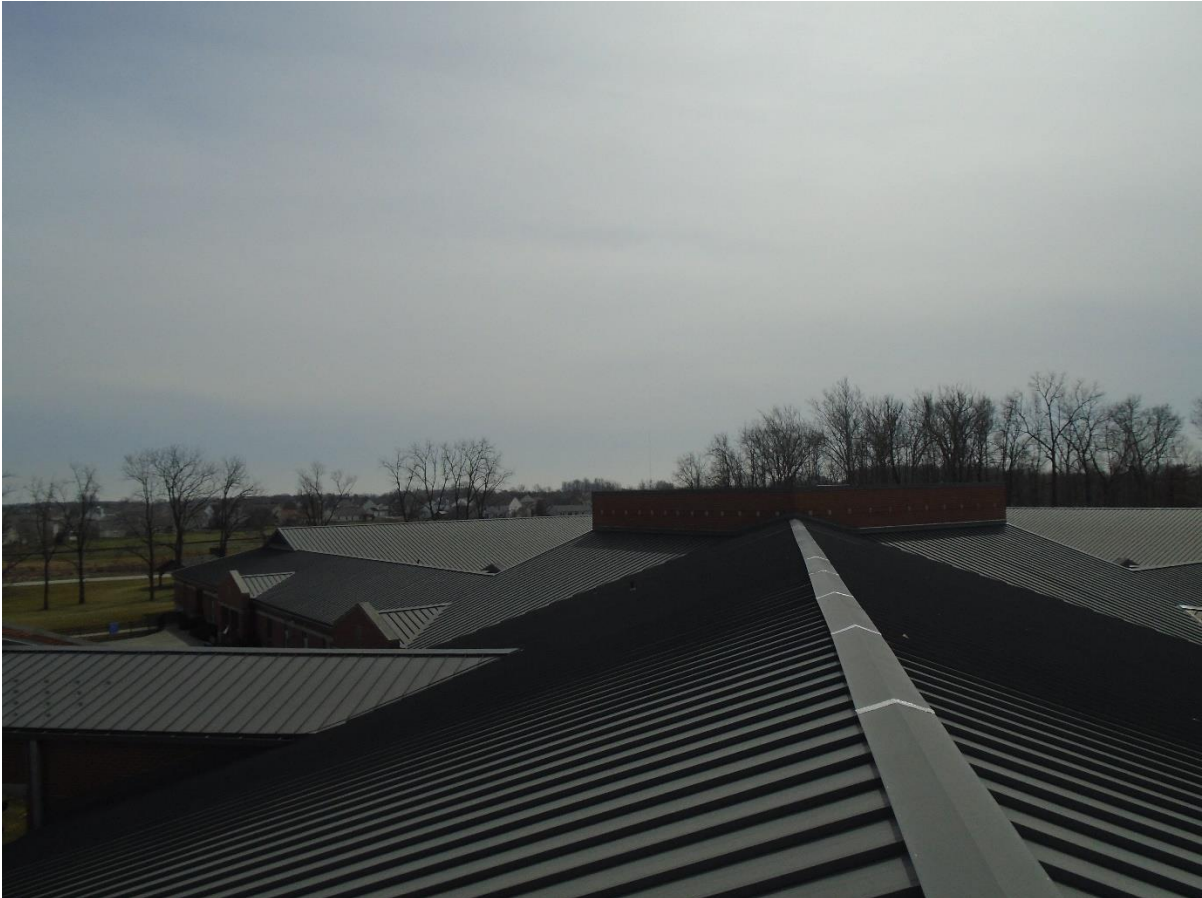
PHOTO TWENTY-SEVEN

CONDITION: An overview of the Metal Roof System on Section J.

RECOMMENDED ACTION: For your information.

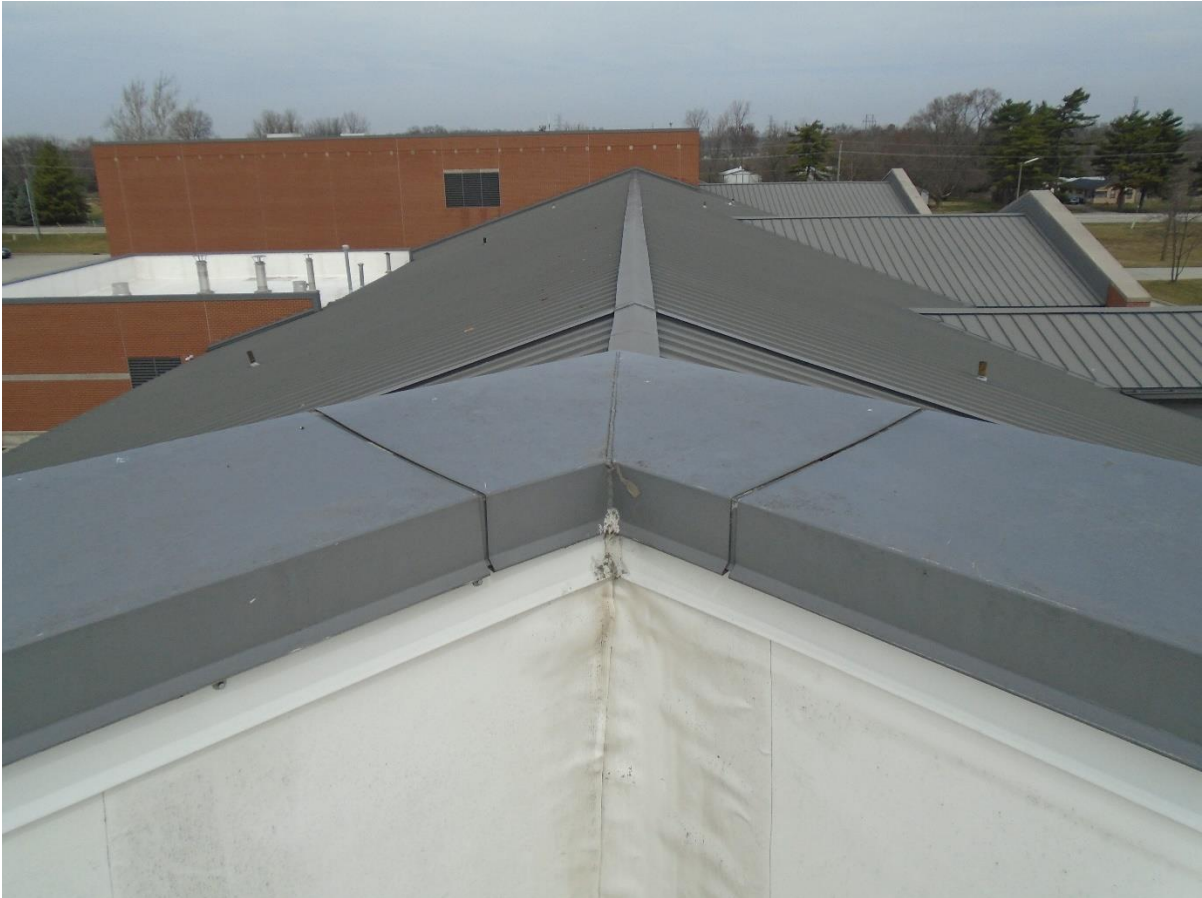
PHOTO TWENTY-EIGHT

CONDITION: **An overview of the Metal Roof System on Section J.**

RECOMMENDED ACTION: **For your information.**
