## ***ROOF EVALUATION REPORT***

***FRANKLIN TOWNSHIP COMMUNITY SCHOOL CORPORATION  
SOUTH CREEK ELEMENTARY SCHOOL  
9010 EAST SOUTHPORT ROAD  
INDIANAPOLIS, INDIANA***

***REVISED APRIL 12, 2021***

**R.M.I. # 021-192  
*REVISED* APRIL 12, 2021**

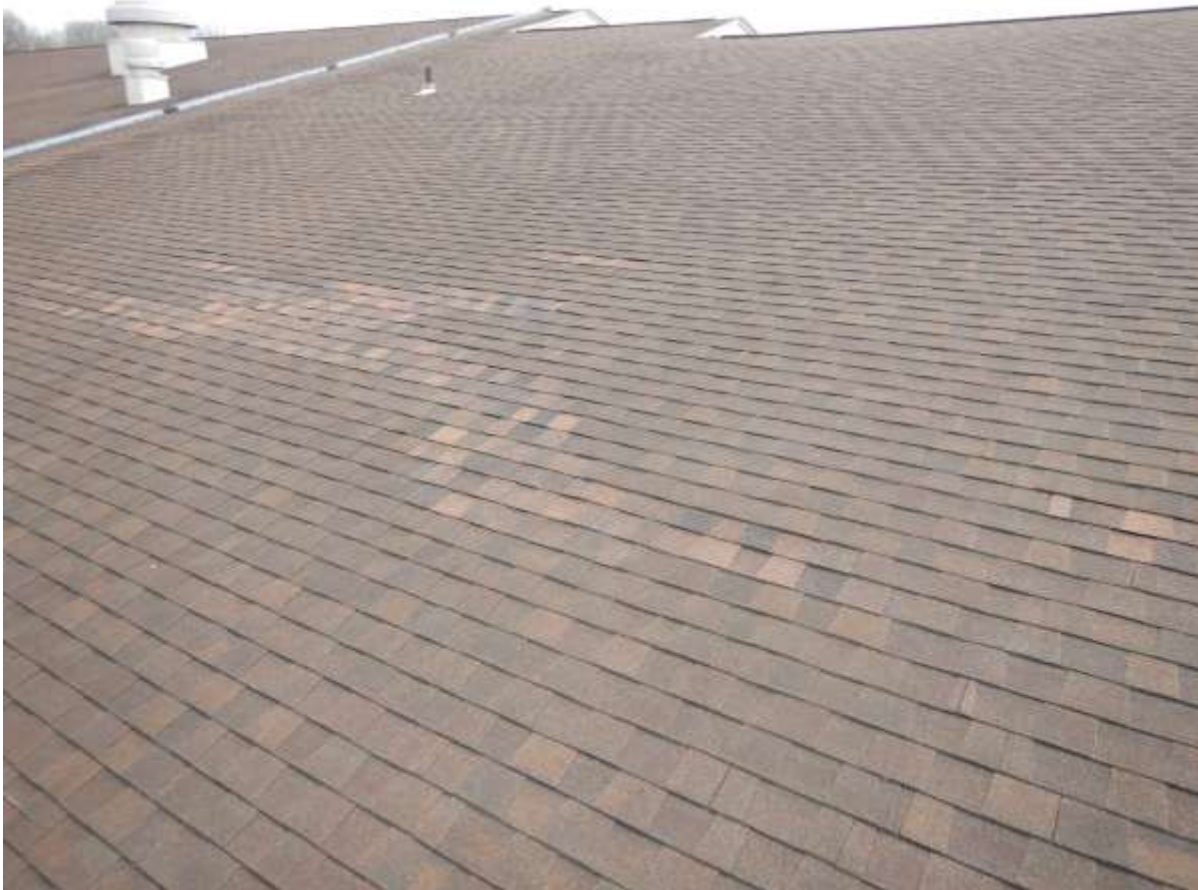
**PHOTO THIRTY-ONE**

**CONDITION:** An overview of the existing Dimensional Shingle Roof System on Section F1.

**RECOMMENDED ACTION:** For your information.

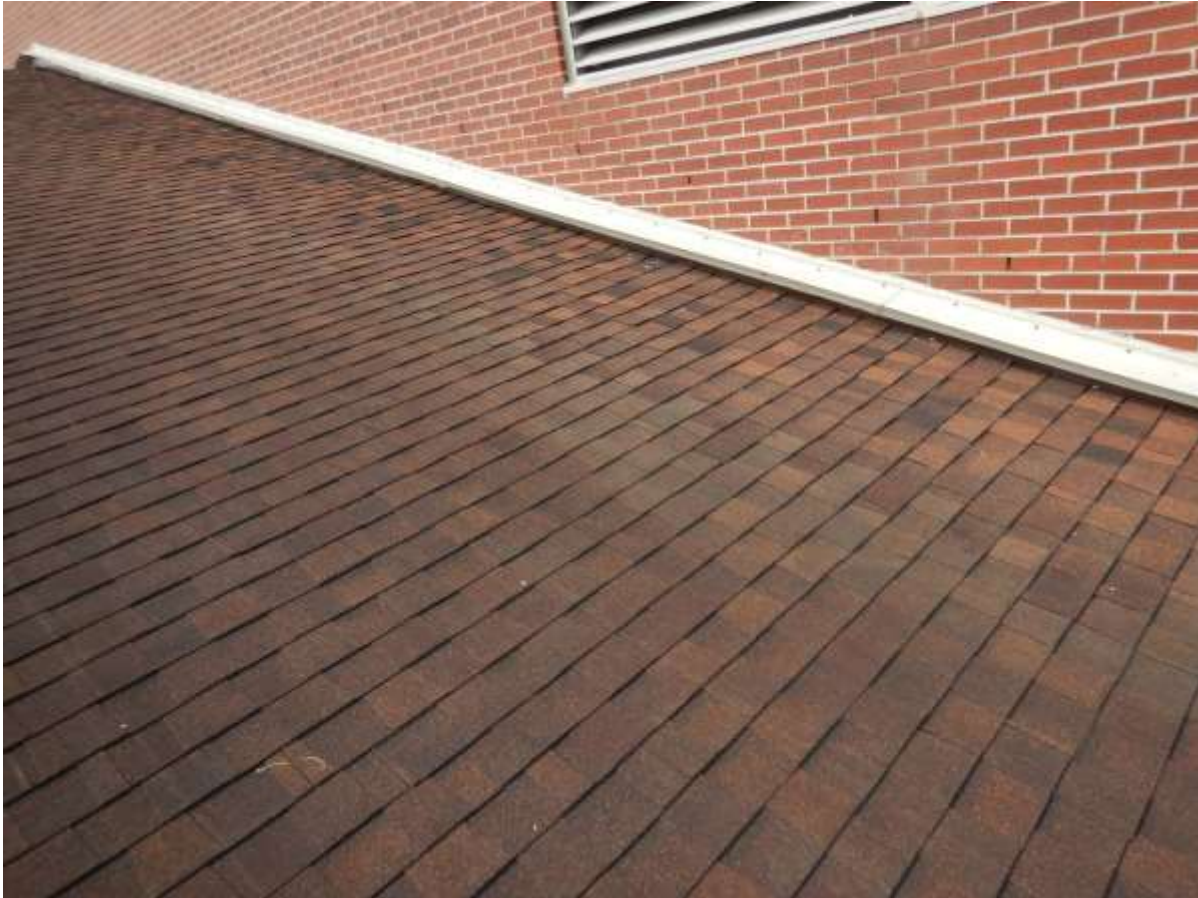
**PHOTO FORTY-FOUR**

**CONDITION:** Previous repairs were noted in random locations.

**RECOMMENDED ACTION:** This condition will be corrected during roof replacement.

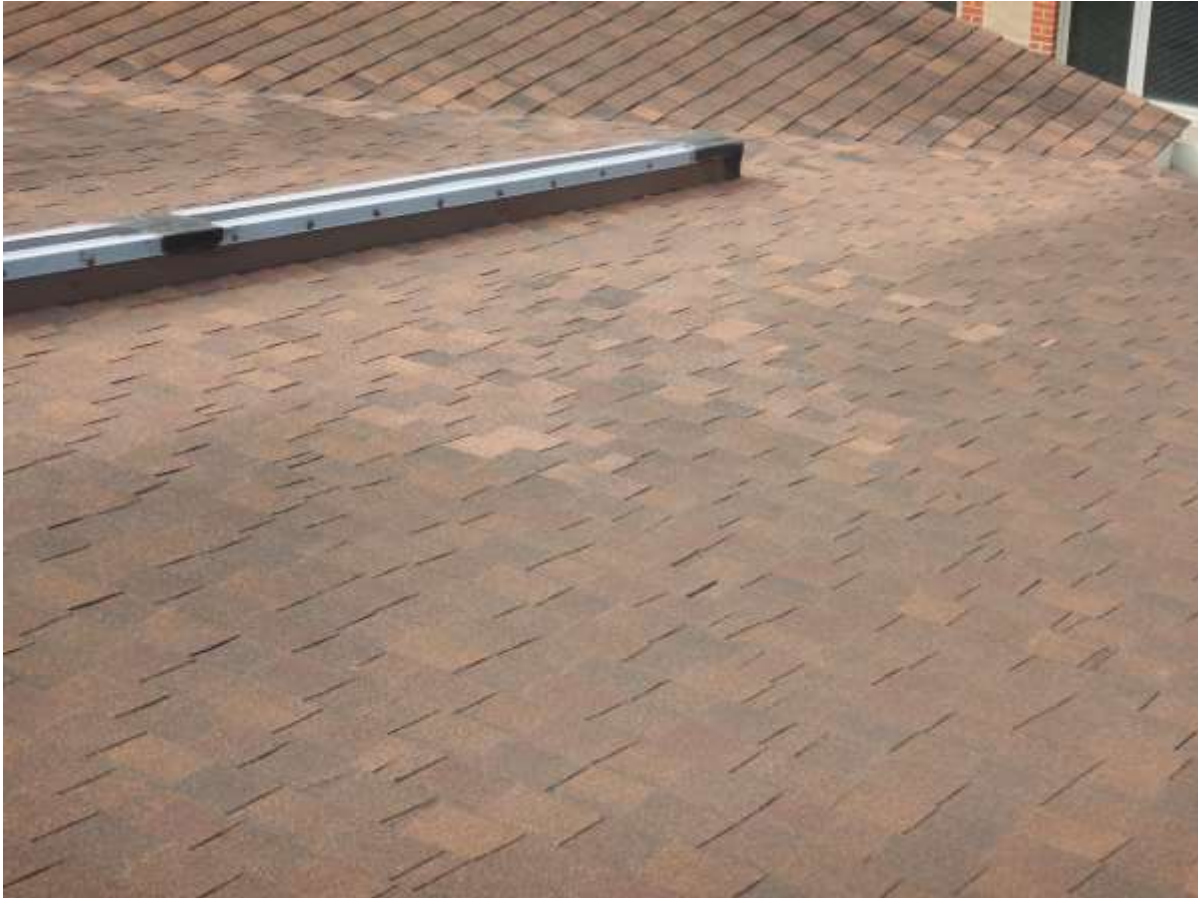
**PHOTO FORTY-SEVEN**

**CONDITION:** Previous repairs were noted in random locations.

**RECOMMENDED ACTION:** This condition will be corrected during roof replacement.

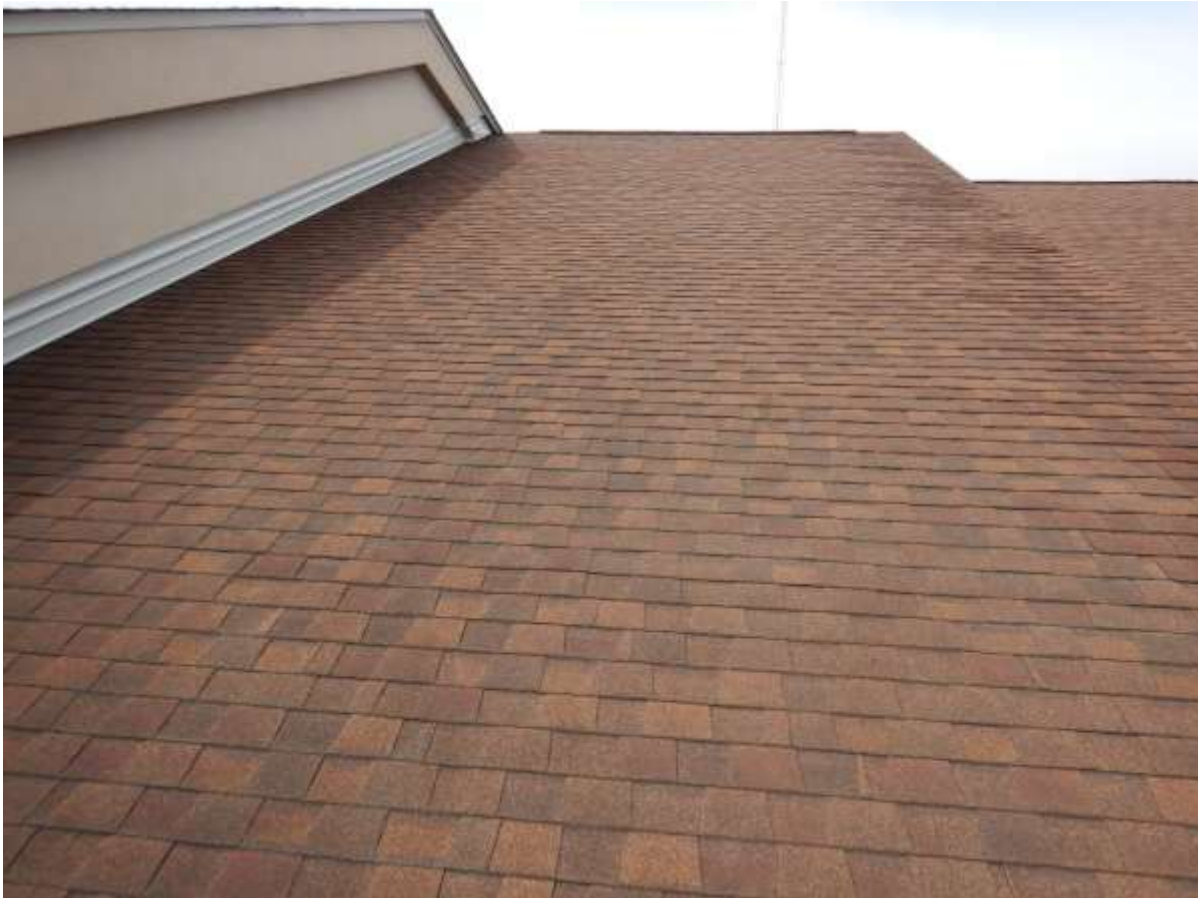
**PHOTO FORTY-NINE**

**CONDITION:** An overview of the existing Dimensional Shingle Roof System on Section H1.

**RECOMMENDED ACTION:** For your information.

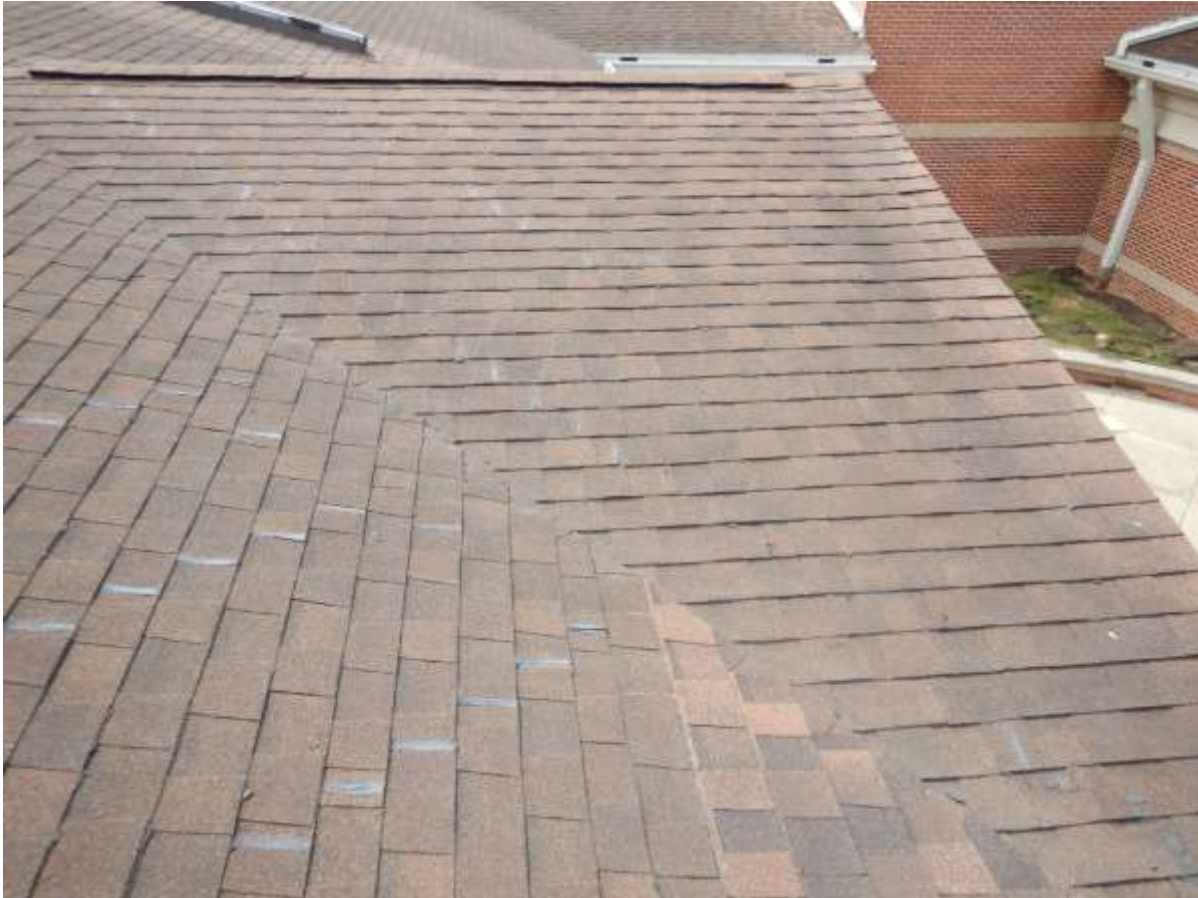
**PHOTO FIFTY-FIVE**

**CONDITION:** Previous repairs were noted in widespread locations.

**RECOMMENDED ACTION:** This condition will be corrected during roof replacement.

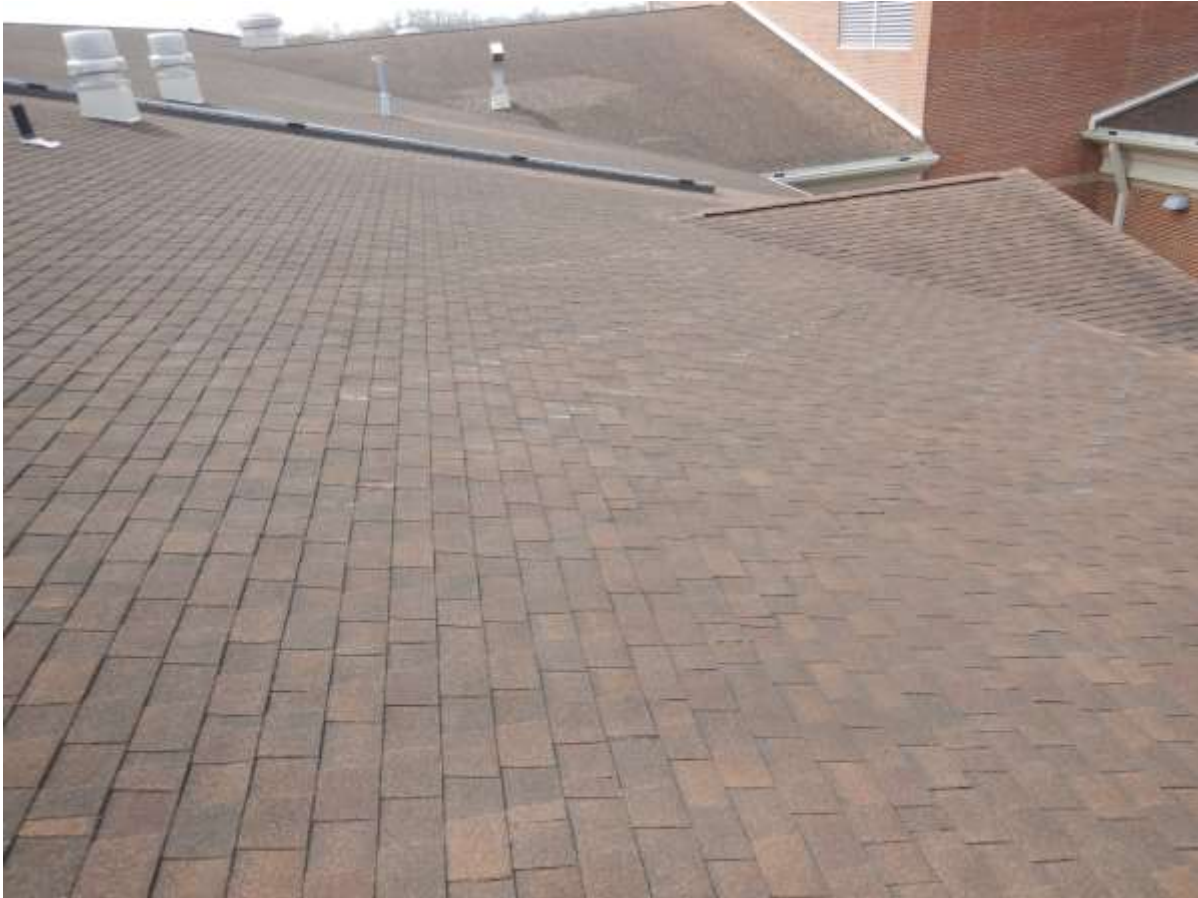
**PHOTO FIFTY-SIX**

**CONDITION:** A view of widespread caulk repairs in this area.

**RECOMMENDED ACTION:** This condition will be corrected during roof replacement.

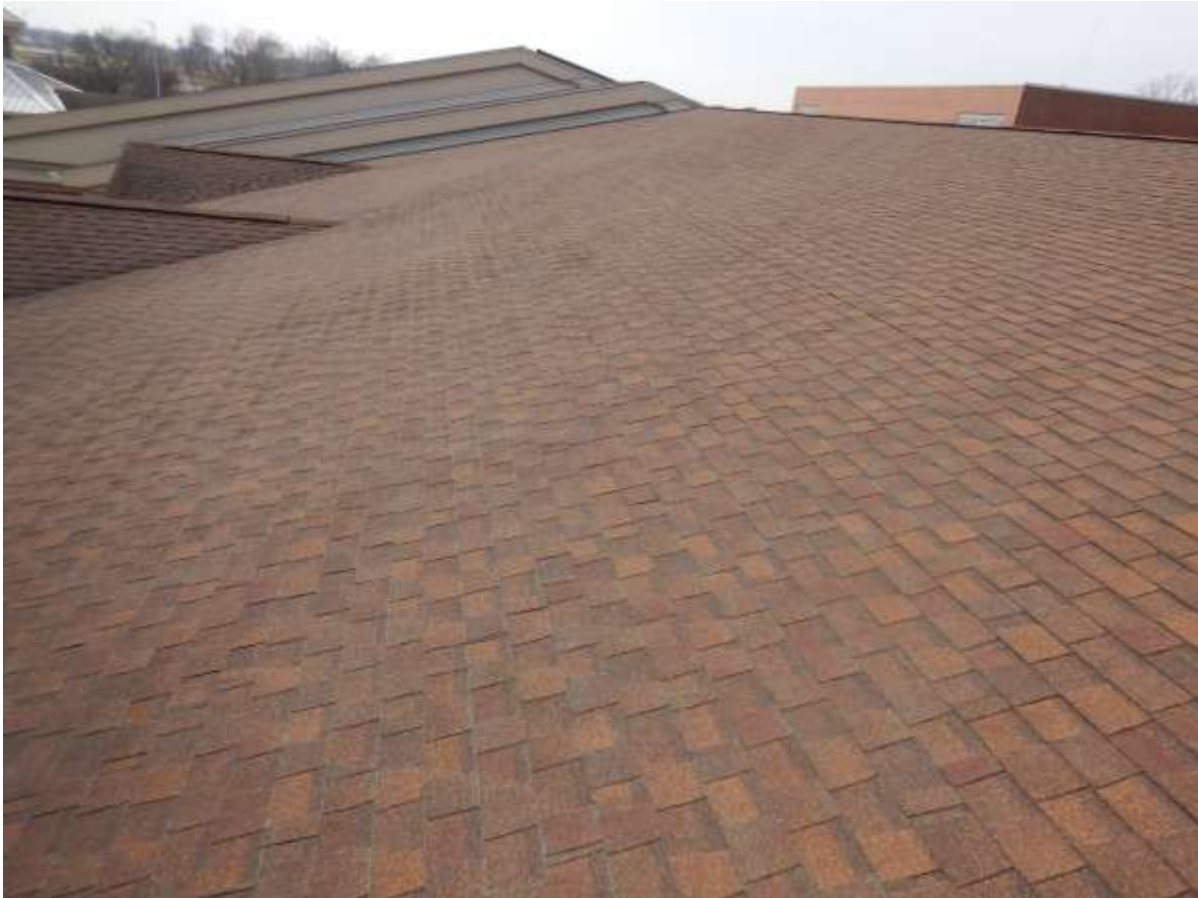
**PHOTO FIFTY-SEVEN**

**CONDITION:** An overview of the existing Dimensional Shingle Roof System on Section H2.

**RECOMMENDED ACTION:** For your information.

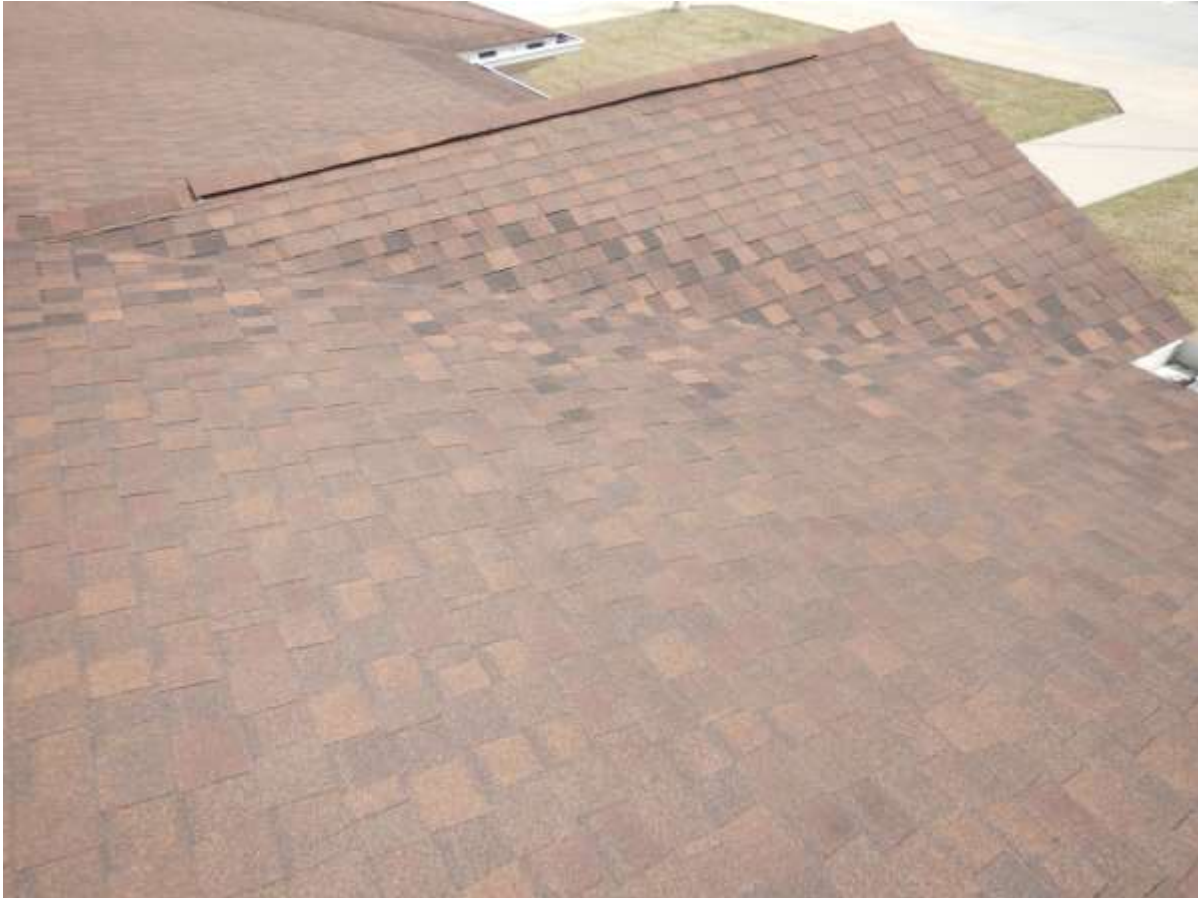
**PHOTO FIFTY-EIGHT**

**CONDITION:** Previous repairs were noted in widespread locations.

**RECOMMENDED ACTION:** This condition will be corrected during roof replacement.

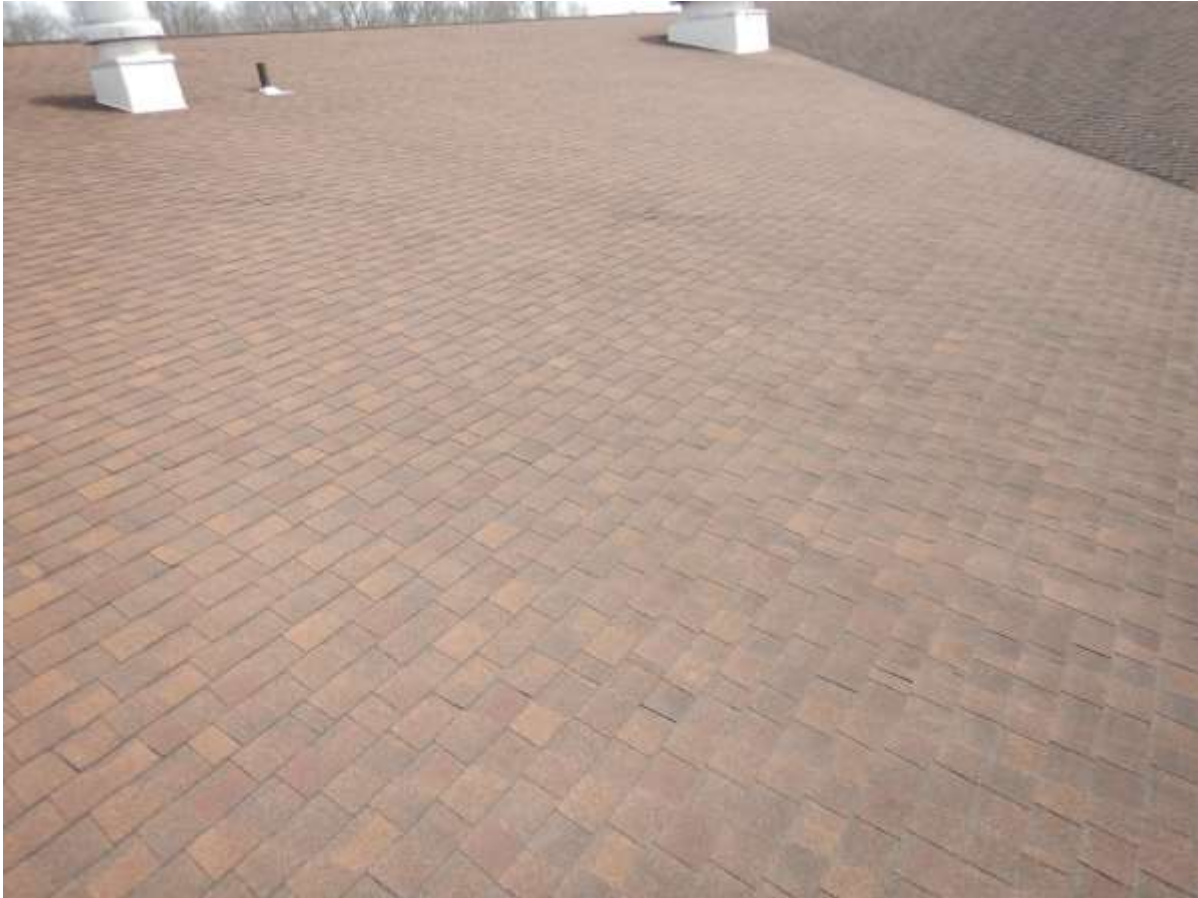
**PHOTO SIXTY-ONE**

**CONDITION:** An overview of the existing Dimensional Shingle Roof System on Section I1.

**RECOMMENDED ACTION:** For your information.

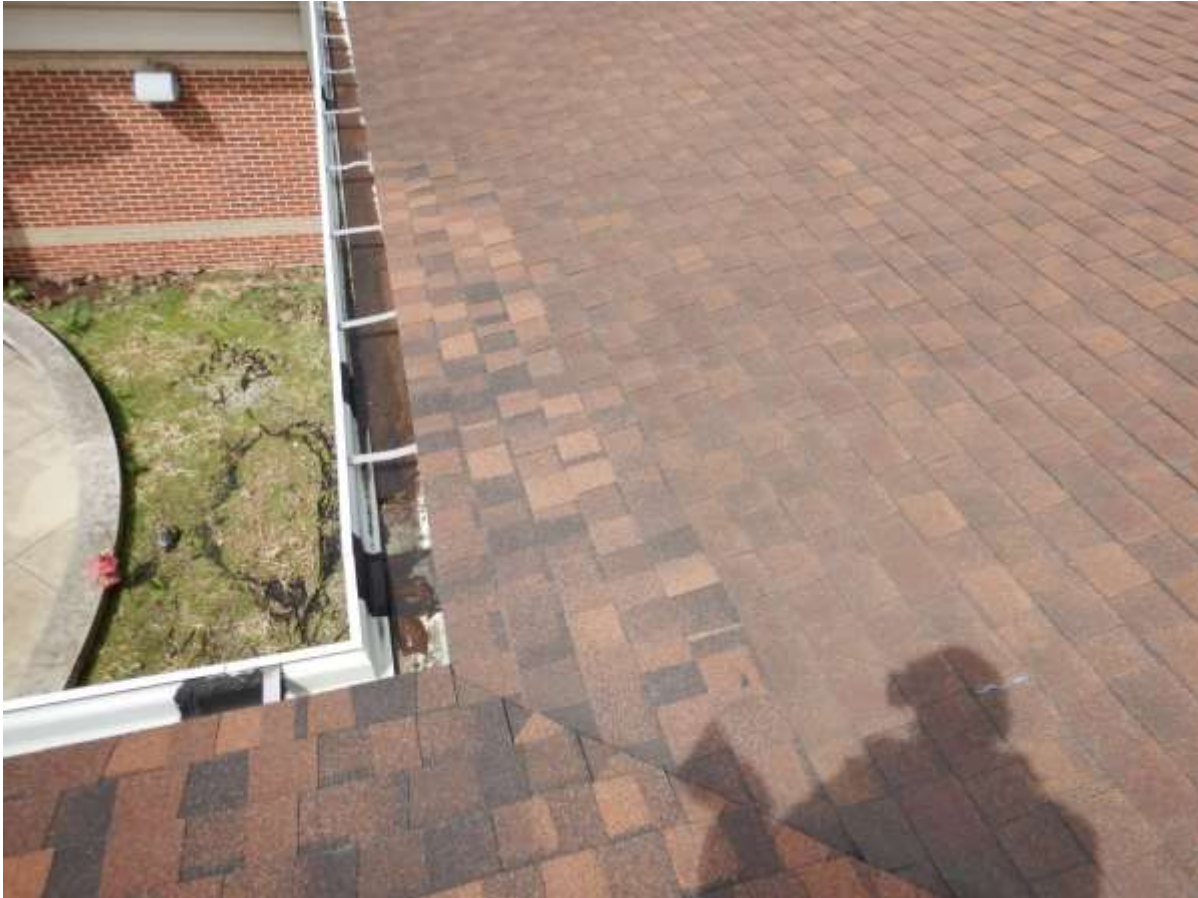
**PHOTO SIXTY-FOUR**

**CONDITION:** Previous repairs were noted in random locations.

**RECOMMENDED ACTION:** This condition will be corrected during roof replacement.

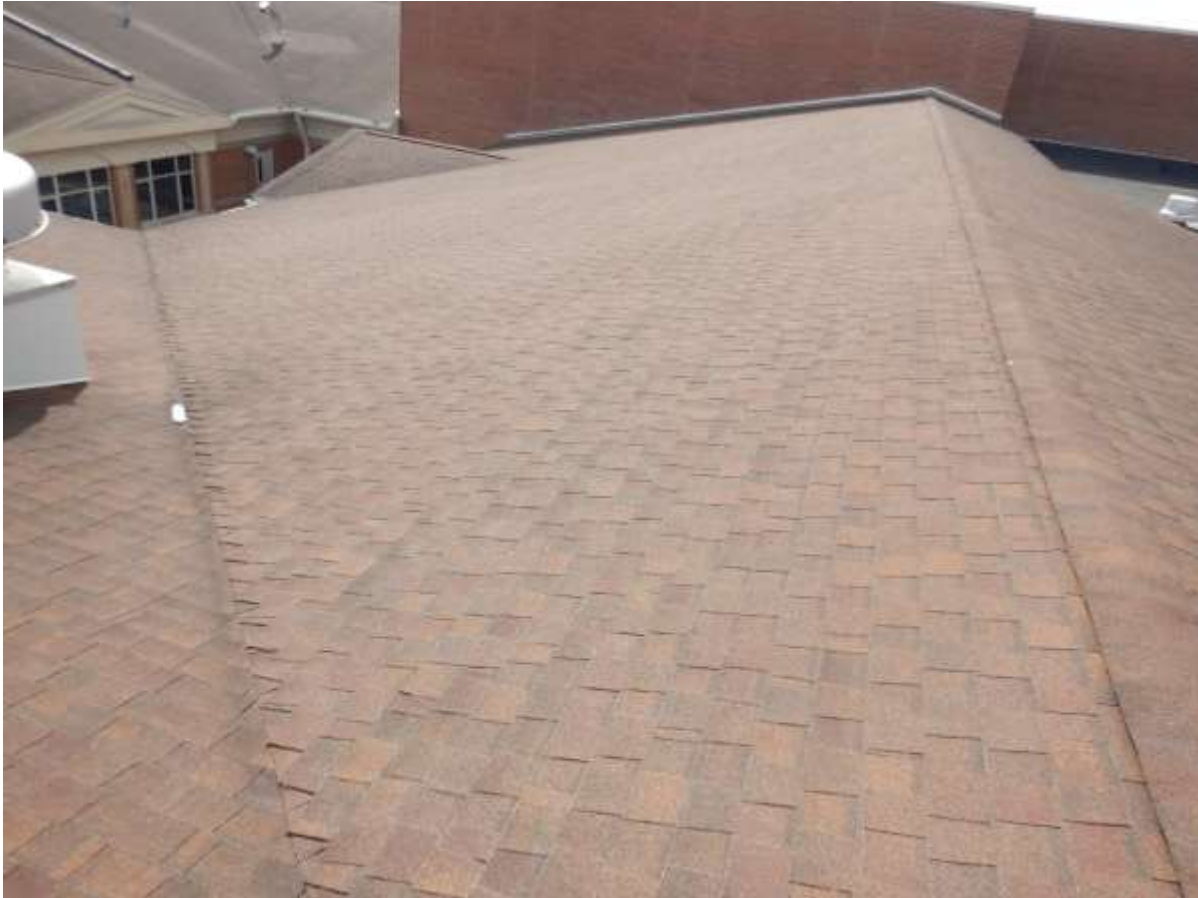
**PHOTO SEVENTY-FOUR**

**CONDITION:** An overview of the existing Dimensional Shingle Roof System on Section J1.

**RECOMMENDED ACTION:** For your information.

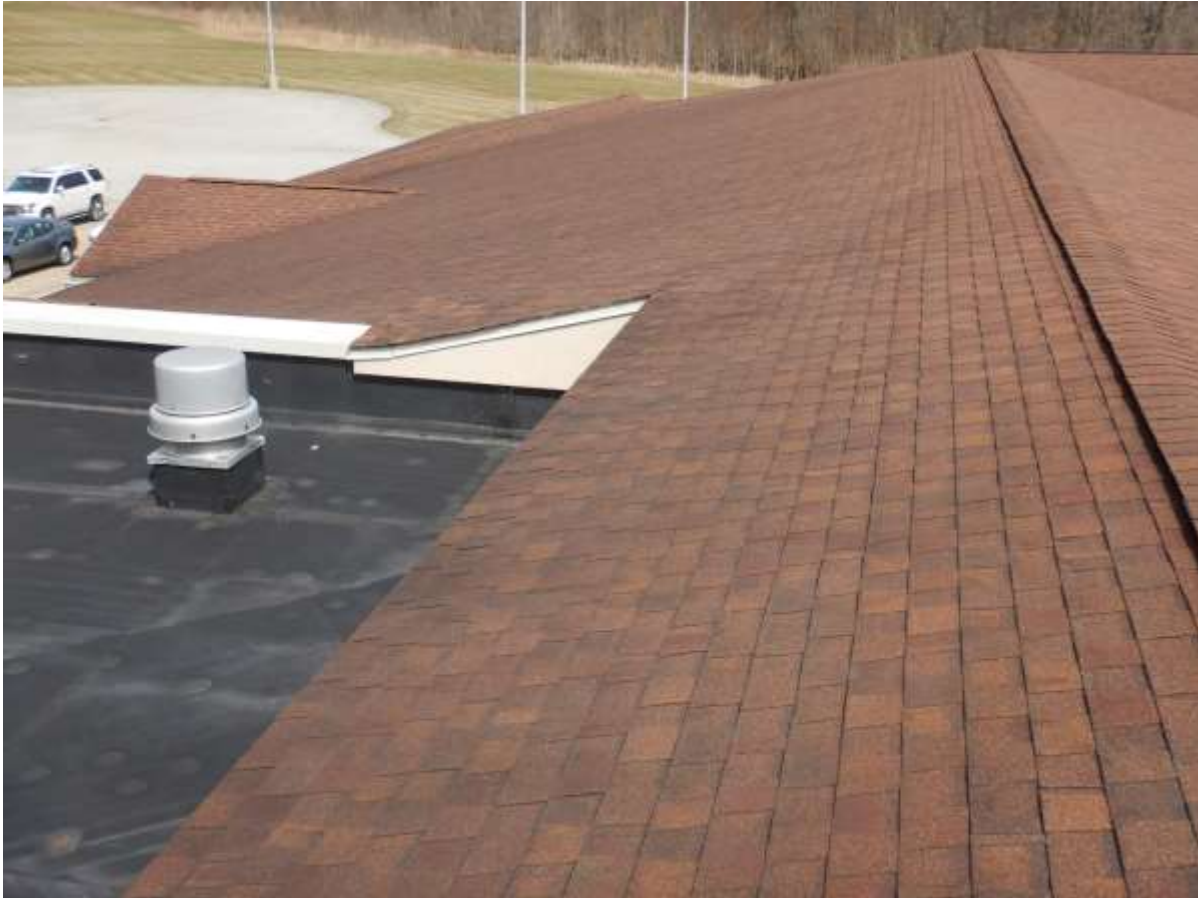
**PHOTO SEVENTY-NINE**

**CONDITION:** An overview of the existing Dimensional Shingle Roof System on Section J2.

**RECOMMENDED ACTION:** For your information.

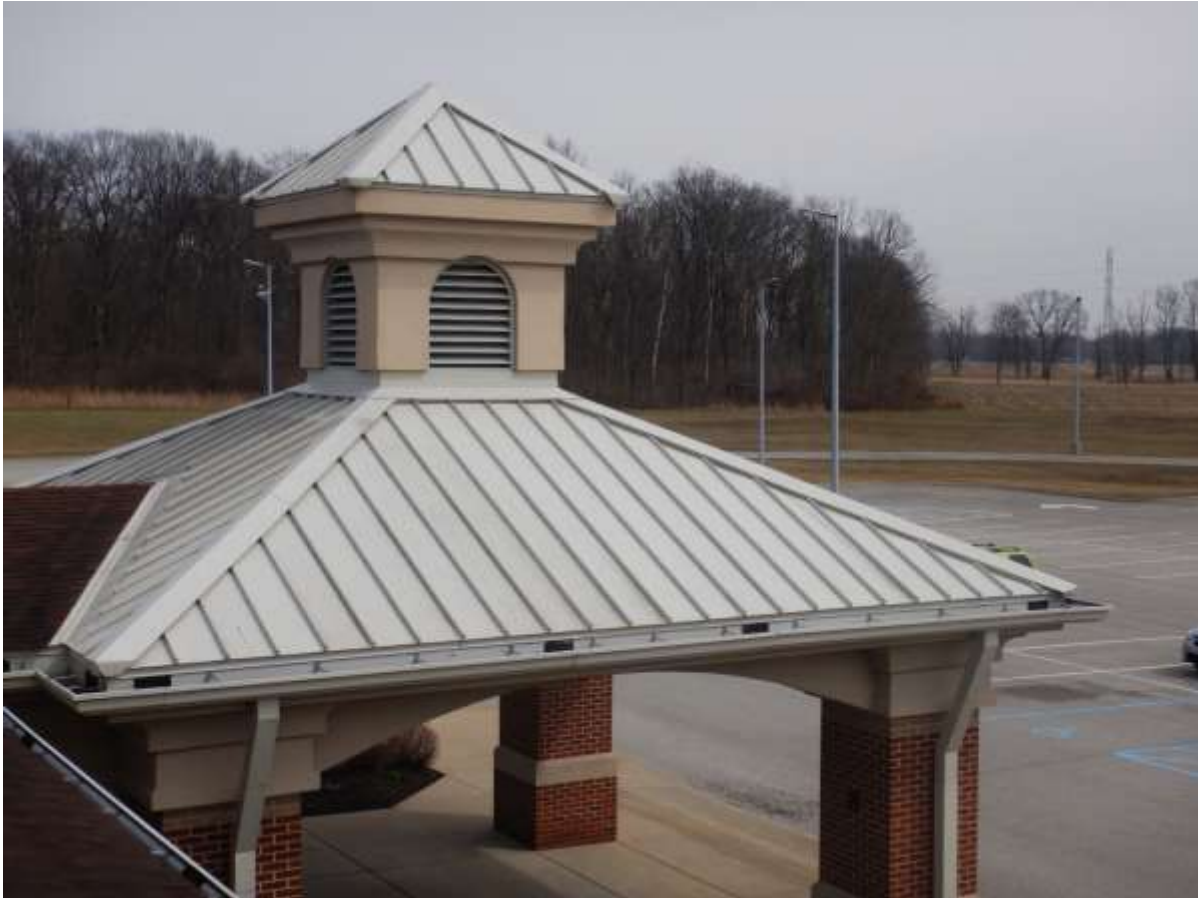
**PHOTO EIGHTY-TWO**

**CONDITION:** An overview of the Metal Roof System on Section K.

**RECOMMENDED ACTION:** For your information.

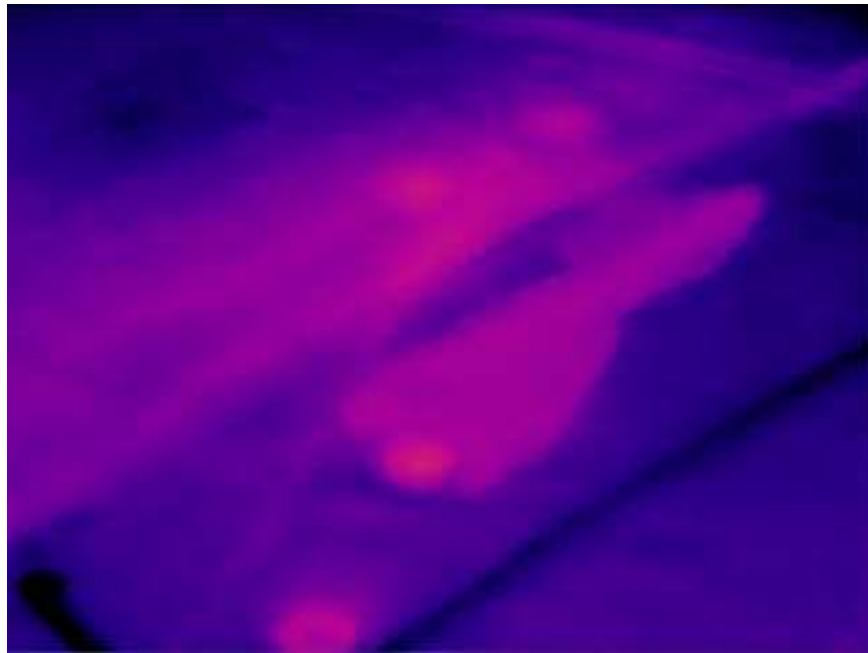
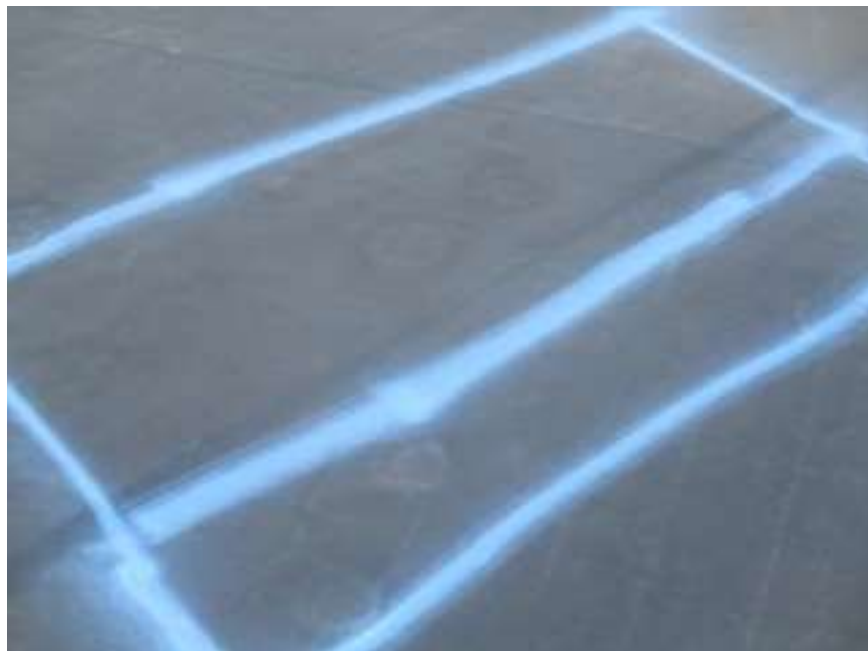
**LOCATION:** Roof Section B, Wet Area #1

**REMARKS:** The brighter area appearing on the surface of the roof depicts moisture laden insulation. This small wet area is the result of a puncture in the surface membrane.

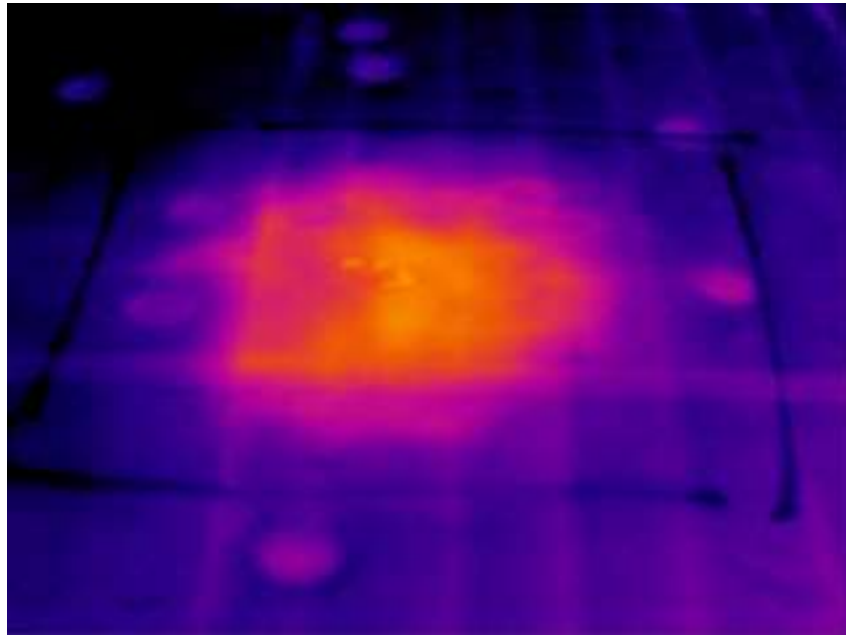
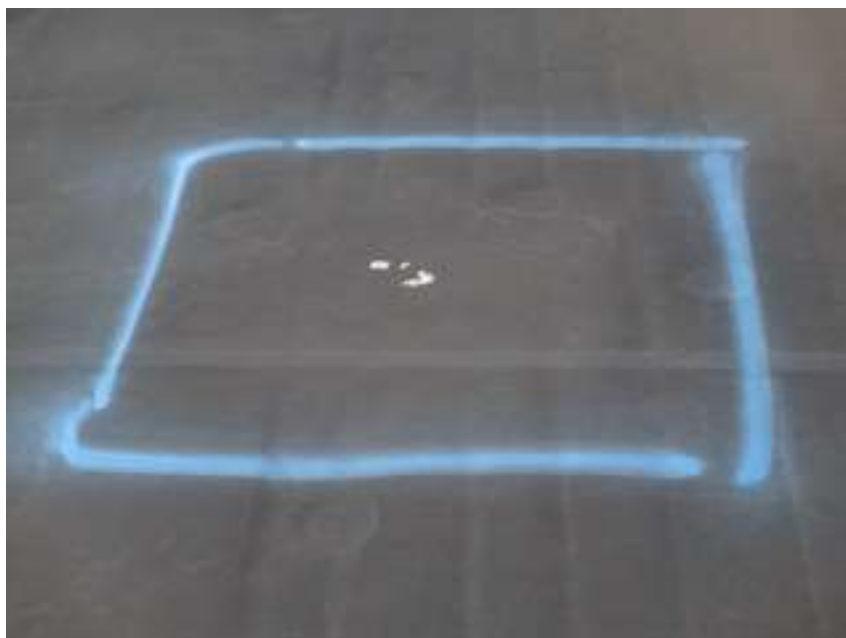
**LOCATION:** Roof Section C, Wet Area #3

**REMARKS:** There is a distinct difference between wet and dry insulation visible in this infrared image. Sub-surface moisture is spreading out from the brightest, or most saturated insulation in this area.
